UNITED STATES  
NUCLEAR REGULATORY COMMISSION  
OFFICE OF INSPECTION AND ENFORCEMENT  
WASHINGTON, D.C. 20555

IE Bulletin No. 79-13

## CRACKING IN FEEDWATER SYSTEM PIPING

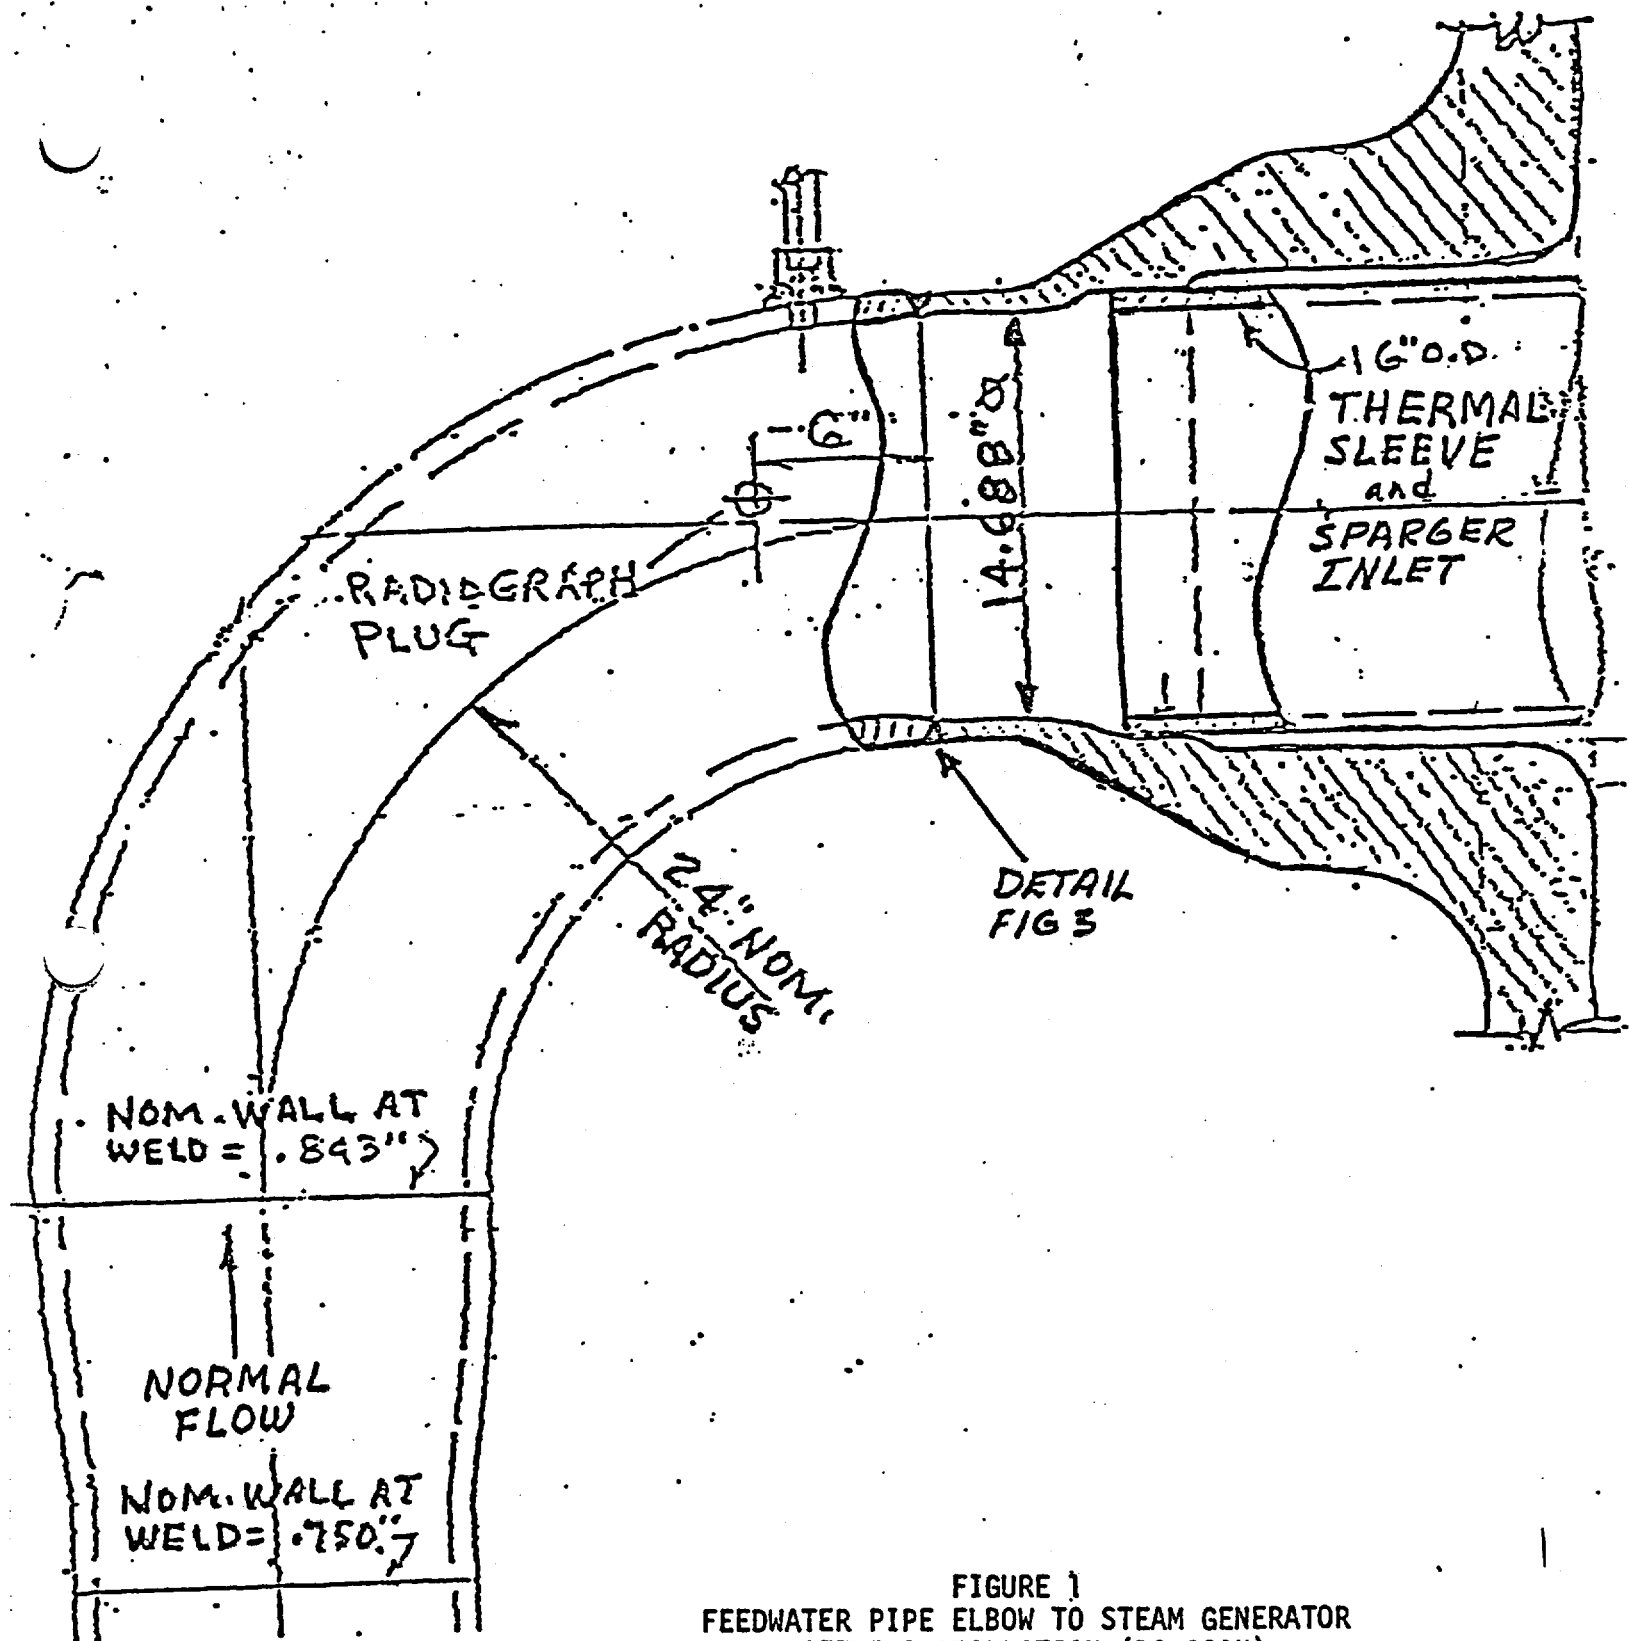
FIGURE 1  
FEEDWATER PIPE ELBOW TO STEAM GENERATOR  
NOZZLE INSTALLATION (DC COOK)

On May 20, 1979, Indiana and Michigan Power Company notified the NRC of cracking in two feedwater lines at their D. C. Cook Unit 2 facility. The cracking was discovered following a shutdown on May 19 to investigate leakage inside containment. Leaking circumferential cracks were identified in the 16-inch feedwater elbows adjacent to two steam generator nozzle elbow welds. Subsequent radiographic examination revealed crack indications in all eight steam generator feedwater lines at this location on both Units 1 and 2.

The feedwater nozzle-to-pipe configurations for D.C. Cook and for San Onofre are shown on the attached figures 1 and 2. A typical feedwater pipe-to-nozzle weld joint detail showing the principal crack locations for D.C. Cook and San Onofre are shown on the attached figure 3.

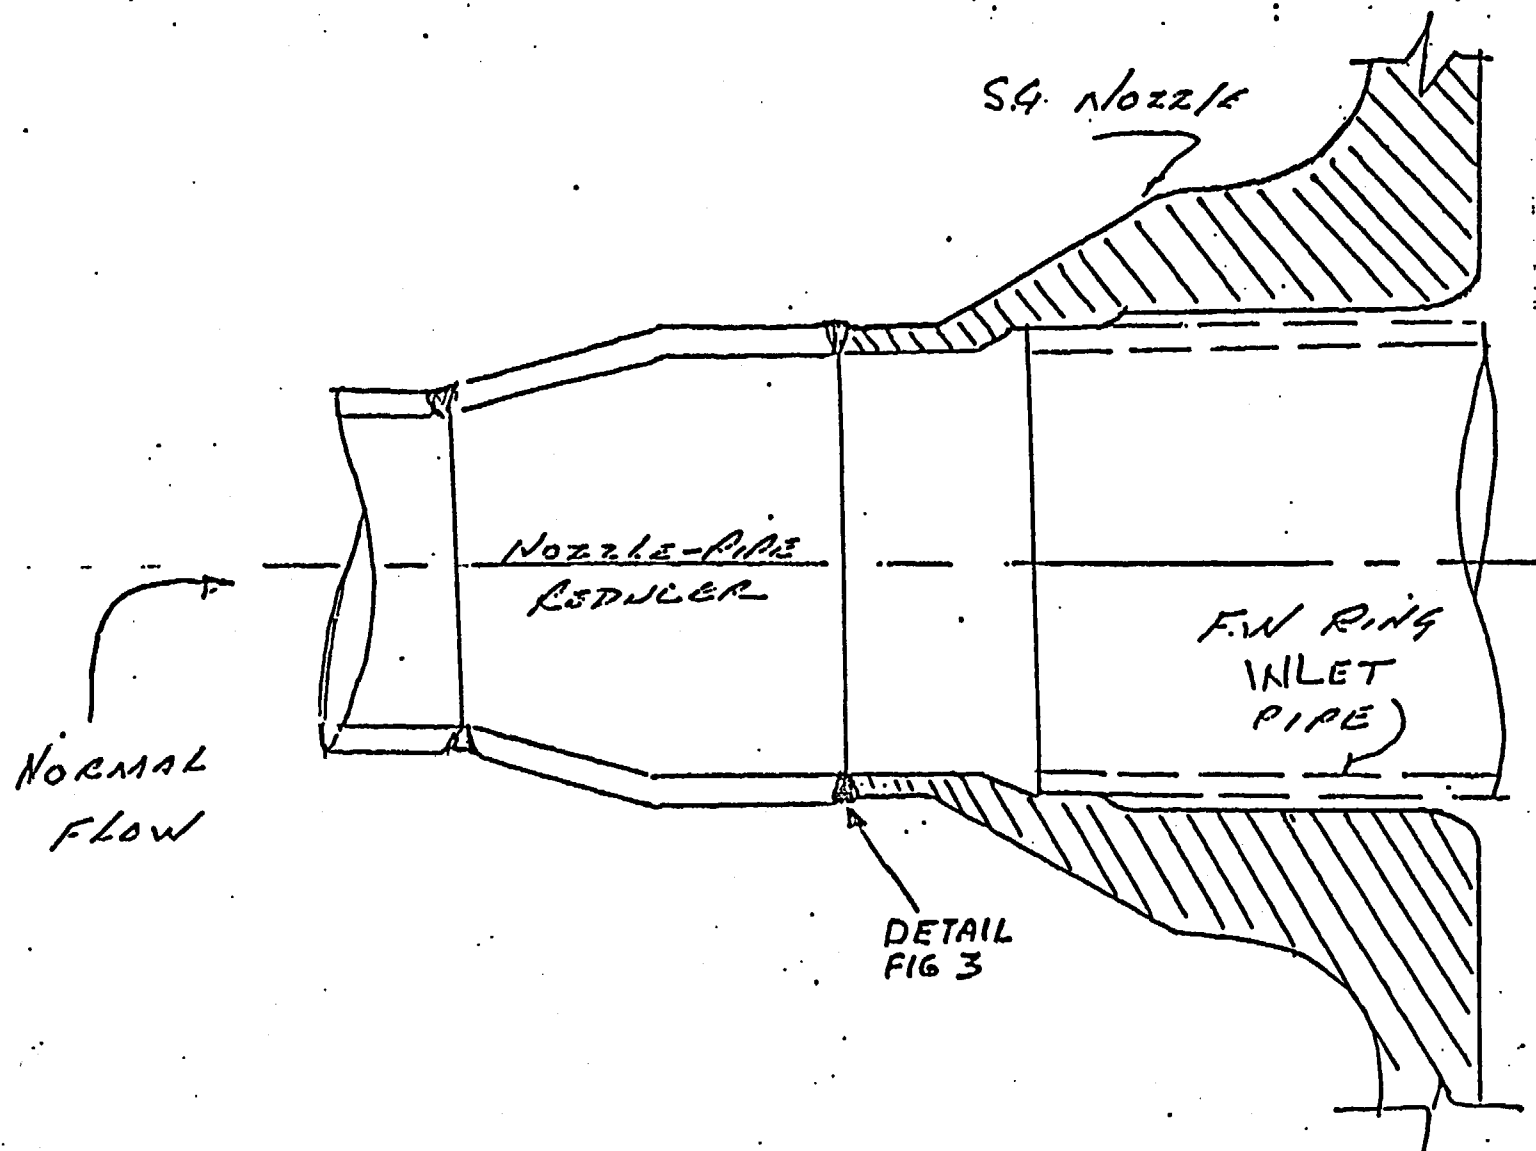
FIGURE 2  
FEEDWATER PIPE REDUCER TO STEAM GENERATOR  
NOZZLE INSTALLATION (SAN ONOFRE).

As a result of these actions, several other licensees with Westinghouse steam generators reported crack indications. Southern California Edison reported on June 5, 1979, that radiographic examination revealed indications of cracking in feedwater nozzle-to-piping welds on two of three steam generators of San Onofre Unit 1. On June 15, 1979, Carolina Power and Light reported that radiography showed crack indications in similar locations at their H. B. Robinson Unit 2. Duquesne Power and Light confirmed on June 18, 1979, that radiography has shown cracking in their Beaver Valley Unit 1 feedwater piping to vessel nozzle weld. Public Service Electric and Gas Company reported on June 20, 1979 that Salem Unit 1 also has crack indications. Wisconsin Public Service company decided on June 20, 1979 to cut out a feedwater nozzle to pipe weld which contained questionable indication, for metallurgical examination. As of June 22, 1979 and since May 25, 1979 seven other PWR facilities have inspected the feedwater nozzle-to-pipe welds without finding cracking indications.

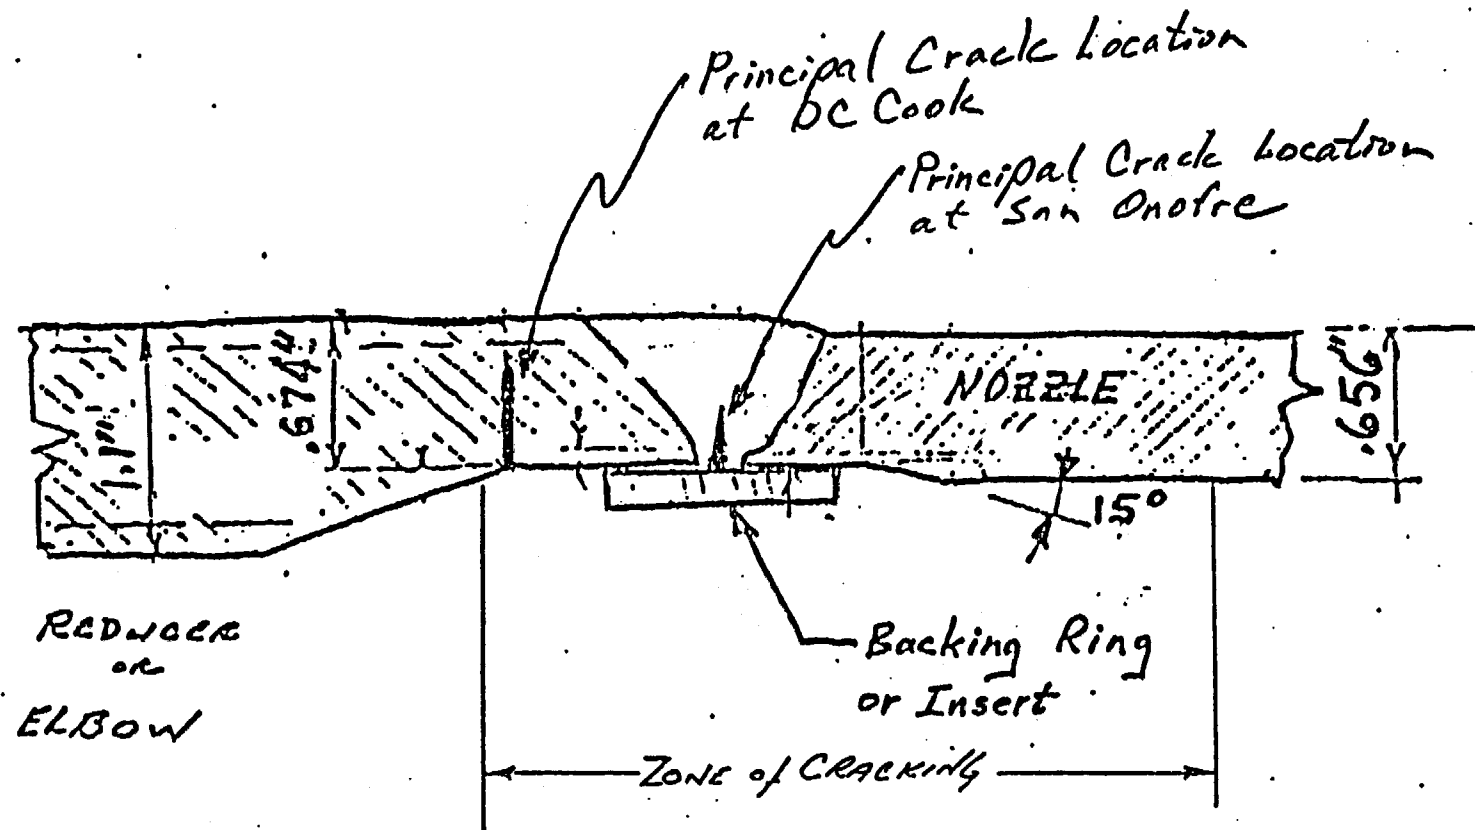
FIGURE 3  
TYPICAL FEEDWATER PIPE TO NOZZLE  
WELD JOINT DETAIL  
( W , CE )

Cracked weldments have been removed from the D. C. Cook Units 1 and 2 and San Onofre Unit 1 feedwater systems for extensive metallurgical investigation by Westinghouse. Based on preliminary analysis, Westinghouse stated the D. C. Cook failure may be "fatigue assisted by corrosion." The San Onofre cracking was stated to be characteristic of "stress assisted corrosion."
