UNITED STATES
NUCLEAR REGULATORY COMMISSION
OFFICE OF NUCLEAR REACTOR REGULATION
WASHINGTON, D.C. 20555

NRC BULLETIN NO. 88-01: DEFECTS IN WESTINGHOUSE CIRCUIT BREAKERS

Subject			Westinghouse Circuit Breakers Type DS/DSL: Welds on Breaker's Pole Shaft			Number			NSID-TB-87-11		
System(s)			All Plant Systems			Date			December 1, 1987		
Affected Plants			All Plants with DS/DSL Circuit Breakers			S.O.(s)			309, 386, BOP		
References			See Below			Affects Safety Related Equipment			Yes <input checked="" type="checkbox"/> No <input type="checkbox"/>		
						Sheet			1 Of 17

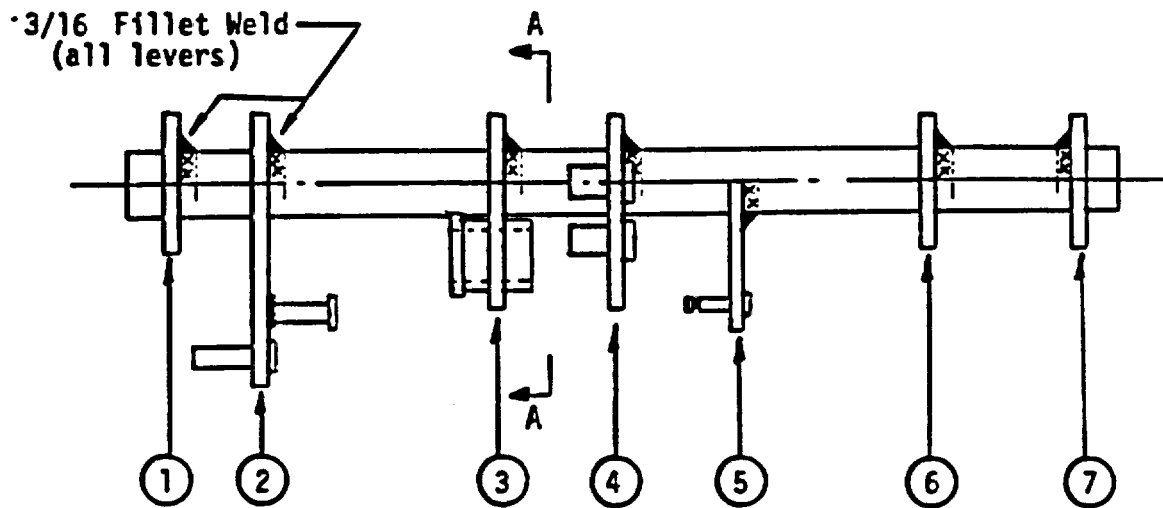
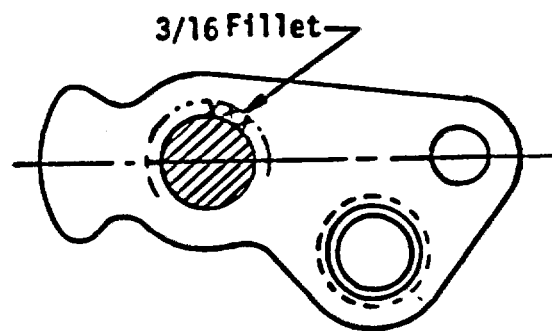
FIGURE 1

This section lists the criteria to be applied to the welds for the three pole levers on the pole shaft. See Figure 1, items 2, 3, and 6. The remaining welds are discussed in Section 7.0.

- 6.1.1 A pole shaft, for which the 3 noted welds meet or exceed all of the criteria listed below, is to be considered acceptable for continued service up to the limit defined in Section 6.2.1.
 - a) weld size - 3/16 inch fillet
 - b) length - 180° continuous around the pole shaft
 - c) fusion - fused to lever and shaft for the above length
 - d) cracks - no cracks are allowed
- 6.1.2 If the criteria listed in 6.1.1 are not satisfied, the pole shaft can still be retained in service, but for a limited time as defined in 6.2.2, provided it meets or exceeds the criteria given below.

- a) weld size and length - 3/16 inch fillet for 90° continuously around the pole shaft, or 1/8 inch fillet for 120° continuously around the pole shaft
- b) fusion - fused to lever and shaft for the above length
- c) cracks - no cracks are allowed

This section lists the criteria for acceptance of the 4 welds on the pole shaft, which were not addressed in short-term inspection described in Section 6.0. See Figure 1, items 1, 4, 5 and 7.

- a) size and length - at least 3/16 inch fillet for a minimum of 90° continuously around the shaft, or at least 1/8 inch fillet for a minimum of 120° continuously around the shaft.
- b) fusion - good fusion along both legs of weld.
- c) cracks - no cracks are allowed.

Exception - The lever for the Auxiliary Switch Drive Link spans about 90° around the shaft, and carries an extremely light load. This lever should be checked for a well fused joint only.

If the above criteria are not met, replace the pole shaft prior to returning the breaker for service.
