UNITED STATES  
NUCLEAR REGULATORY COMMISSION  
OFFICE OF NUCLEAR REACTOR REGULATION  
WASHINGTON, D.C. 20555

February 5, 1988

**NRC BULLETIN NO. 88-02: RAPIDLY PROPAGATING FATIGUE CRACKS IN STEAM  
GENERATOR TUBES**

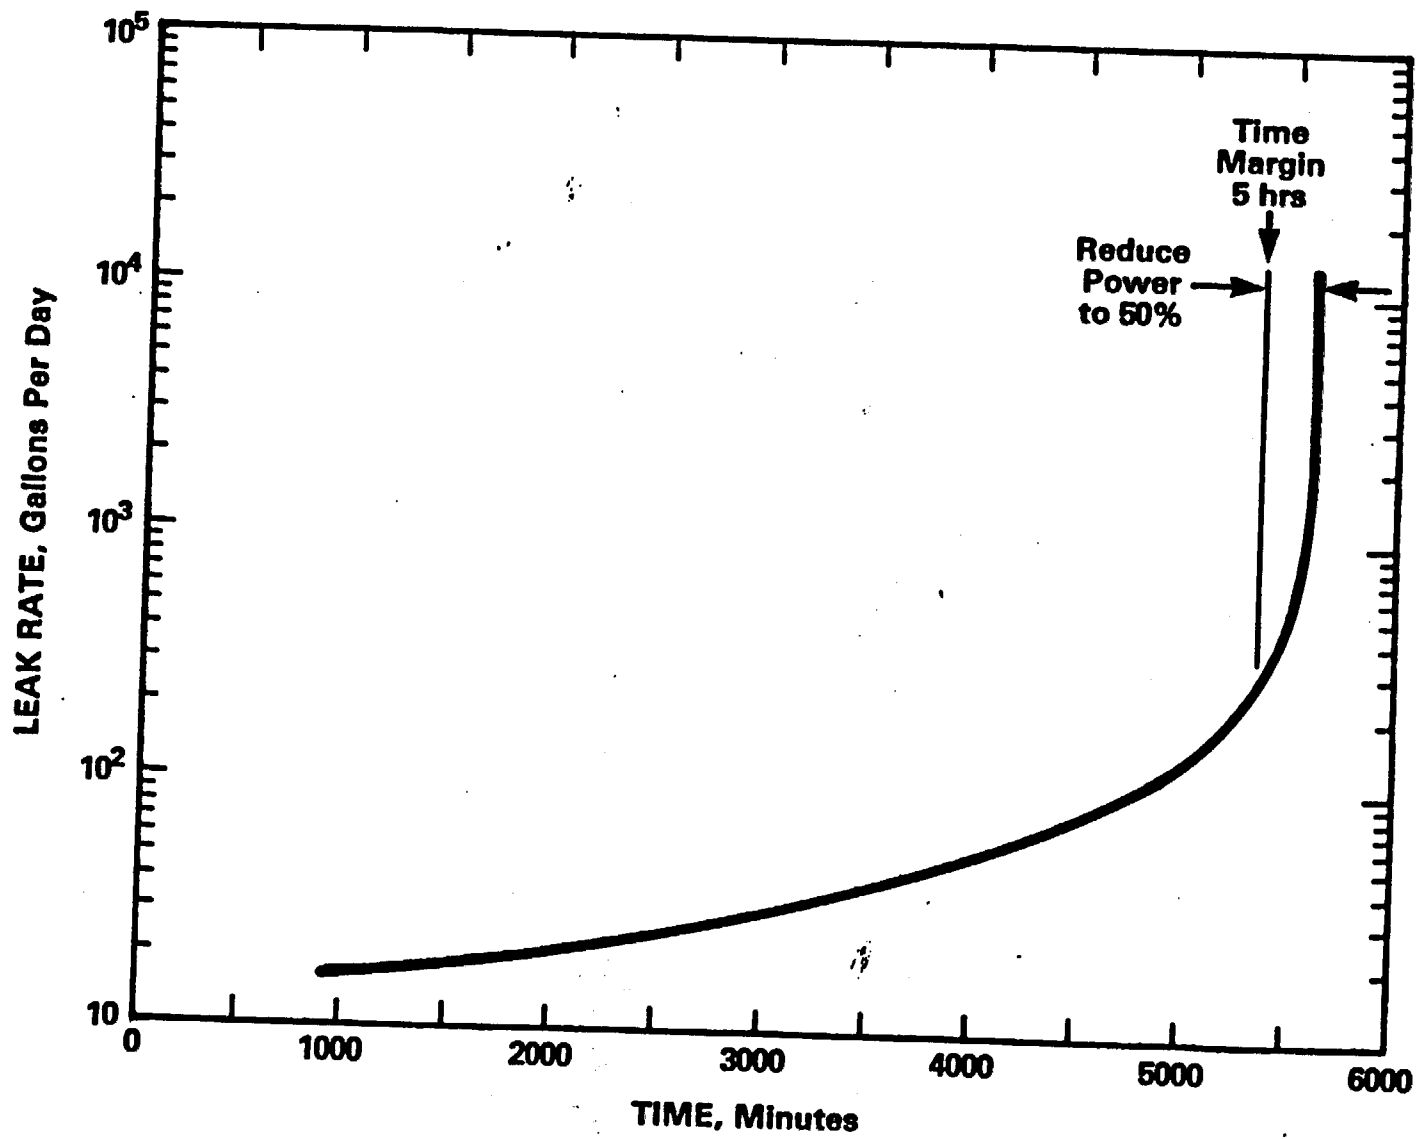
Figure 1 LEAK RATE VERSUS TIME,

- C. For plants where denting is found, the NRC staff requests that the following actions be taken:
1. Pending completion of the NRC staff review and approval of the program described in C.2 below or completion of inspections specified in item A above to confirm that denting does not exist, an enhanced primary-to-secondary leak rate monitoring program should be implemented as an interim compensatory measure within 45 days of the date of receipt of this bulletin.\* Implementation of this program shall be documented as part of the 45-day report. The enhanced monitoring program is intended to ensure that if a rapidly propagating fatigue crack occurs under flow-induced vibration, the plant power level would be reduced to 50% power or less at least 5 hours before a tube rupture was predicted to occur. The effectiveness of this program should be evaluated against the assumed time-dependent leakage curve given in Figure 1.

This program should consider and provide the necessary leakage measurement and trending methods, time intervals between measurements, alarms and alarm setpoints, intermediate actions based on leak rates or receipt of alarms, administrative limits for commencing plant shutdown, and time limitations for (1) reducing power to less than 50% and (2) shutting down to cold shutdown. Appropriate allowances for instrument errors should be considered. Finally, the program should make provision for out of service radiation monitors, including action statements and compensatory measures.
