UNITED STATES
NUCLEAR REGULATORY COMMISSION
OFFICE OF NUCLEAR REACTOR REGULATION
WASHINGTON, D.C. 20555

February 5, 1988

NRC BULLETIN NO. 88-02: RAPIDLY PROPAGATING FATIGUE CRACKS IN STEAM
GENERATOR TUBES

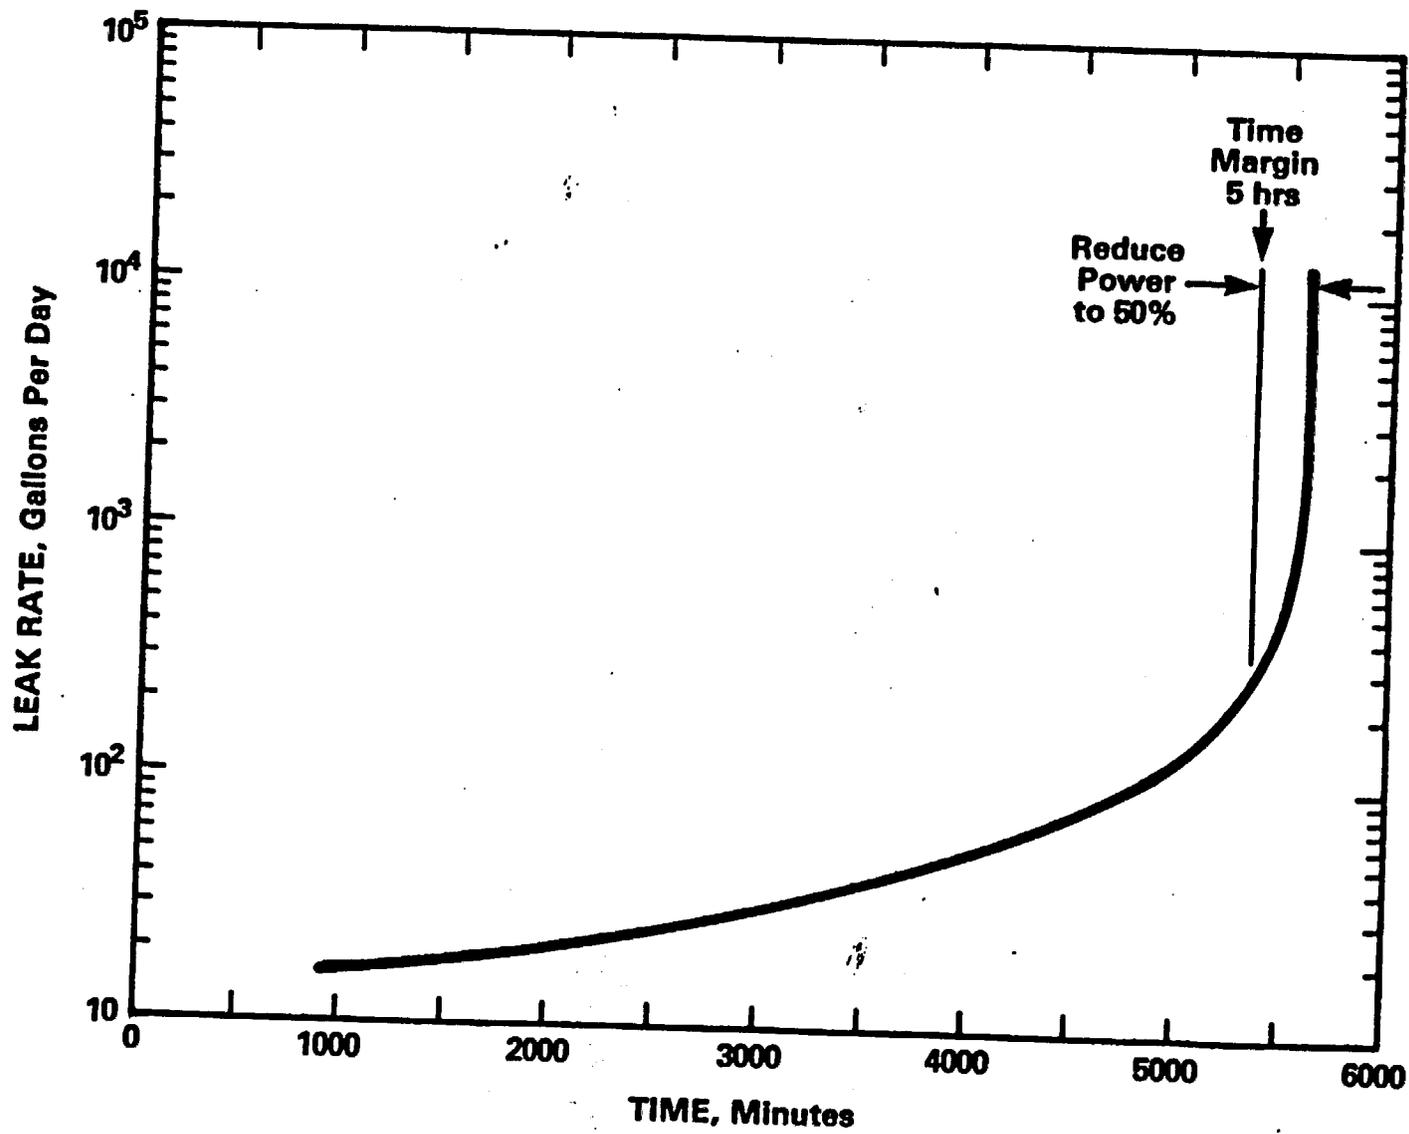
Figure 1 LEAK RATE VERSUS TIME,

- C. For plants where denting is found, the NRC staff requests that the following actions be taken:
1. Pending completion of the NRC staff review and approval of the program described in C.2 below or completion of inspections specified in item A above to confirm that denting does not exist, an enhanced primary-to-secondary leak rate monitoring program should be implemented as an interim compensatory measure within 45 days of the date of receipt of this bulletin.* Implementation of this program shall be documented as part of the 45-day report. The enhanced monitoring program is intended to ensure that if a rapidly propagating fatigue crack occurs under flow-induced vibration, the plant power level would be reduced to 50% power or less at least 5 hours before a tube rupture was predicted to occur. The effectiveness of this program should be evaluated against the assumed time-dependent leakage curve given in Figure 1.

This program should consider and provide the necessary leakage measurement and trending methods, time intervals between measurements, alarms and alarm setpoints, intermediate actions based on leak rates or receipt of alarms, administrative limits for commencing plant shutdown, and time limitations for (1) reducing power to less than 50% and (2) shutting down to cold shutdown. Appropriate allowances for instrument errors should be considered. Finally, the program should make provision for out of service radiation monitors, including action statements and compensatory measures.
