UNITED STATES  
NUCLEAR REGULATORY COMMISSION  
OFFICE OF INSPECTION AND ENFORCEMENT  
WASHINGTON, D.C. 20555

IE Bulletin No. 79-15

## DEEP DRAFT PUMP DEFICIENCIES

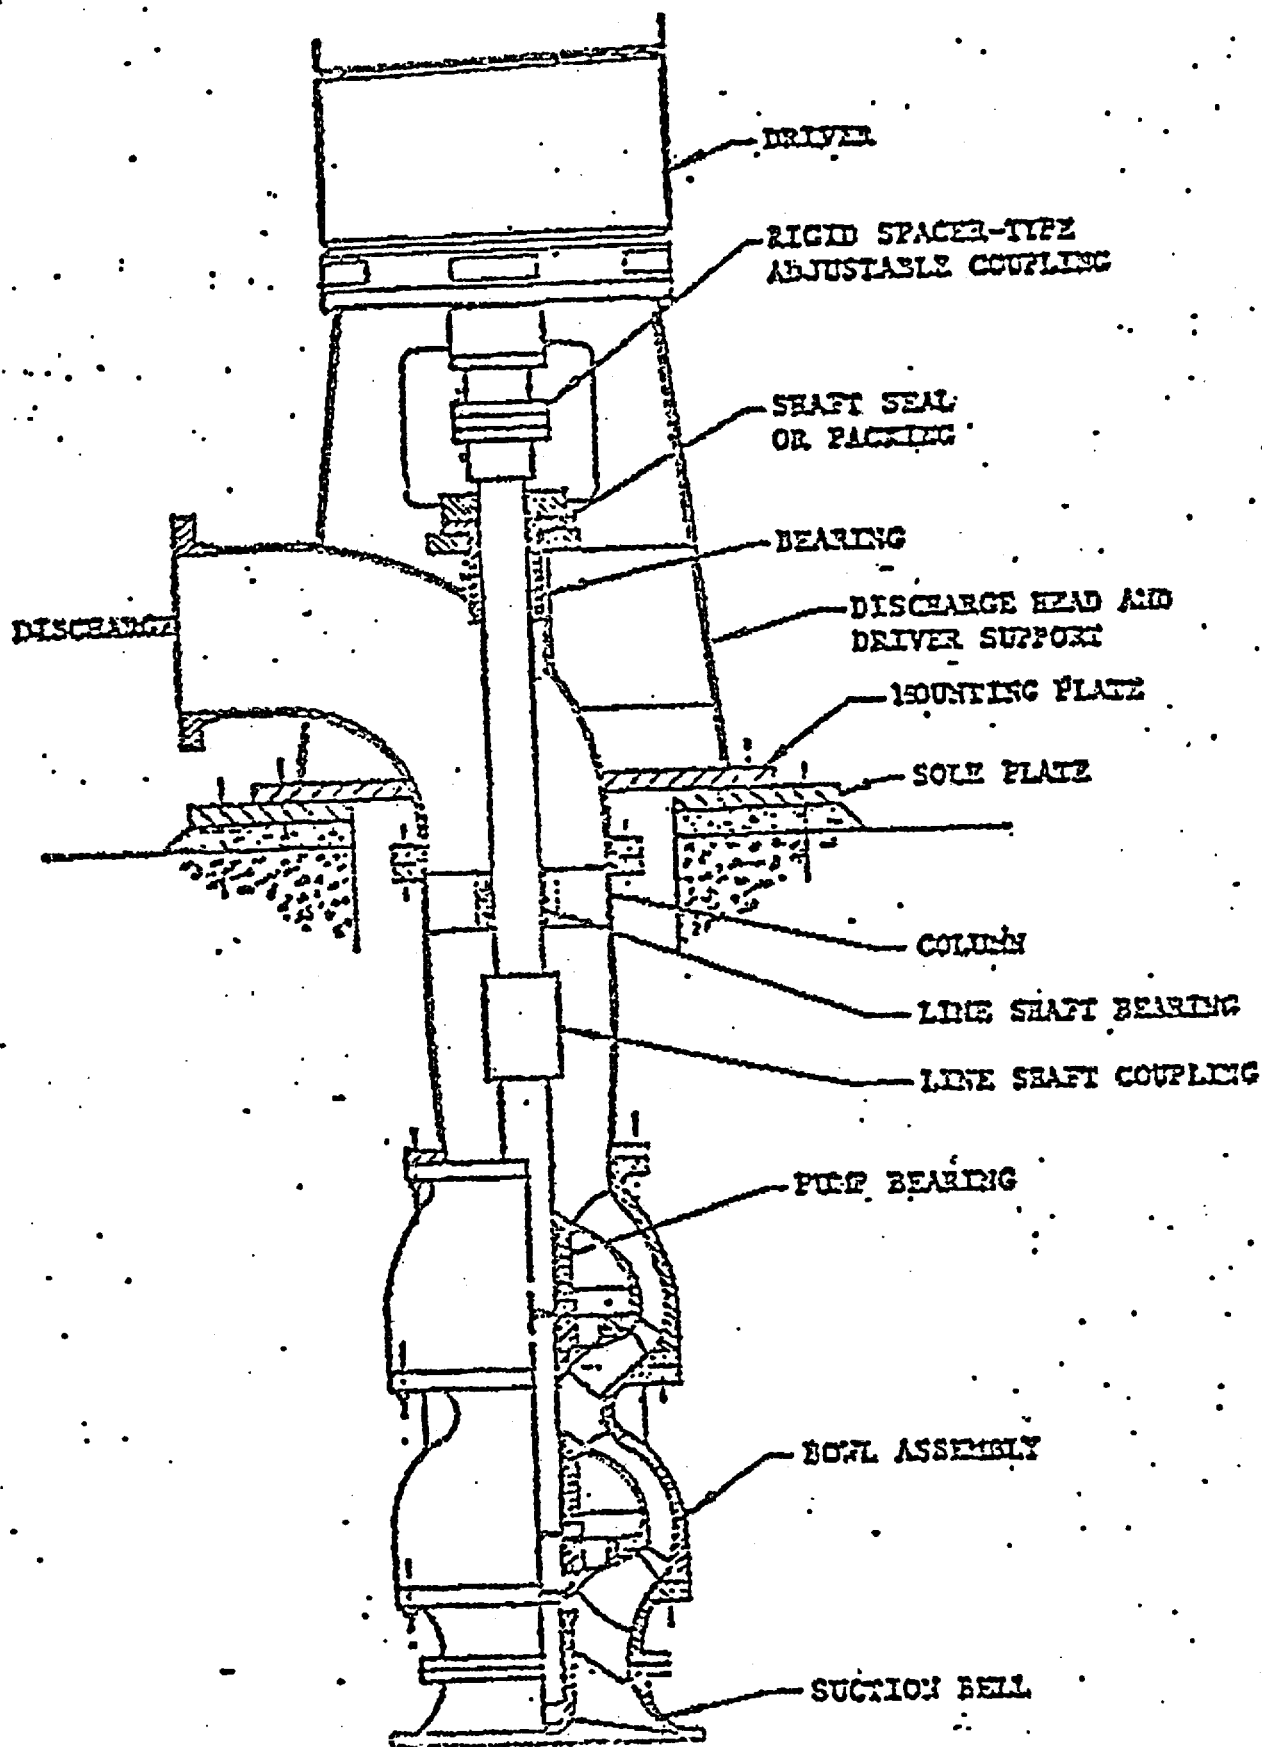
FIGURE 4

VERTICAL TURBINE PUMP

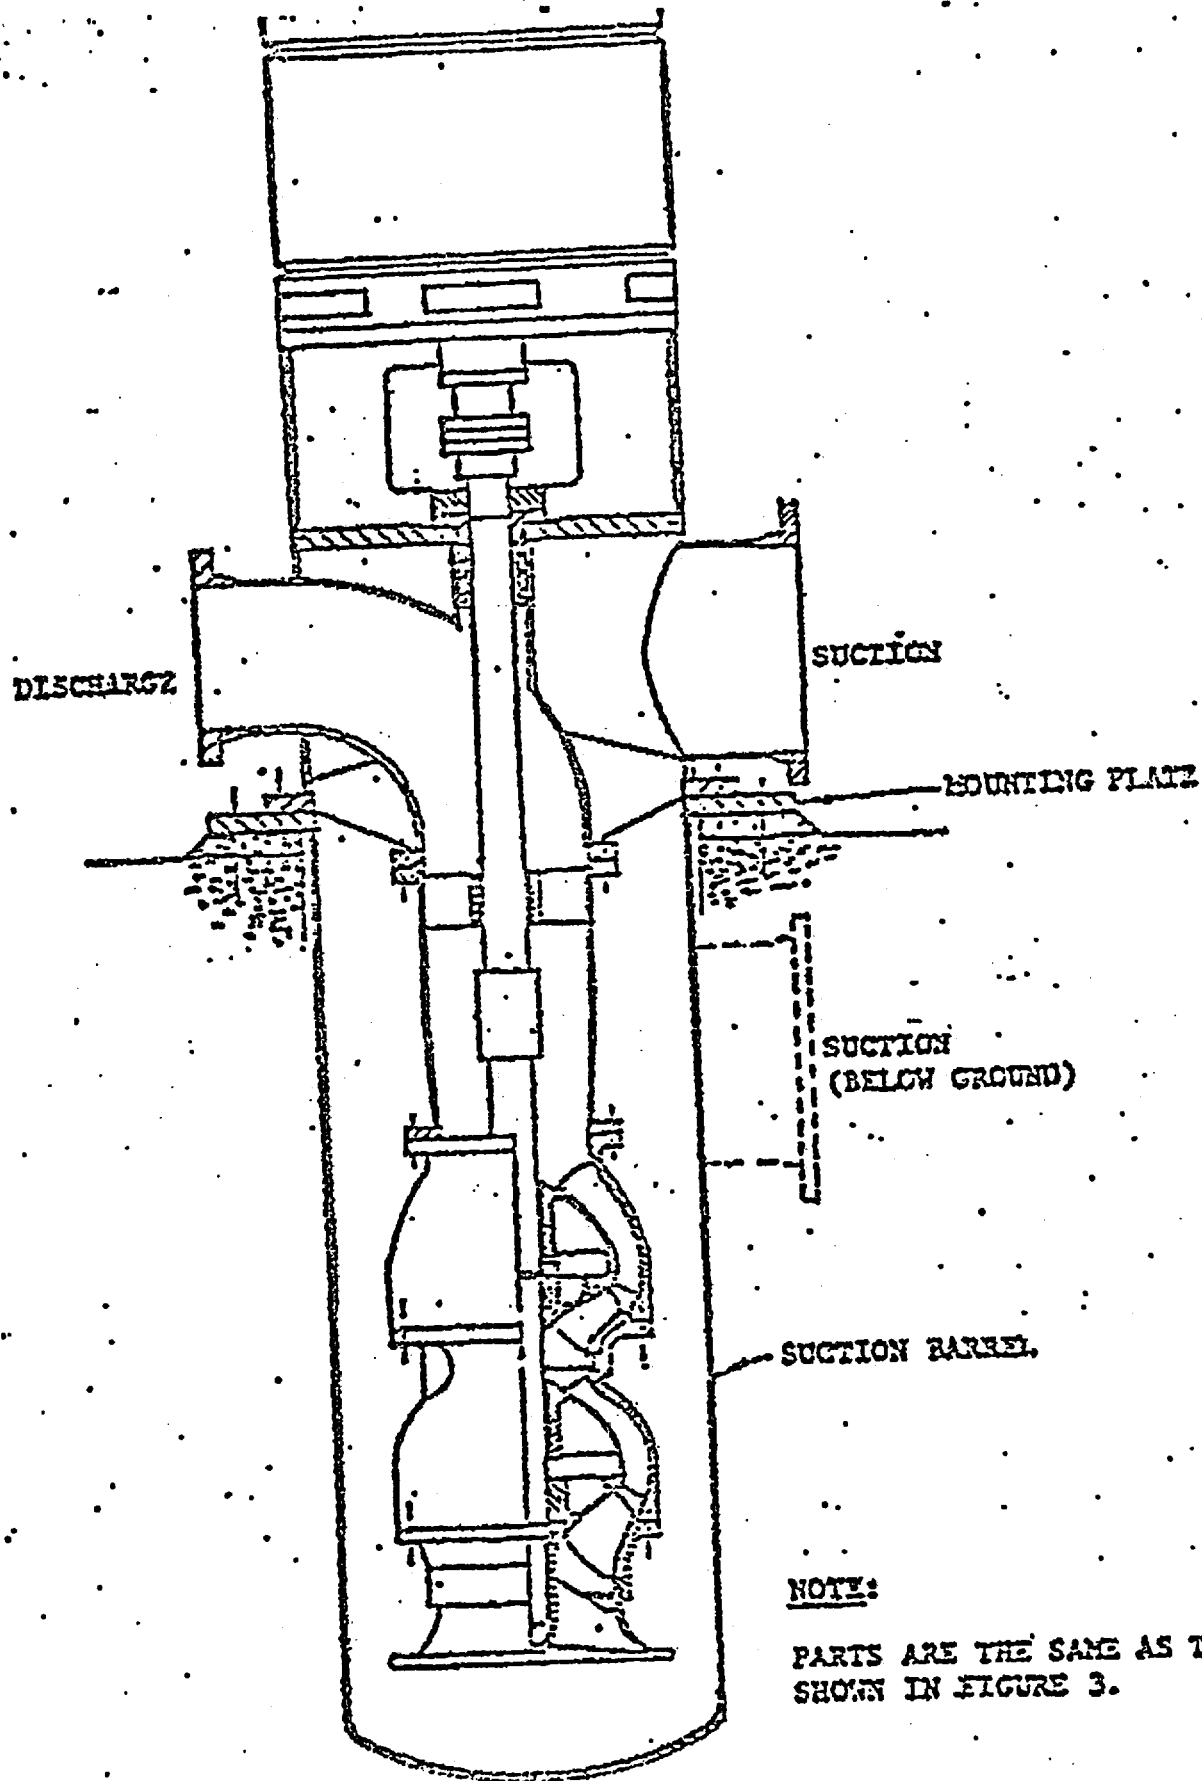
FIGURE 2.

PARTS ARE THE SAME AS THOSE  
SHOWN IN FIGURE 3.

CROSS SECTION OF PUMP  
AND SUCTION BARREL
