UNITED STATES
NUCLEAR REGULATORY COMMISSION
OFFICE OF NUCLEAR REACTOR REGULATION
WASHINGTON, D. C. 20555

June 24, 1988

NRC BULLETIN NO. 88-08, SUPPLEMENT 1: THERMAL STRESSES IN PIPING CONNECTED
TO REACTOR COOLANT SYSTEMS

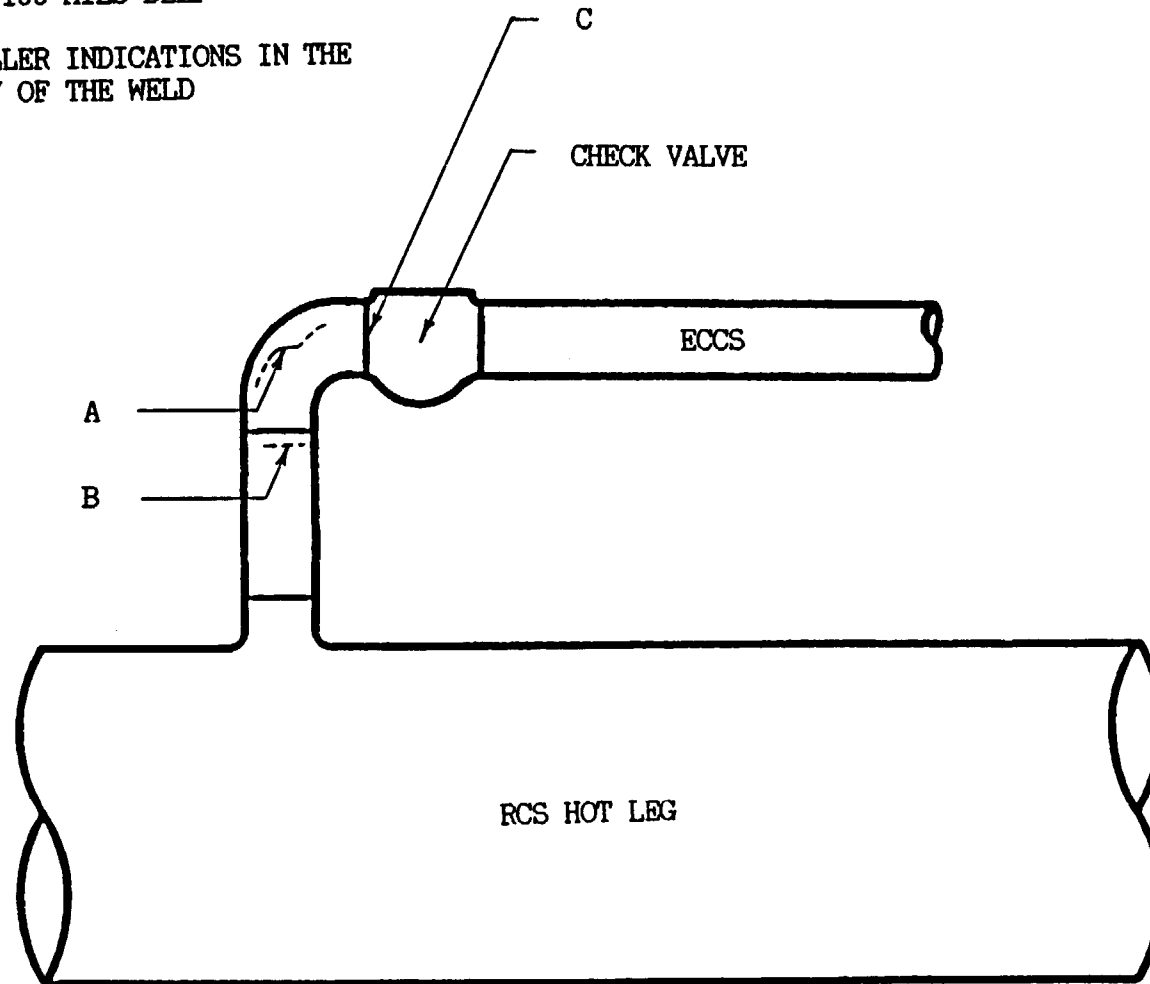
TIHANGE 1 PIPING

Tihange 1 is an 870 MWe, Westinghouse-type, 3-loop, pressurized-water reactor located at Tihange, Belgium. On June 18, 1988, while the reactor was operating, a sudden leak occurred in a short, unisolable section of emergency core cooling system (ECCS) piping that is connected to the hot leg of loop 1 of the RCS. The operator noted increases in radioactivity and moisture within containment and a decrease of water level in the volume control tank. The leak rate was 6 gpm, and the source of leakage was a crack extending through the wall of the piping. The location of the crack and its orientation are shown in Figure 1.

The crack, which is in the base metal of the elbow wall and not in the weld or heat-affected zone, is 3.5 inches long on the inside surface of the elbow and 1.6 inches long on the outside surface. A crack indication also exists in the spool connecting the elbow to the nozzle in the RCS hot leg. That indication is in the heat-affected zone at the weld connecting the spool to the elbow. The indication is circumferential, extends 3.9 inches on the inner surface of the spool, and is 100 mils deep. Two smaller indications exist in the vicinity of the weld connecting the elbow to the check valve.

A - THROUGH-WALL CRACK, 3.5 INCHES LONG
INSIDE, 1.6 INCHES LONG OUTSIDE

B - CRACK INDICATION, 3.9 INCHES LONG
INSIDE, 100 MILS DEEP

C - TWO SMALLER INDICATIONS IN THE
VICINITY OF THE WELD

Although the actions requested in NRC Bulletin 88-08 are unchanged, it should be noted that examinations of high stress locations would include the base metal, as appropriate.
