SSINS No.: 6835  
IN 86-01

January 6, 1986

IE INFORMATION NOTICE NO. 86-01: FAILURE OF MAIN FEEDWATER CHECK VALVES CAUSES  
LOSS OF FEEDWATER SYSTEM INTEGRITY AND  
WATER-HAMMER DAMAGE

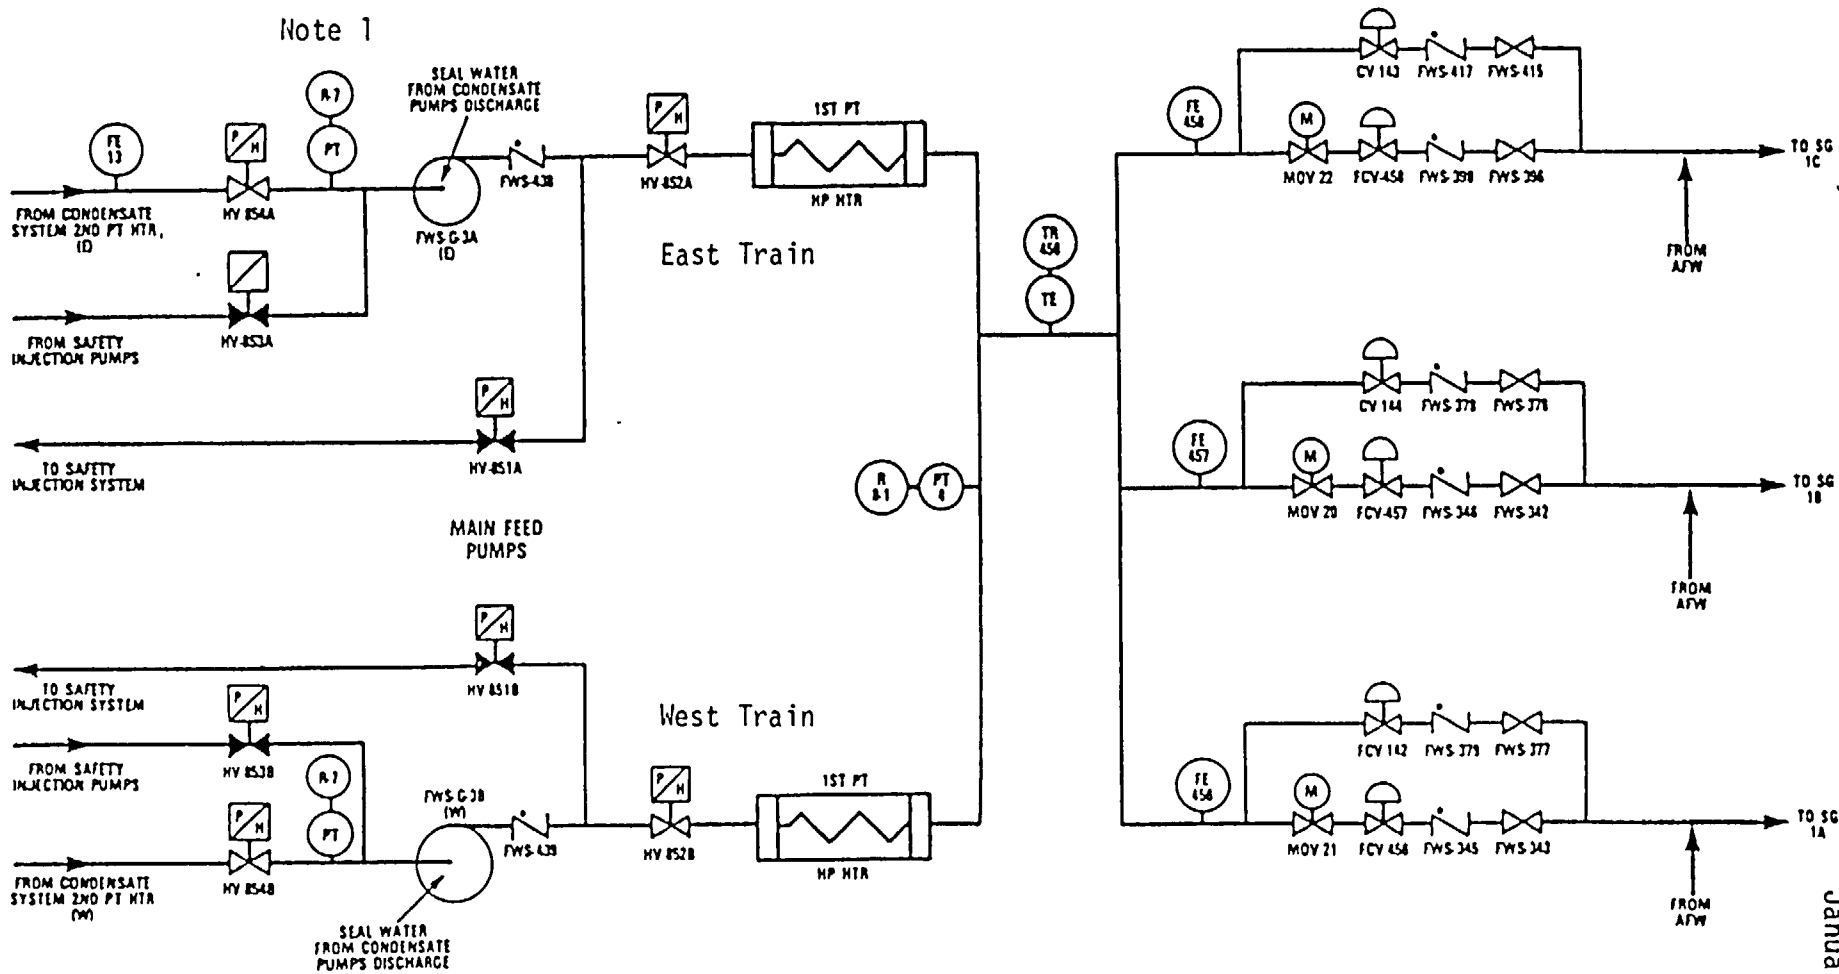
Figure 1, San Onofre Unit, Main Feedwater System Schematic Diagram

On November 21, 1985, San Onofre Unit 1 was operating at 60% power when an auxiliary transformer failed, resulting in a loss of power to a vital bus and to the bus feeding the east (electric) MFW pump. (A schematic of the MFW system is enclosed as Figure 1.) The west (electric) MFW pump remained energized from the unit main generator due to an abnormal electrical lineup. When the east MFW pump tripped, its discharge-check valve (FWS-438) failed to seat properly. As a result of the failure of the east MFW pump discharge-check valve, the west MFW pump supplied feedwater backwards through this discharge-check valve and overpressurized the east feedwater heater-condensate train. Several tubes apparently ruptured in the east feedwater train fifth stage (low pressure) feedwater heater as a result of the overpressurization, causing the shell side of this feedwater heater to rupture also. In addition, several main turbine rupture discs failed. Following the above events, the operators tripped the reactor and turbine by procedure because of the loss of power to a vital bus. This also caused the west MFW pump to trip. Both 12-inch MFW pump discharge-check valves (FWS-438 and 439) were later found cocked open, supported by their disc antirotation lugs that had rotated under the check valve hinge arm.

When the west MFW pump tripped, all three steam generator (SG) MFW regulating valve discharge-check valves (FWS-345, 346 and 398) also failed to seat. Two of these 10-inch check valves were later found to have their flappers loose in the bottom of the valve body with their nuts missing. The third 10-inch check valve was later found to have failed in the same mode as FWS-438 and 439. These check valve failures in the MFW system resulted in leak paths from the SGs backward through the MFW regulating valves and the east MFW pump to the ruptured east train FW heater. In addition, the west MFW train may have been pressurized from the SGs. The net effect of this is that the inventory in all three SGs began to blow steam and hot water back through the east MFW train.

Note: The ruptured fifth stage feedwater heater (not shown) is the lowest pressure heater in this east train.
