NUCLEAR REGULATORY COMMISSION
OFFICE OF INSPECTION AND ENFORCEMENT
WASHINGTON, D. C. 20555

IE CIRCULAR 77-03
Date: February 28, 1977
Page 1 of 2

FIRE INSIDE A MOTOR CONTROL CENTER

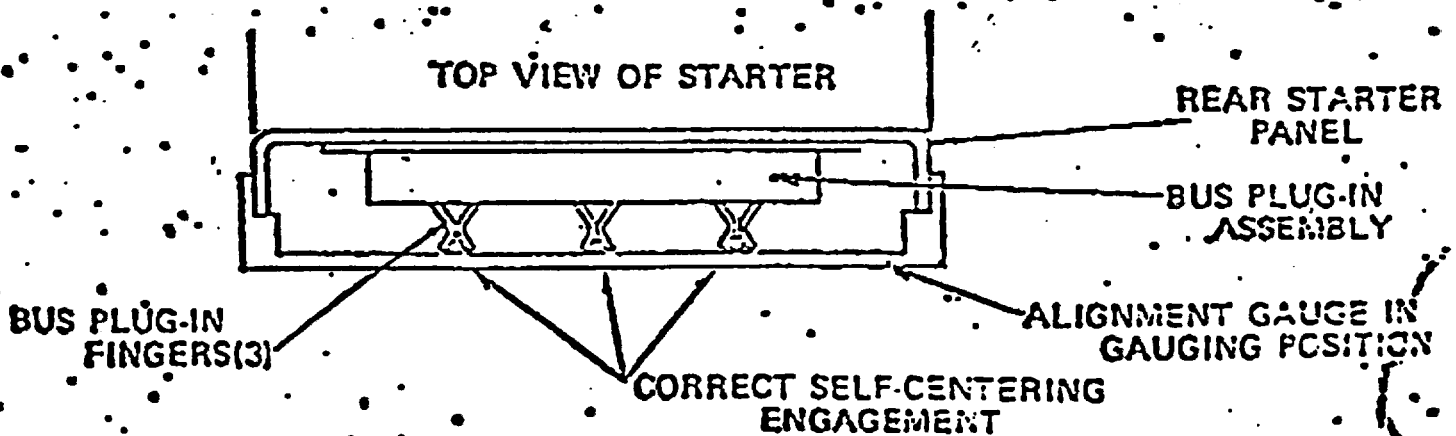
- (2) Seat the stops on the inside of the ends of the alignment gauge against the flanges of the starter mounting panel as illustrated.
- (3) The 1/4" round bars welded to the gauge approximate the vertical bus positions in the MCC. These bars should be within the flared ends of the plug-in fingers, allowing the fingers to self-center themselves lightly around the bars. If fingers are not deformed, there will be no problem visually verifying correct self-centering engagement as illustrated below.

- (4) If the self-centering action is not properly achieved, the plug-in assembly must be repaired or replaced.
- (5) After correct gauging, the starter should be handled with care and immediately installed into the Motor Control Center.
