NUCLEAR REGULATORY COMMISSION  
OFFICE OF INSPECTION AND ENFORCEMENT  
WASHINGTON, D. C. 20555

IE CIRCULAR 77-03  
Date: February 28, 1977  
Page 1 of 2

FIRE INSIDE A MOTOR CONTROL CENTER

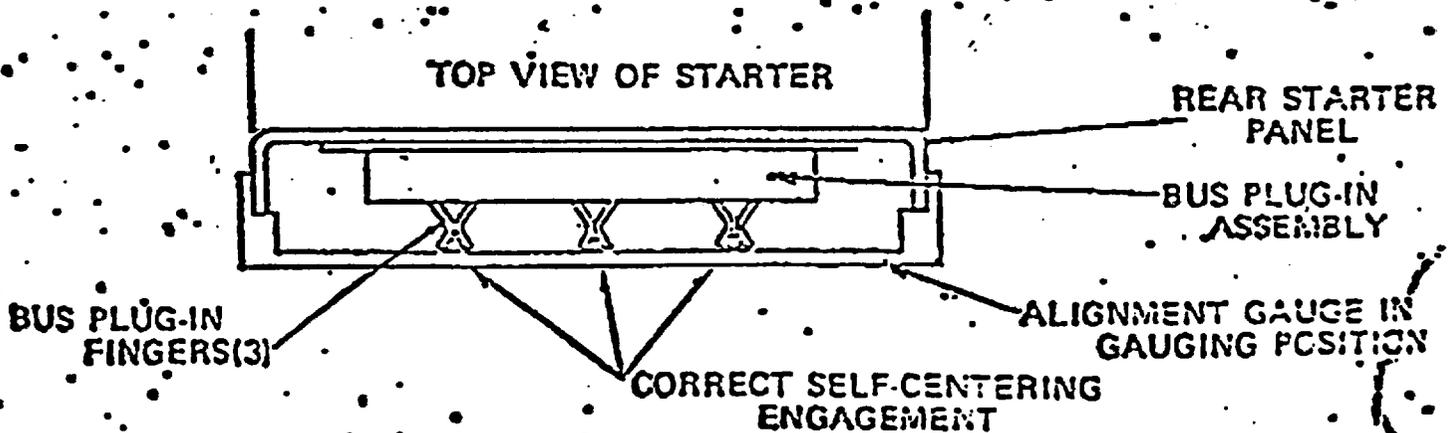
- (2) Seat the stops on the inside of the ends of the alignment gauge against the flanges of the starter mounting panel as illustrated.
- (3) The 1/4" round bars welded to the gauge approximate the vertical bus positions in the MCC. These bars should be within the flared ends of the plug-in fingers, allowing the fingers to self-center themselves lightly around the bars. If fingers are not deformed, there will be no problem visually verifying correct self-centering engagement as illustrated below.

- (4) If the self-centering action is not properly achieved, the plug-in assembly must be repaired or replaced.
- (5) After correct gauging, the starter should be handled with care and immediately installed into the Motor Control Center.
