UL FIRE TEST

Background

On September 15, 1978, a fire test of a full-scale vertical cable tray array was conducted at the Underwriters Laboratory (UL) near Chicago, Illinois. It was part of the fire protection research program managed by Sandia Laboratories under NRC contract. The purpose of the test was to demonstrate the effectiveness of area sprinklers and cable tray fire barriers constructed of ceramic fiber blankets in preventing damage to cables as a result of an exposure to a flammable liquid fire. The test resulted in damage to some electrical cables.

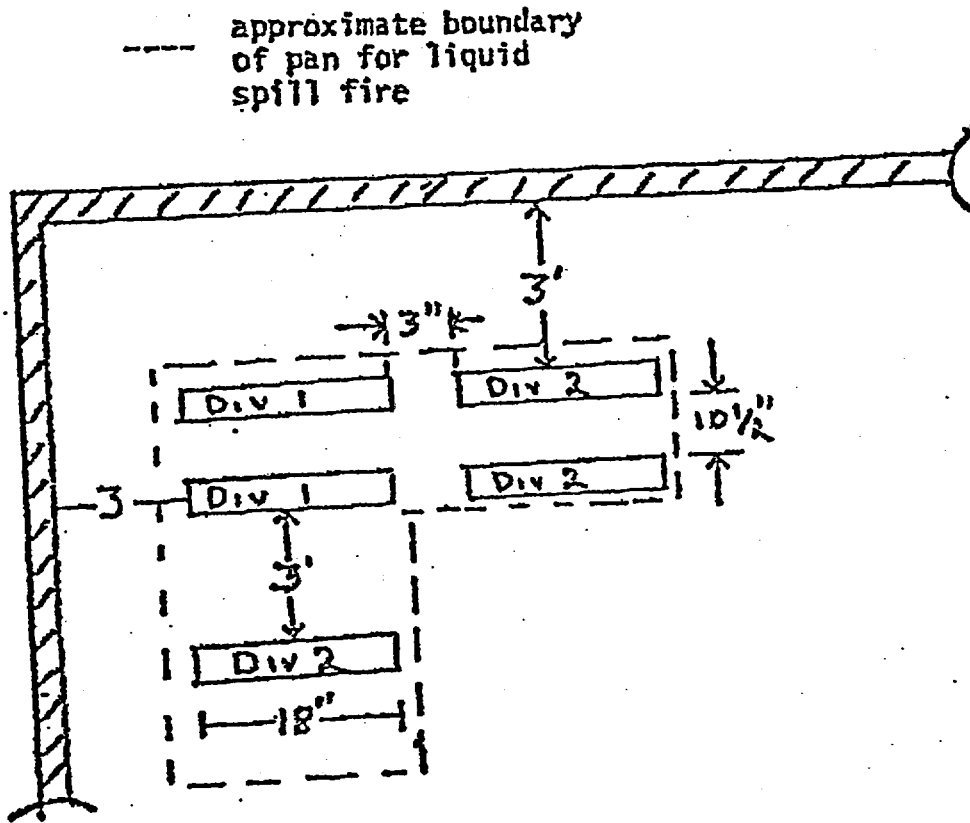
Figure 1

Vertical Tray Corner Test
