UL FIRE TEST

Background

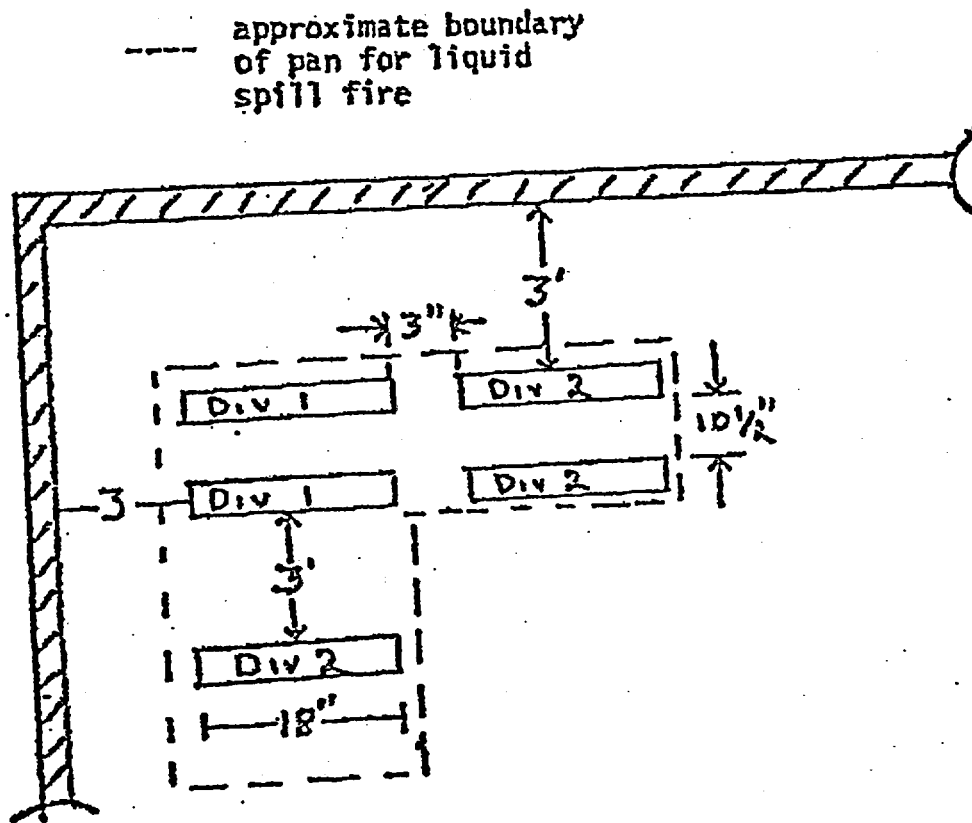
Figure 1

Vertical Tray Corner Test
