EFFECTS OF HYDRAULIC FLUID ON ELECTRICAL CABLES

Reference: Quad-Cities Nuclear Power Station
Docket No. 50-265, DPR-30, Unit 2

Distribution: IE Circular No.: 77-06 Effects of Hydraulic Fluid on Electrical Cables

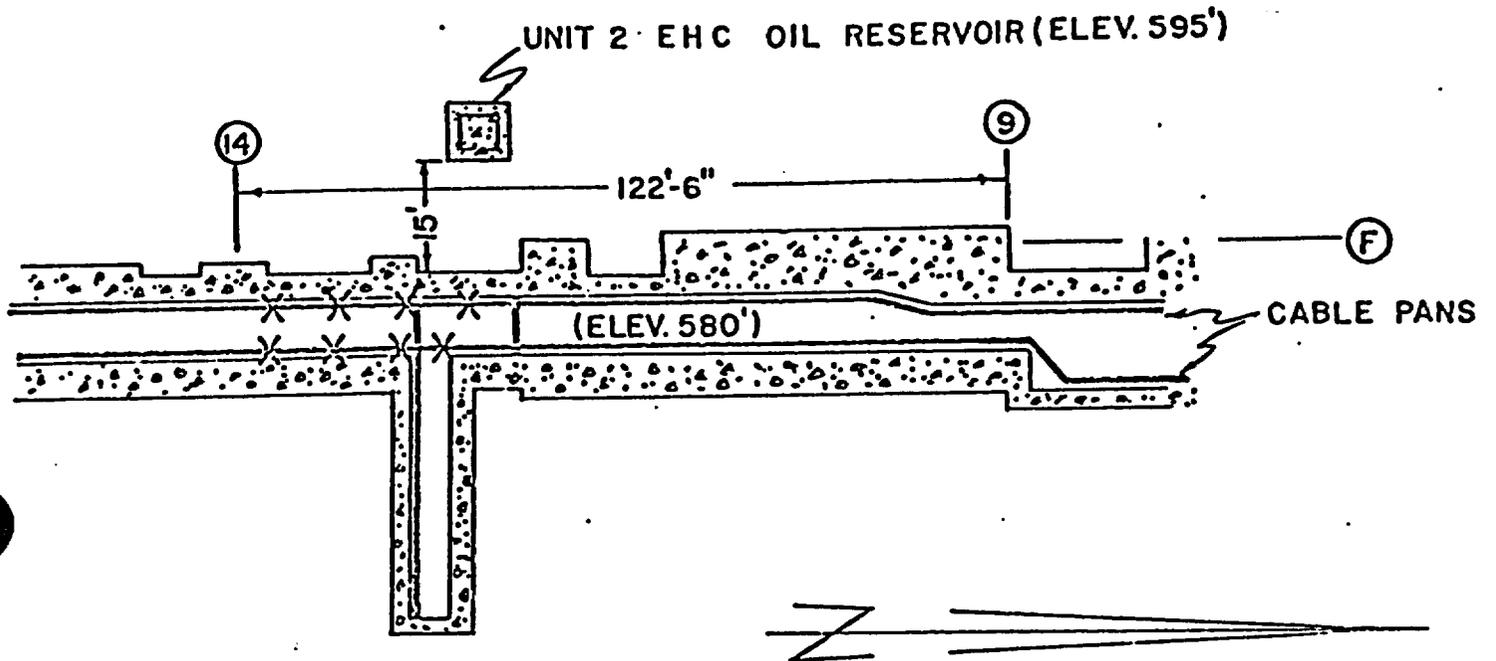
FIGURE. 1

On October 9, 1975, station personnel were cleaning up EHC fluid which had been dripping on the Unit 2 cable tunnel floor. It was noticed not only had the EHC fluid been leaking onto the floor but also it had been leaking onto the cables in the surrounding cable pans. Closer inspection of the cables revealed puffing and plasticization of cables that the EHC fluid had made contact with. At the time of discovery, Unit 2 was in the cold shutdown condition.

Figure 1 shows the approximate locations where EHC fluid accumulated. Figure 2 illustrates the postulated path of EHC fluid migration from the EHC fluid reservoir to the Unit 2 cable tunnel area. The accumulation of EHC fluid around the EHC fluid reservoir foundation, and subsequent migration between the finish floor and rough slab, via small cracks in the concrete, is the postulated cause of the EHC fluid problem.

UNIT 2 CABLE TUNNEL
PARTIAL PLAN

X- DENOTES AREAS WHERE THE EHC OIL HAD ACCUMULATED
REFERENCE DRAWING - SARGENT & LUNDY M-5

The immediate action taken was to determine the extent of plasticization of the affected cables. All the cables and cable pans in the affected area of the Unit 2 cable tunnel were cleaned with a soap and water solution as recommended by information from the EHC fluid manufacturer. The cleaning of EHC fluid from the cables should eliminate further effects of plasticization. A small section of control cable, which was hand traced to identify its function, was cut out and analyzed. It was discovered that only the overall jacketing material had been affected by the EHC fluid.

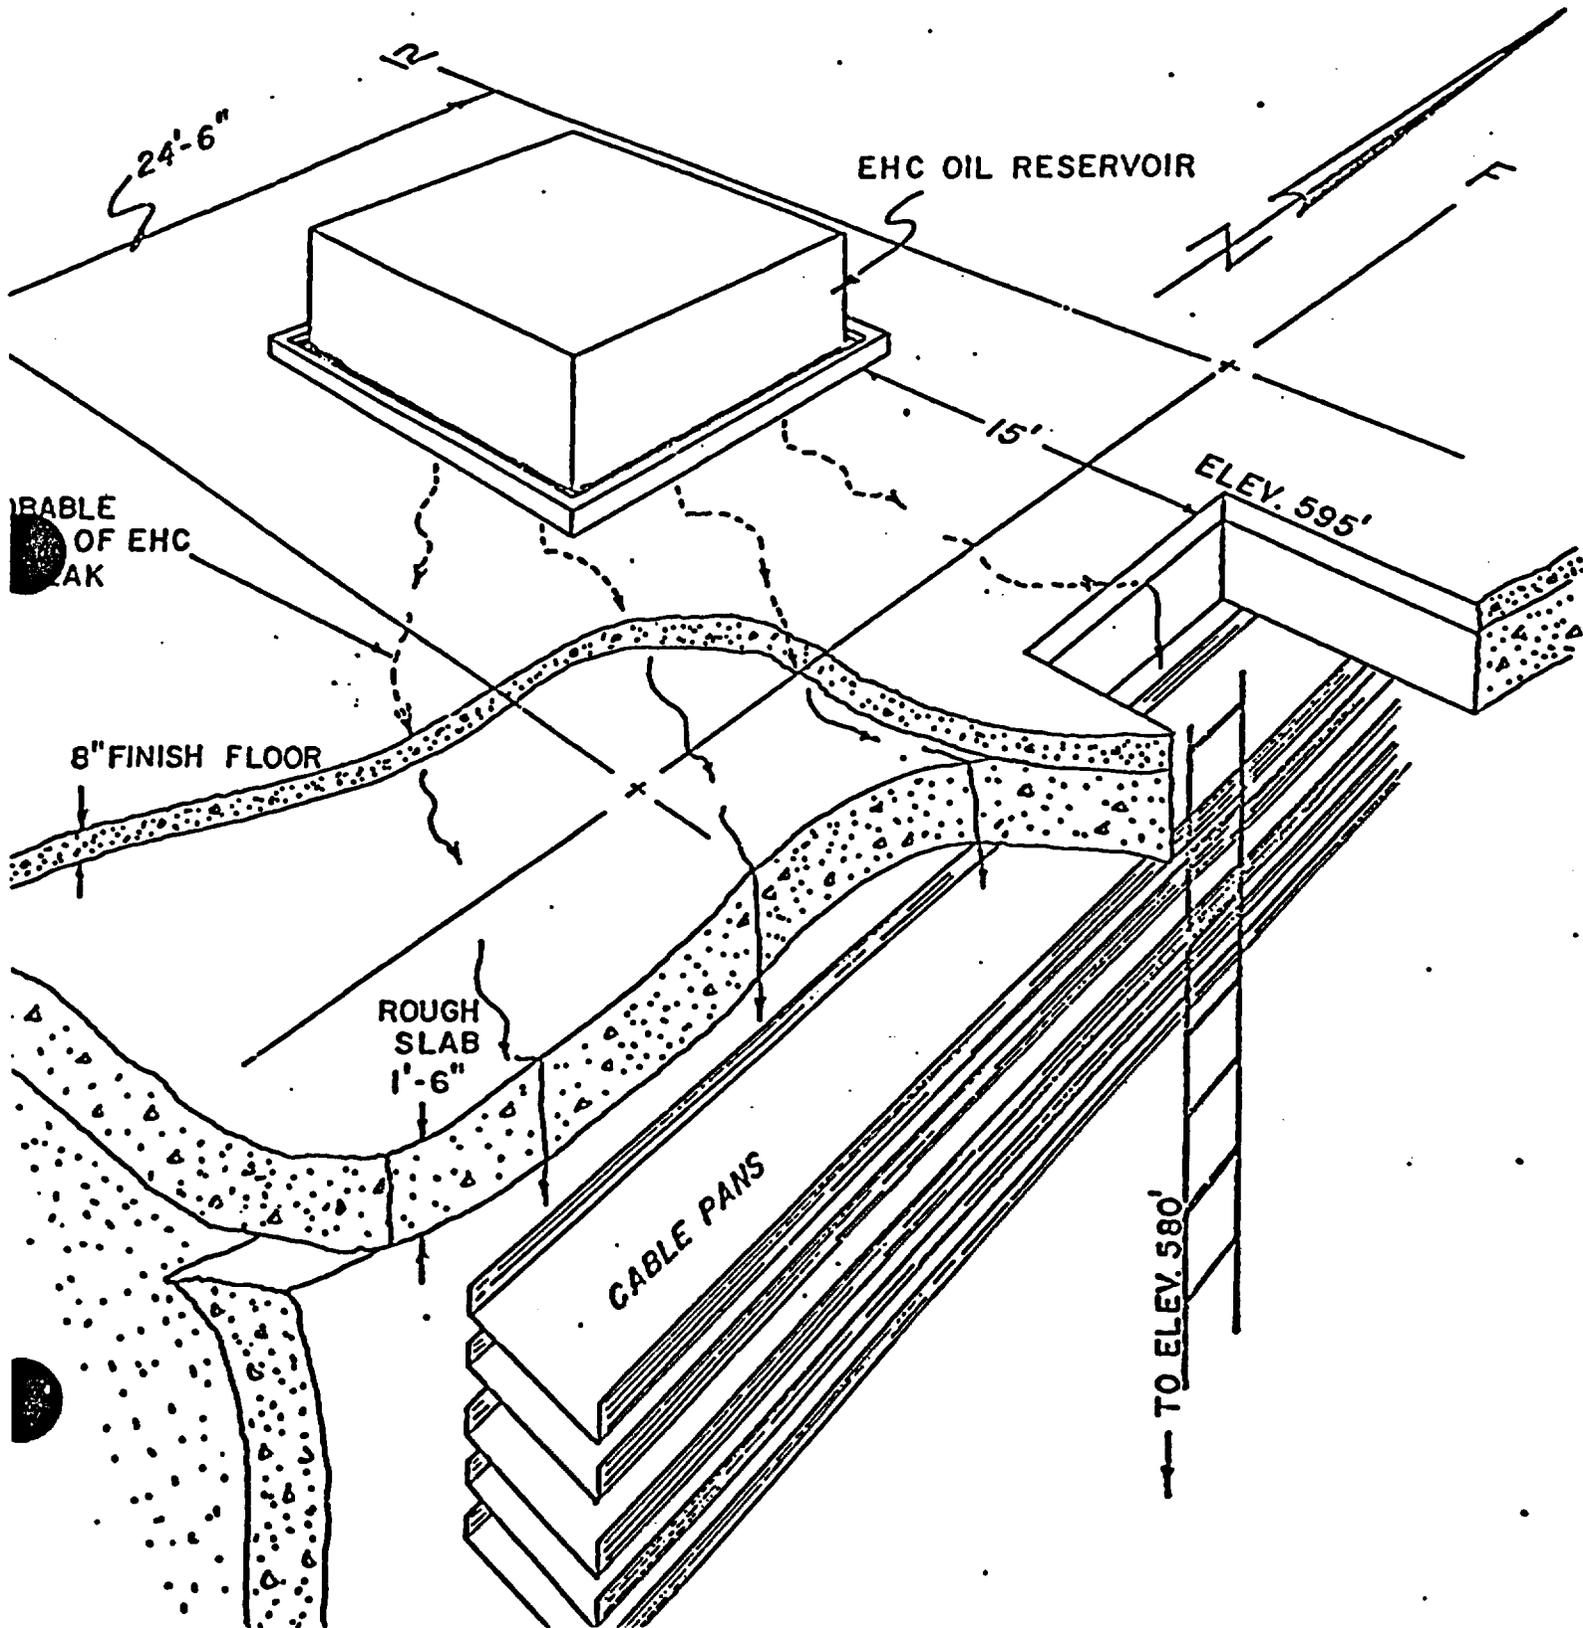
FIGURE. 2

The rough slab serves as the ceiling in the Unit 2 cable tunnel and minor small cracks in the ceiling served as a leak path out of the concrete and onto the cable trays and floor. Portions of cables within these trays thus became saturated with the EHC fluid.

The upper cable trays did not contain all of the EHC fluid, even though the pans in the cable tunnel were of solid bottom construction. This was because the EHC fluid had leaked through the cable pan connecting joints and thus all the cable pans below were subjected to the EHC fluid. The cables closest to the bottom of the cable pans were most affected by the EHC fluid because these cables were in constant saturation with EHC fluid.

UNIT 2 CABLE TUNNEL
CUT-AWAY

At the present time, all the cables in the affected area of the Unit 2 cable tunnel are being protected from the continuing EHC fluid leakage. The leakage has subsided and once it has stopped the ceiling area will be cleaned and a protective sealer will be applied to prevent any possible leakages.

The EHC fluid reservoir foundation must also be sealed with the same protective sealer once leakages have been resolved. The sealer has been ordered from the Carboline Company, type 187 HFP, which is a recommended EHC fluid sealant.
