EFFECTS OF HYDRAULIC FLUID ON ELECTRICAL CABLES

Reference: Quad-Cities Nuclear Power Station  
Docket No. 50-265, DPR-30, Unit 2

Distribution: IE Circular No.: 77-06 Effects of Hydraulic Fluid on Electrical Cables

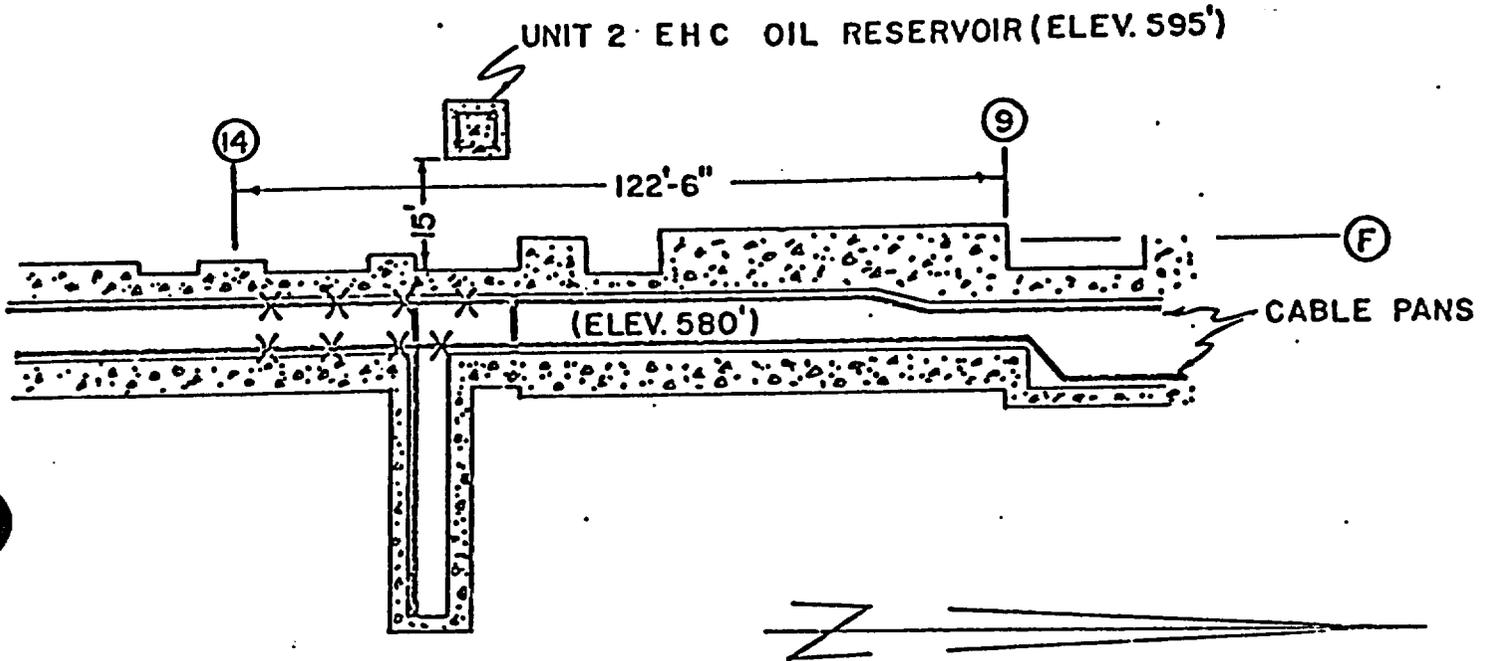
FIGURE. 1

Figure 1 shows the approximate locations where EHC fluid accumulated. Figure 2 illustrates the postulated path of EHC fluid migration from the EHC fluid reservoir to the Unit 2 cable tunnel area. The accumulation of EHC fluid around the EHC fluid reservoir foundation, and subsequent migration between the finish floor and rough slab, via small cracks in the concrete, is the postulated cause of the EHC fluid problem.

UNIT 2 CABLE TUNNEL  
PARTIAL PLAN

X- DENOTES AREAS WHERE THE EHC OIL HAD ACCUMULATED  
REFERENCE DRAWING - SARGENT & LUNDY M-5
