UNITED STATES
NUCLEAR REGULATORY COMMISSION
OFFICE OF INSPECTION AND ENFORCEMENT
WASHINGTON, D.C. 20555

IE Circular No. 79-13

REPLACEMENT OF DIESEL FIRE PUMP STARTING CONTACTORS

New Components Available For Industrial Fire Pumps (NH-220-IF, N-855-F, NT-855-F1, and NT-855-F2 Series Engines)

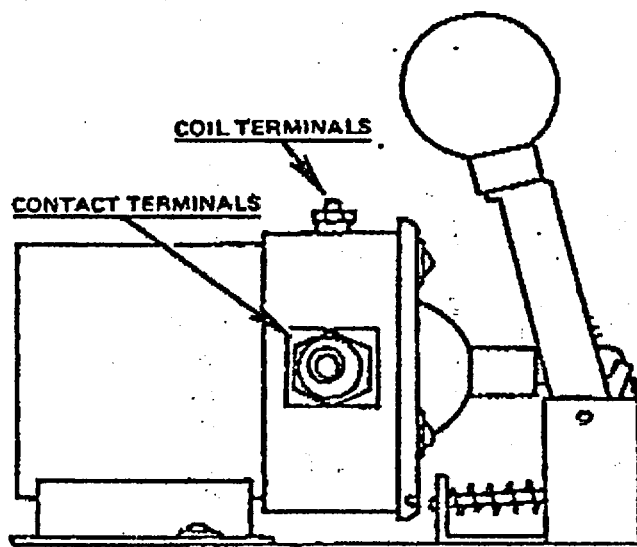
Fig. 2 Magnetic Switch

A new high pressure fuel pump shut-off valve Part No. 216930, Fig. 1, (optional field replacement) and magnetic switch Part No. 217588, Fig. 2, have been released to improve operation of inline 6 cylinder Industrial Fire Pump engines.

Caution: When replacing 118848 Magnetic Switch and 199573 DC Relay Contactor with 217588 Magnetic Switch always check the controller relay for maximum current draw. The new 217588 Magnetic Switch has a 6 ampere draw whereas the old combination has approximately 3 amperes draw. Where necessary the controller relay can usually be replaced. Contact local controller representative.

When replacing 118848 Magnetic Switch, 199573 DC Relay Contactor and 212461 Wiring Harness in the field they should be replaced with new design components.

A new wiring harness, AR-12498, which includes two (2) Part No. 217588 Magnetic Switches, wiring harness and mounting hardware must be used when making conversion.
