UNITED STATES
NUCLEAR REGULATORY COMMISSION
OFFICE OF INSPECTION AND ENFORCEMENT
WASHINGTON, D.C. 20555

IE Circular No. 79-13

REPLACEMENT OF DIESEL FIRE PUMP STARTING CONTACTORS

New Components Available For Industrial Fire Pumps (NH-220-1F, N-855-F, NT-855-F1, and NT-855-F2 Series Engines)

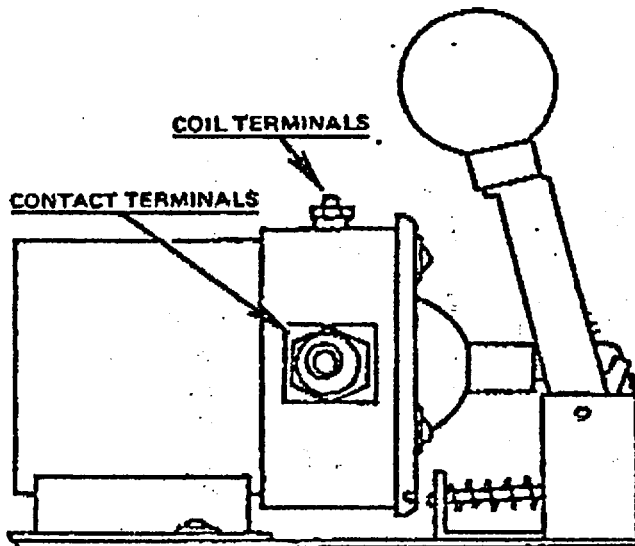
A new high pressure fuel pump shut-off valve Part No. 216930, Fig. 1, (optional field replacement) and magnetic switch Part No. 217588, Fig. 2, have been released to improve operation of inline 6 cylinder Industrial Fire Pump engines.

Fig. 2 Magnetic Switch

Caution: When replacing 118848 Magnetic Switch and 199573 DC Relay Contactor with 217588 Magnetic Switch always check the controller relay for maximum current draw. The new 217588 Magnetic Switch has a 6 ampere draw whereas the old combination has approximately 3 amperes draw. Where necessary the controller relay can usually be replaced. Contact local controller representative.

When replacing 118848 Magnetic Switch, 199573 DC Relay Contactor and 212461 Wiring Harness in the field they should be replaced with new design components.

A new wiring harness, AR-12498, which includes two (2) Part No. 217588 Magnetic Switches, wiring harness and mounting hardware must be used when making conversion.

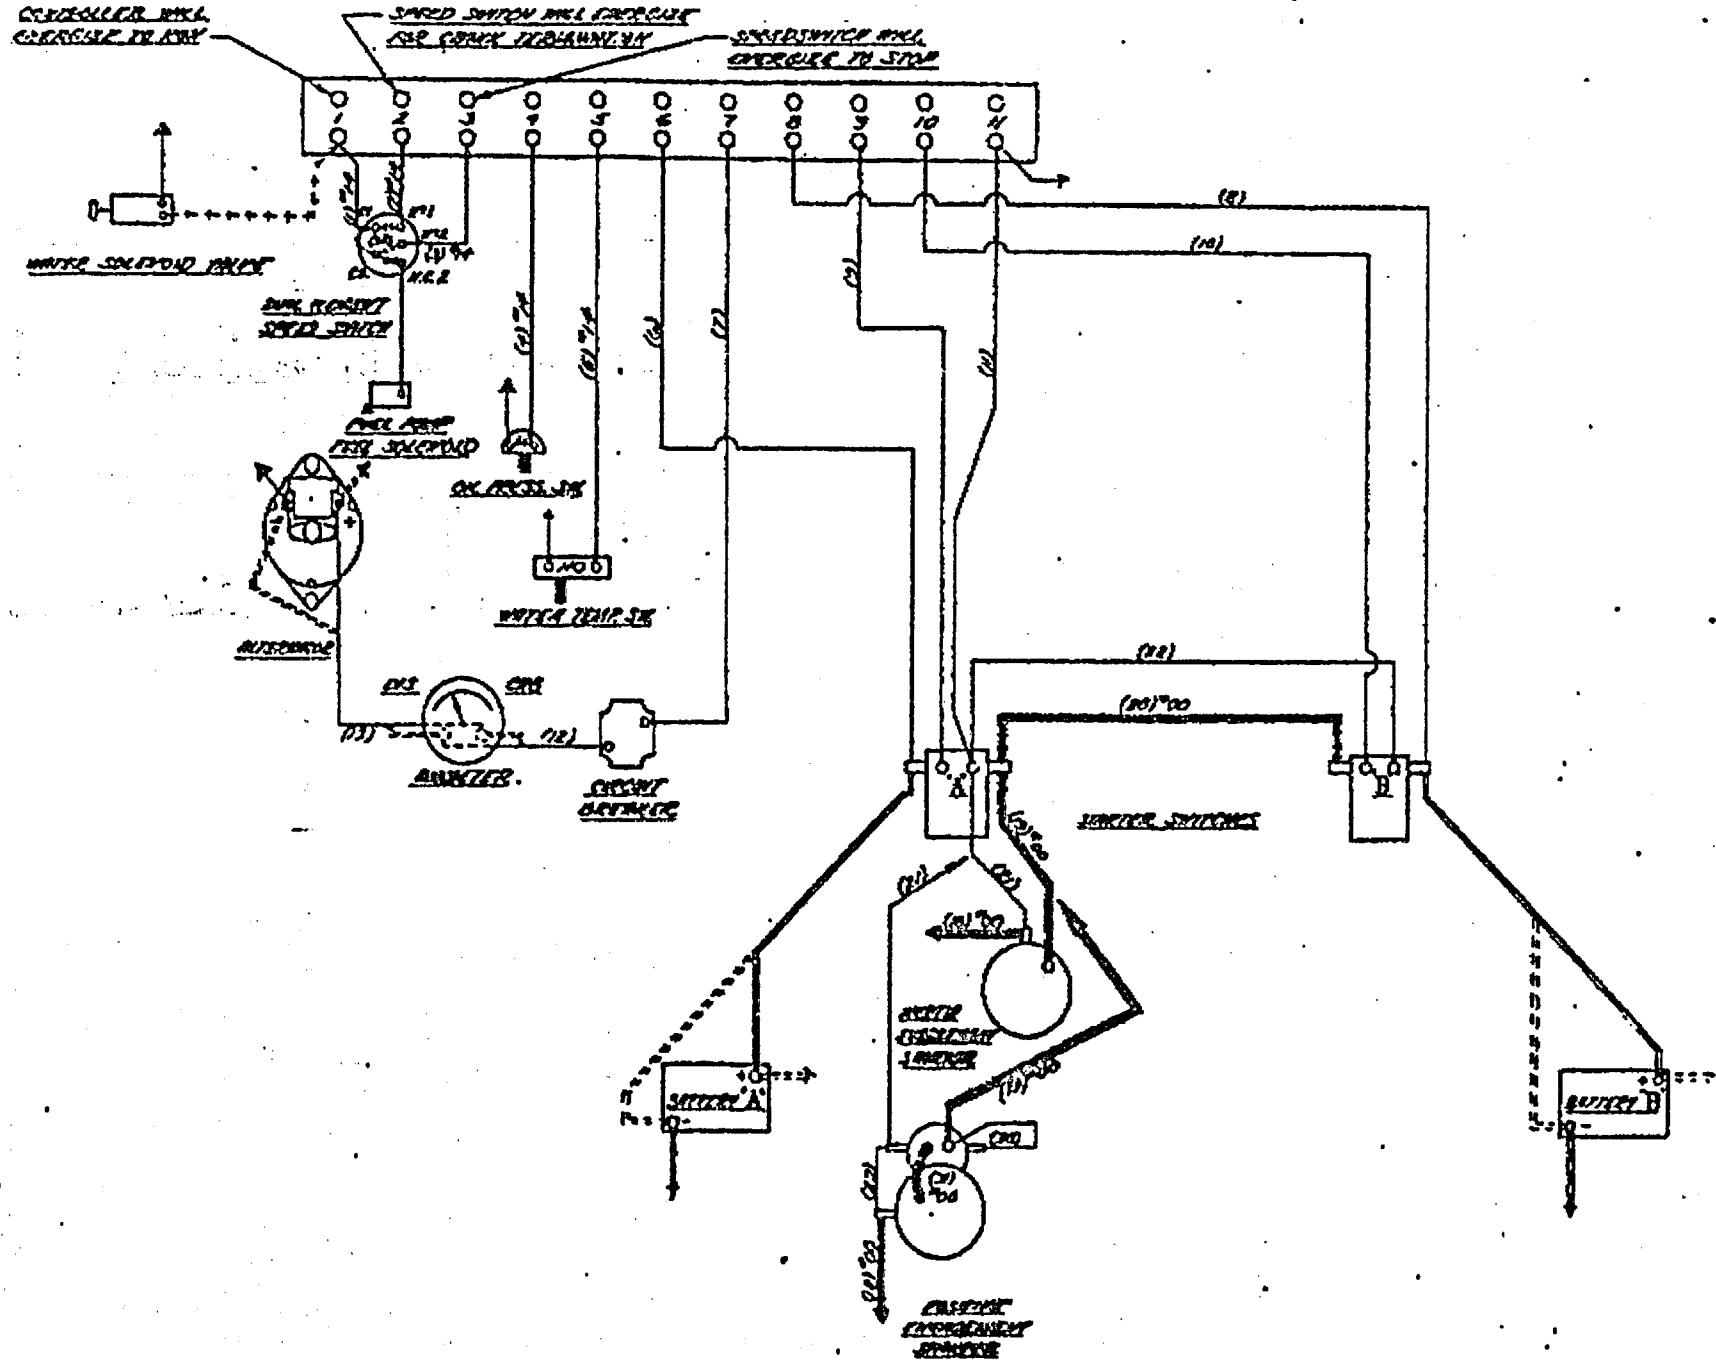
Fig. 1. Wiring diagram

1. Remove wire harness connecting terminal block, ammeter, magnetic switches and voltage regulator or alternator.
2. Remove magnetic switch and DC relay.
3. Install 211088 Bracket to cylinder block above cranking motor.
4. Install two (2) 217588 Magnetic Switches opposite each other with manual start handles in "up" position.
5. Install new wiring harness as follows: Replace wires No. 2, 6, 8, 9, 10 and 11 on terminal block, No. 13 on ammeter and No's. 2 and 13 on voltage regulator. See wiring diagram, Fig. 3.
