SSINS No.: 6835  
IN 86-06

February 3, 1986

IE INFORMATION NOTICE NO. 86-06: FAILURE OF LIFTING RIG ATTACHMENT, WHILE  
LIFTING THE UPPER GUIDE STRUCTURE AT  
ST. LUCIE UNIT 1

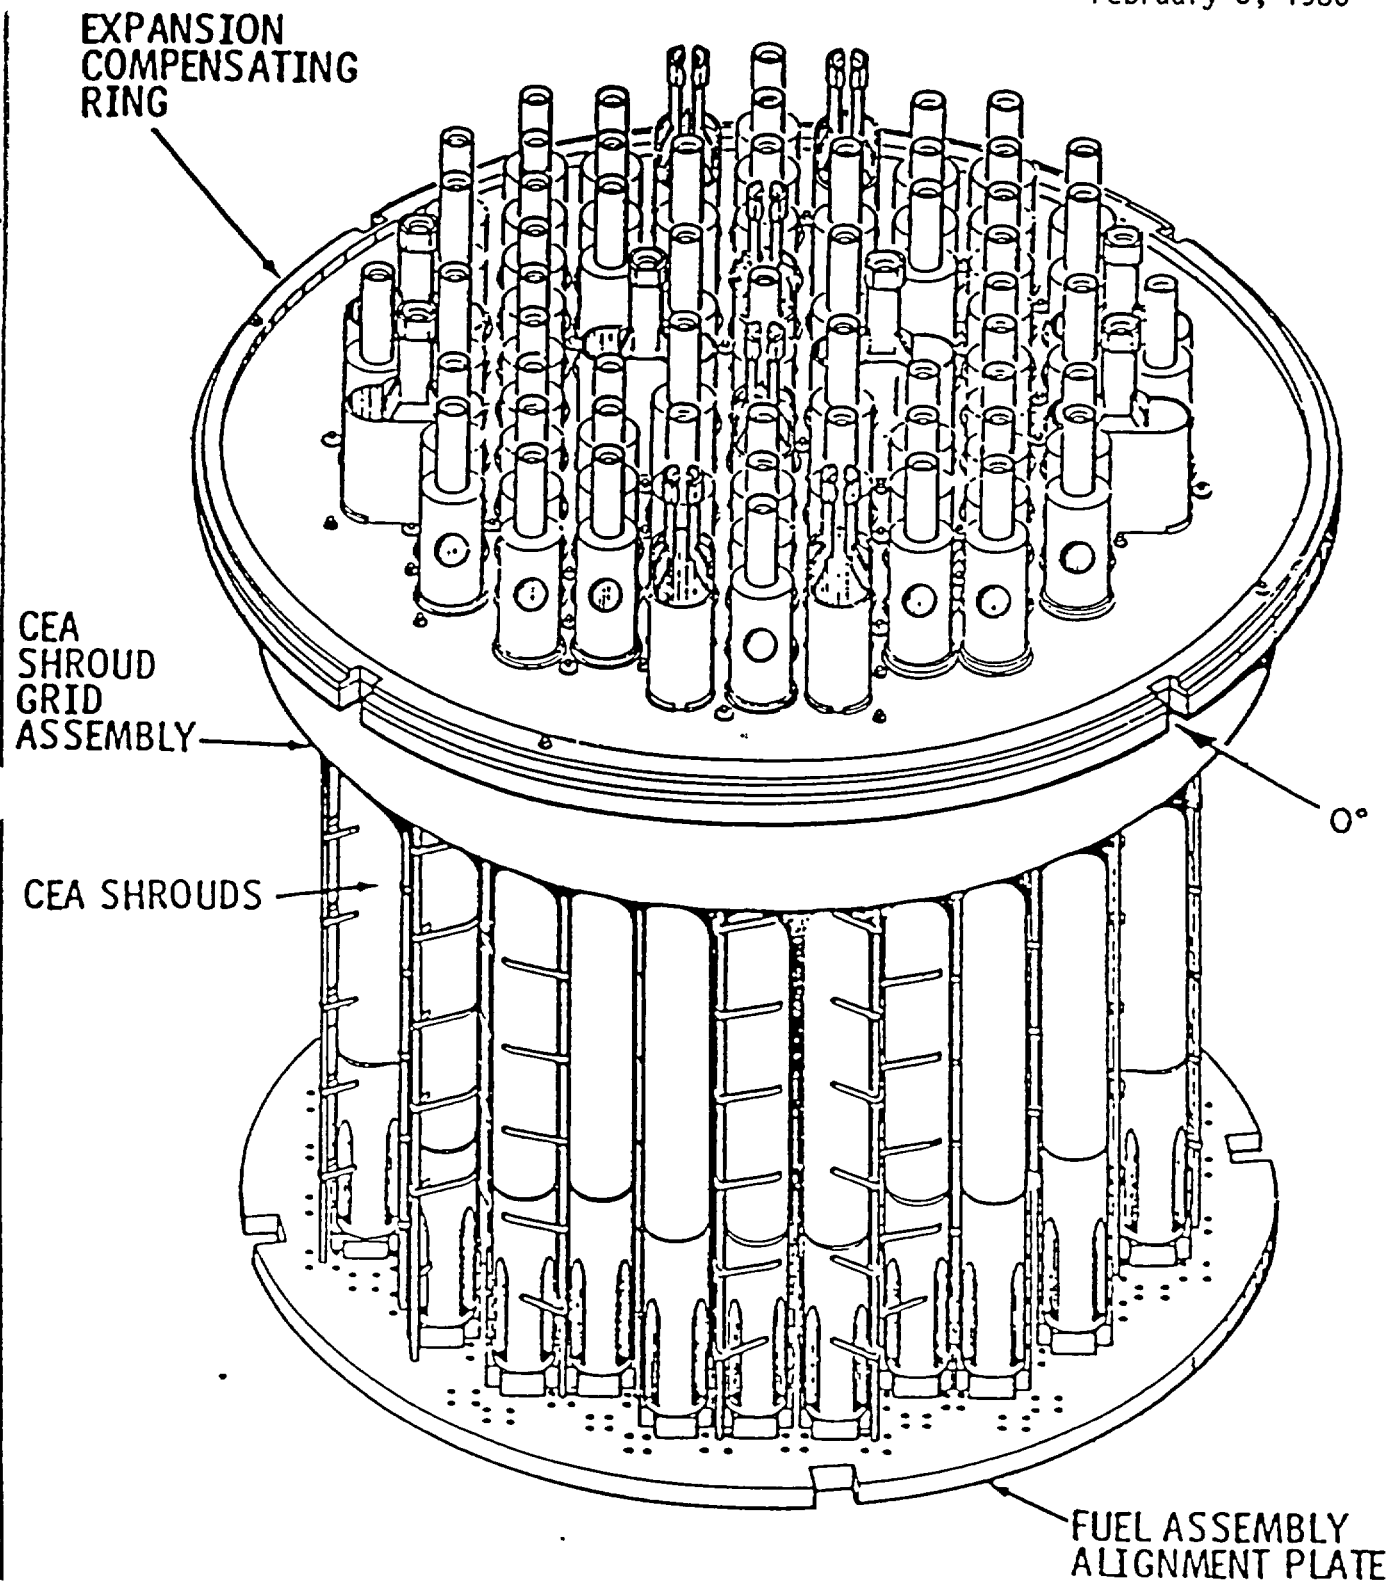
Figure 1: Upper Guide Structure Assembly  
(St. Lucie Unit 1 FSAR figure 4.2-10)

The upper guide structure is shown in Figure 1. It is supported in the reactor vessel by its upper flange. It is aligned by eight alignment keys, four at the top and four at the bottom. The structure fits down inside the core support barrel, just above the fuel assemblies (see Figure 2). The fuel assembly alignment plate is the bottom component of the upper guide structure.

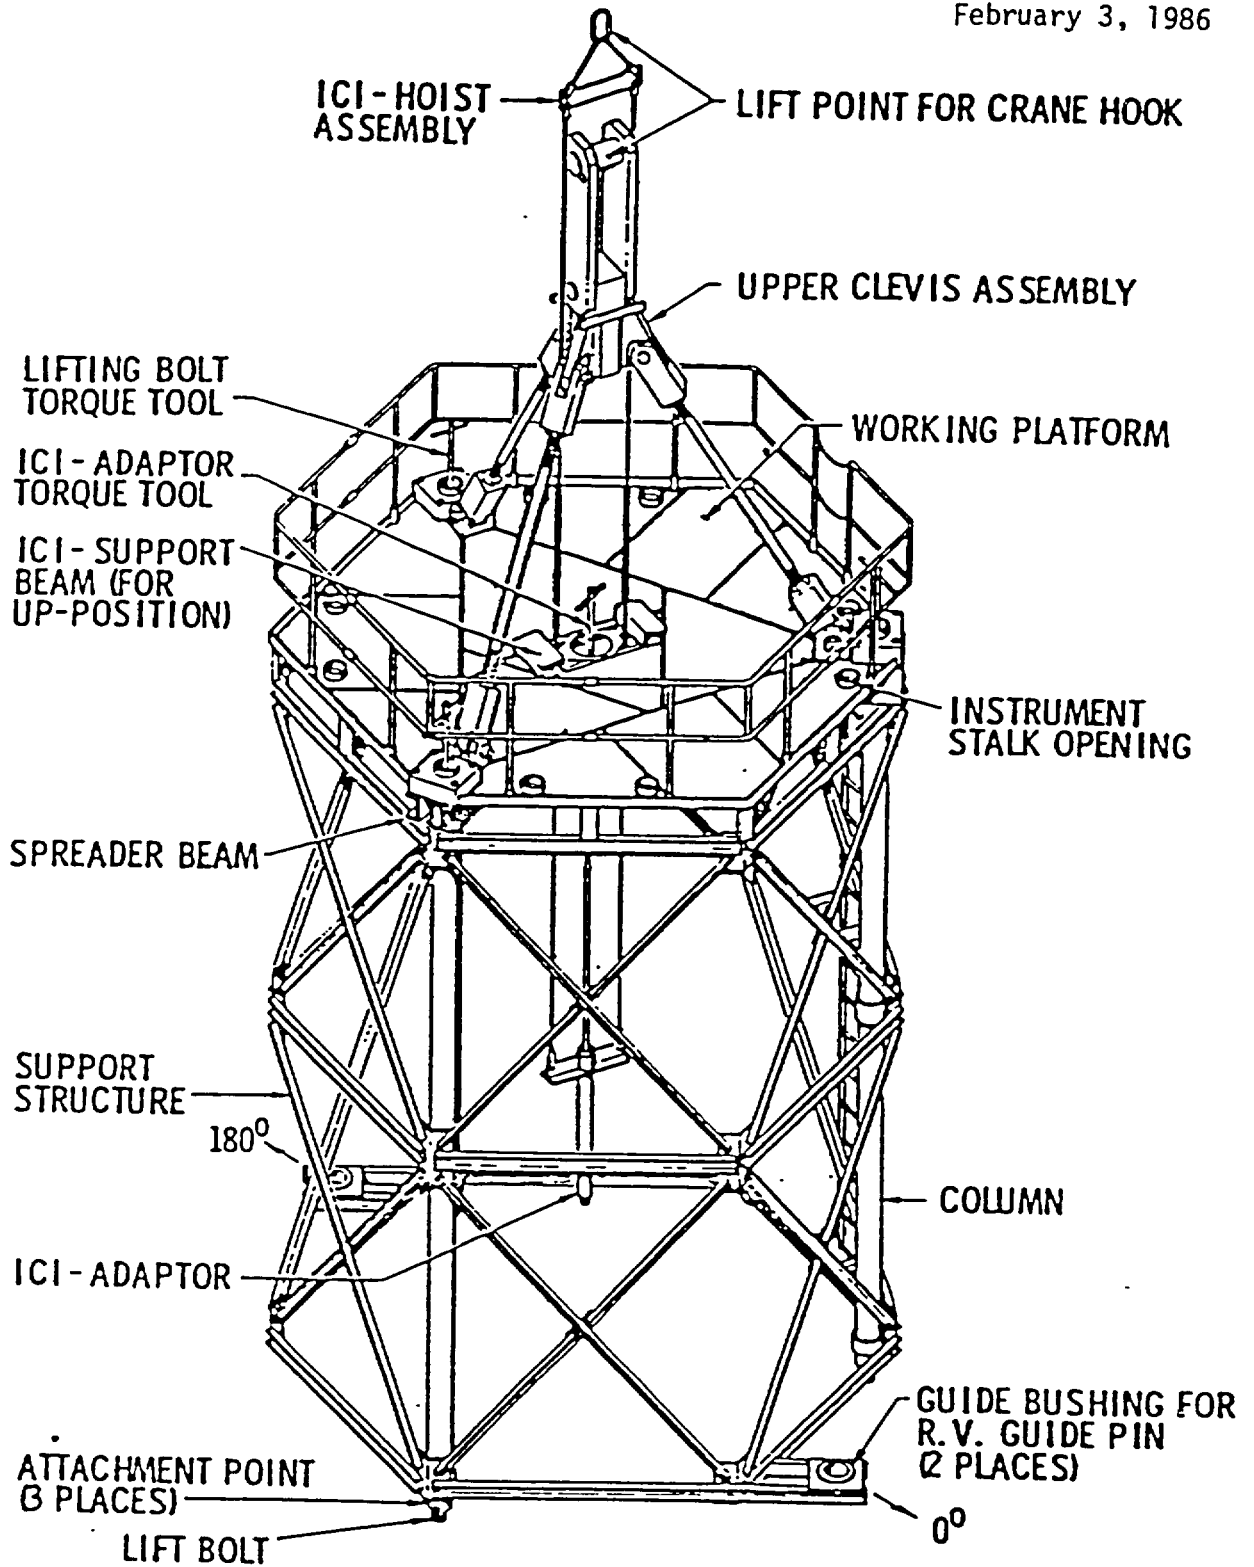
Figure 3: Upper Guide Structure Lifting Rig  
(St. Lucie Unit 1 FSAR figure 9.1-8)

Damage caused during the incident included bending the lifting rig and one of the two guide pins that align the rig with the reactor vessel.

The lifting rig is attached to the upper guide structure by three vertically oriented bolts. These bolts are attached from above the water line by torque tools that run down the hollow columns of the rig (see Figure 3). Combustion Engineering's procedure for attaching the rig calls for checking for thread engagement and torquing each bolt to 50 ft-lbs. The licensee's procedure omitted the step concerning the check for thread engagement. Subsequent inspection of the bolt that had pulled loose indicated that part of the last thread was stripped. It is assumed that this bolt cross-threaded or bound due to rig to guide structure misalignment during attachment and reached the 50 ft-lb torque requirement with only part of one thread engaged. During the lift, the few inches of unengaged bolt shaft were pulled through the lifting rig until the bolt head rested on the rig's surface at the bottom of the column, resulting in an imperceptible tilt. The resulting lateral load was initially supported by the guide pins. When the rig and guide structure were lifted about 8 feet, where the guide bushings on the lifting rig reached the tapered portion of the guide pins, it is surmised that sufficient lateral motion was permitted to allow the thread of the improperly engaged bolt to slip free. This caused the observed motion and tilt.

After the guide structure was supported by the supplemental lifting rig and leveled, it was moved to its normal parking position in the refueling pool. The short attachment bolts and torque tools were then replaced with full-length bolts. The long bolts are designed with heads that rest on surfaces at the top of the three hollow columns of the lifting rig. This has the advantage of making any lack of full thread engagement more apparent to the personnel attaching the rig. The guide structure was subsequently returned to its installed position using the long attachment bolts.

The licensee has not yet decided whether to permanently modify the attachment bolts. The licensee plans to review all reactor-related lifts for adequacy of the procedures to ensure proper lift rig attachment, including provisions for measuring thread engagement.
