SSINS No.: 6835  
IN 86-09

February 3, 1986

IE INFORMATION NOTICE NO. 86-09: FAILURE OF CHECK AND STOP CHECK VALVES  
SUBJECTED TO LOW FLOW CONDITIONS

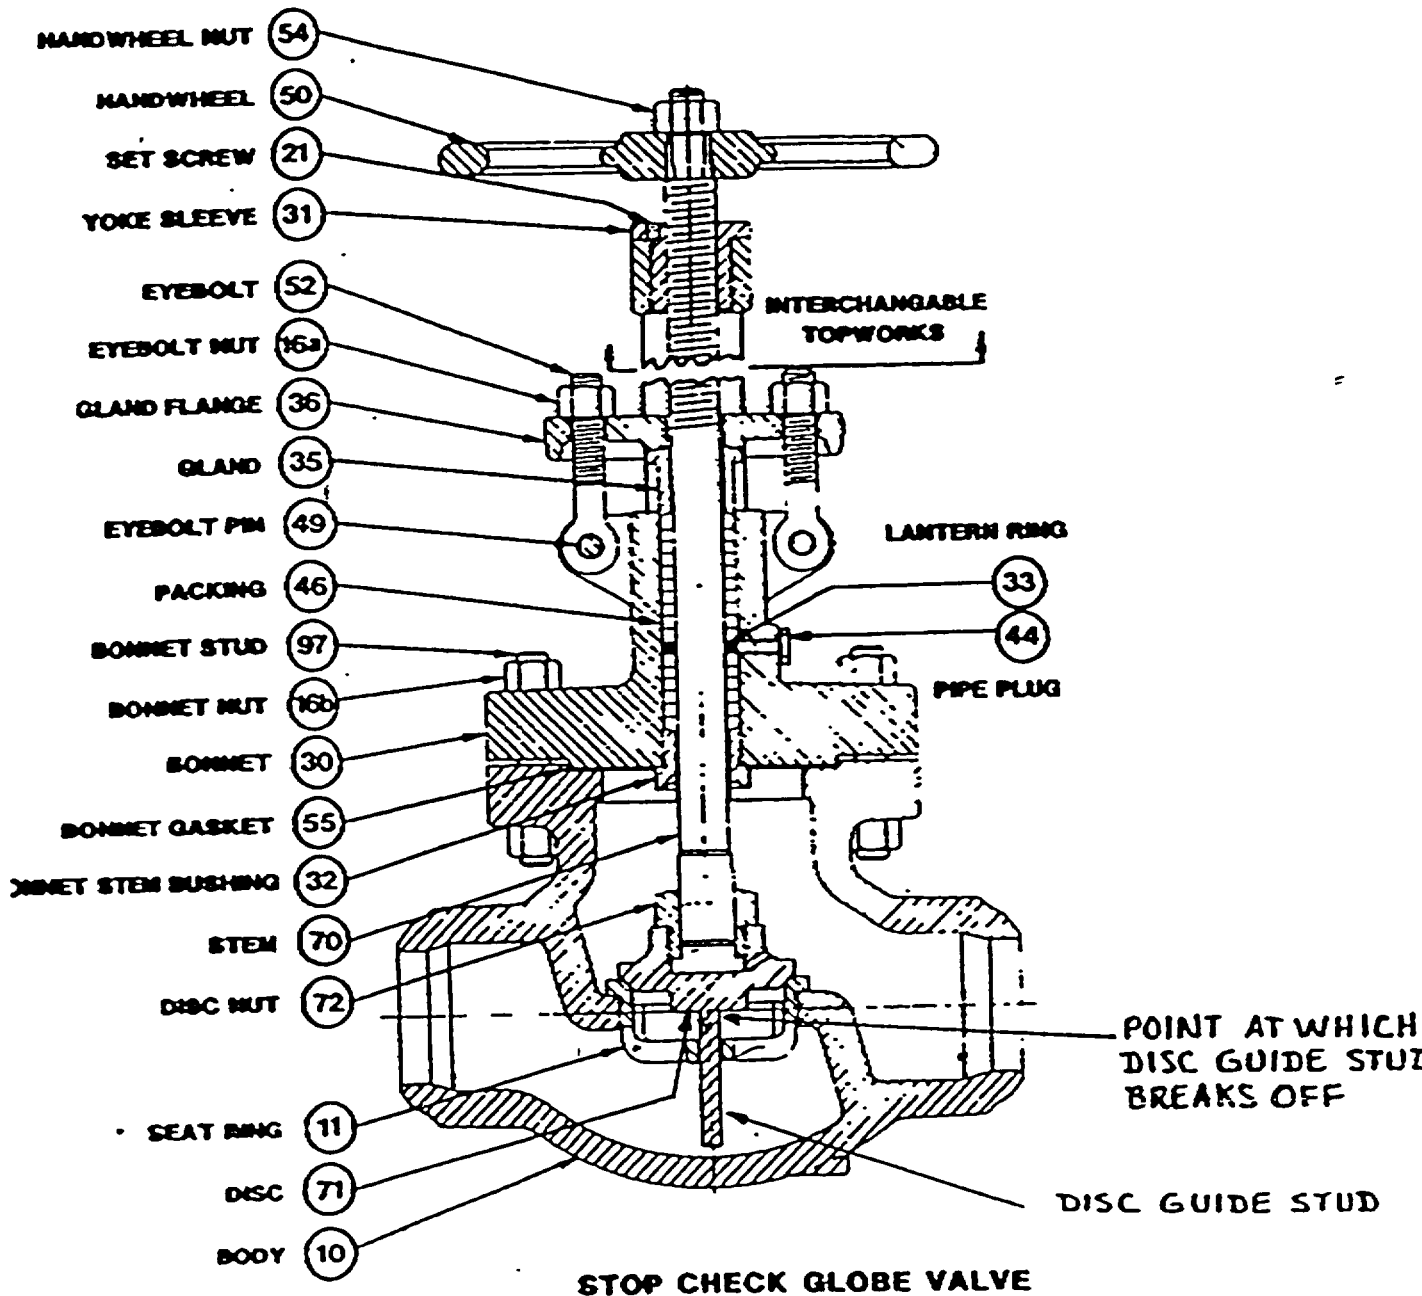
1. Sketch of Stop Check Globe Valve
2. List of Recently Issued IE Information Notices

The mode of failure of the valve was degradation of the disc and disc nut assembly (see attached sketch) due to low steam flow conditions caused by slight leakage past the normally closed MOV. The low steam flow rate was not sufficient to keep the disc open and the disc assembly then vibrated and chattered causing excessive wear and damage to the valve internals, in particular, the disc assembly. In many cases (three in November and four in January), the disc guide stud had broken off from the disc. This allowed the disc to become cocked in the valve and prevented full closure (thus defeating both the check and stop features of the valve) and full opening (thus restricting steam flow). In addition, the broken disc guide stud was free to travel downstream with steam flow and could have caused damage to equipment and components in the flow path.

The licensee performed a failure analysis of the disc assembly to verify the acceptability of a higher strength material being used in a redesigned disc guide. In addition, the licensee committed to a program of regular radiographic examination of the valves on Unit 3 for the remainder of the refueling cycle. However, the licensee considers this to be an interim repair pending the completion of the study underway by its AFW Enhancement Task Force.
