UNITED STATES
NUCLEAR REGULATORY COMMISSION
OFFICE OF INSPECTION AND ENFORCEMENT
WASHINGTON, D.C. 20555

SSINS No.: 6835
IN 86-13

IE INFORMATION NOTICE NO. 86-13: STANDBY LIQUID CONTROL SYSTEM SQUIB VALVES
FAILURE TO FIRE

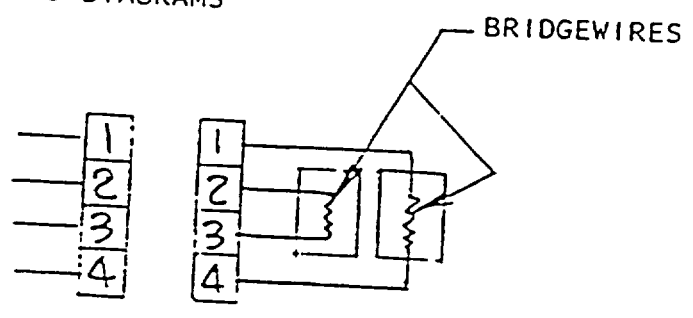
CORRECT
PIN-TO-BRIDGEWIRE
CONNECTION

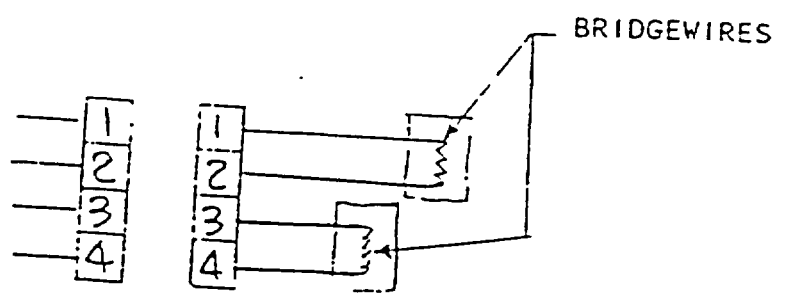
The explosive primer charge assembly for the SLCS at Vermont Yankee was supplied by Conax Corporation. The explosive primer charge assembly has two sets of resistance wires, i.e., bridgewires, internal to the charge either of which will fire the explosive. However, some of the charges were manufactured with incorrect pin-to-bridgewire groupings so that when connected at Vermont Yankee, two high-side leads were connected to one bridgewire set and two neutral leads were connected to the other bridgewire set internal to the explosive primer. Examination of spare squibs at Vermont Yankee identified four others with incorrect pin-to-bridgewire groupings.

The squibs are connected to the plant's wiring via four pin connectors. Incorrect wiring at the Vermont Yankee local terminal box resulted in the sequence around the connector being high, high, neutral, neutral. If the wiring in the terminal box had been according to the design drawing and had been high, neutral, high, neutral, the squib charge would have fired even

though the pin-to-bridgewire connection was incorrect. (See Attachment 1.)
In addition, at Vermont Yankee the control room indication of SLCS circuit status indicated circuit continuity due to the presence of a sneak curcuit.

INCORRECT
PIN-TO-BRIDGEWIRE
CONNECTION

The explosive primer charge assembly may be tested for correct pin-to-bridgewire grouping with an ohmmeter that is current limited to no more than 10 millamperes. Larger currents will cause the charge to explode.
