UNITED STATES
NUCLEAR REGULATORY COMMISSION
OFFICE OF INSPECTION AND ENFORCEMENT
WASHINGTON, D.C. 20555

SSINS No.: 6835
IN 86-13

IE INFORMATION NOTICE NO. 86-13: STANDBY LIQUID CONTROL SYSTEM SQUIB VALVES
FAILURE TO FIRE

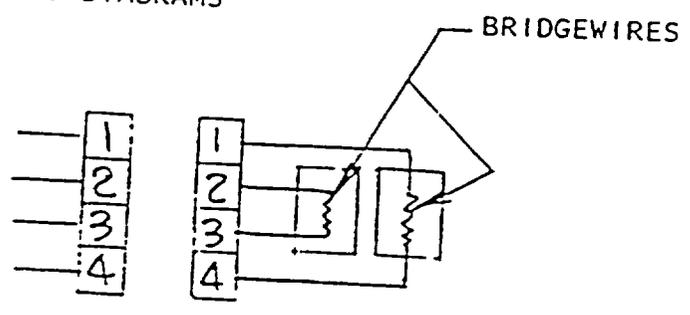
CORRECT
PIN-TO-BRIDGEWIRE
CONNECTION

The squibs are connected to the plant's wiring via four pin connectors. Incorrect wiring at the Vermont Yankee local terminal box resulted in the sequence around the connector being high, high, neutral, neutral. If the wiring in the terminal box had been according to the design drawing and had been high, neutral, high, neutral, the squib charge would have fired even

though the pin-to-bridgewire connection was incorrect. (See Attachment 1.)
In addition, at Vermont Yankee the control room indication of SLCS circuit status indicated circuit continuity due to the presence of a sneak curcuit.

The explosive primer charge assembly may be tested for correct pin-to-bridgewire grouping with an ohmmeter that is current limited to no more than 10 millamperes. Larger currents will cause the charge to explode.

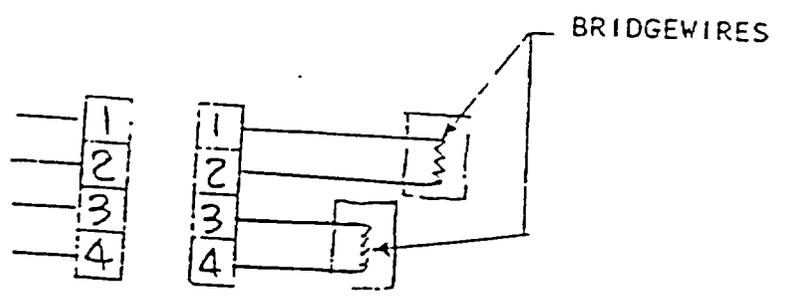
INCORRECT
PIN-TO-BRIDGEWIRE
CONNECTION

The explosive primer charge assembly for the SLCS at Vermont Yankee was supplied by Conax Corporation. The explosive primer charge assembly has two sets of resistance wires, i.e., bridgewires, internal to the charge either of which will fire the explosive. However, some of the charges were manufactured with incorrect pin-to-bridgewire groupings so that when connected at Vermont Yankee, two high-side leads were connected to one bridgewire set and two neutral leads were connected to the other bridgewire set internal to the explosive primer. Examination of spare squibs at Vermont Yankee identified four others with incorrect pin-to-bridgewire groupings.
