UNITED STATES
NUCLEAR REGULATORY COMMISSION
OFFICE OF INSPECTION AND ENFORCEMENT
WASHINGTON, D.C. 20555

IE Circular No. 79-24

PROPER INSTALLATION AND CALIBRATION OF CORE SPRAY PIPE BREAK DETECTION EQUIPMENT
ON BWRs

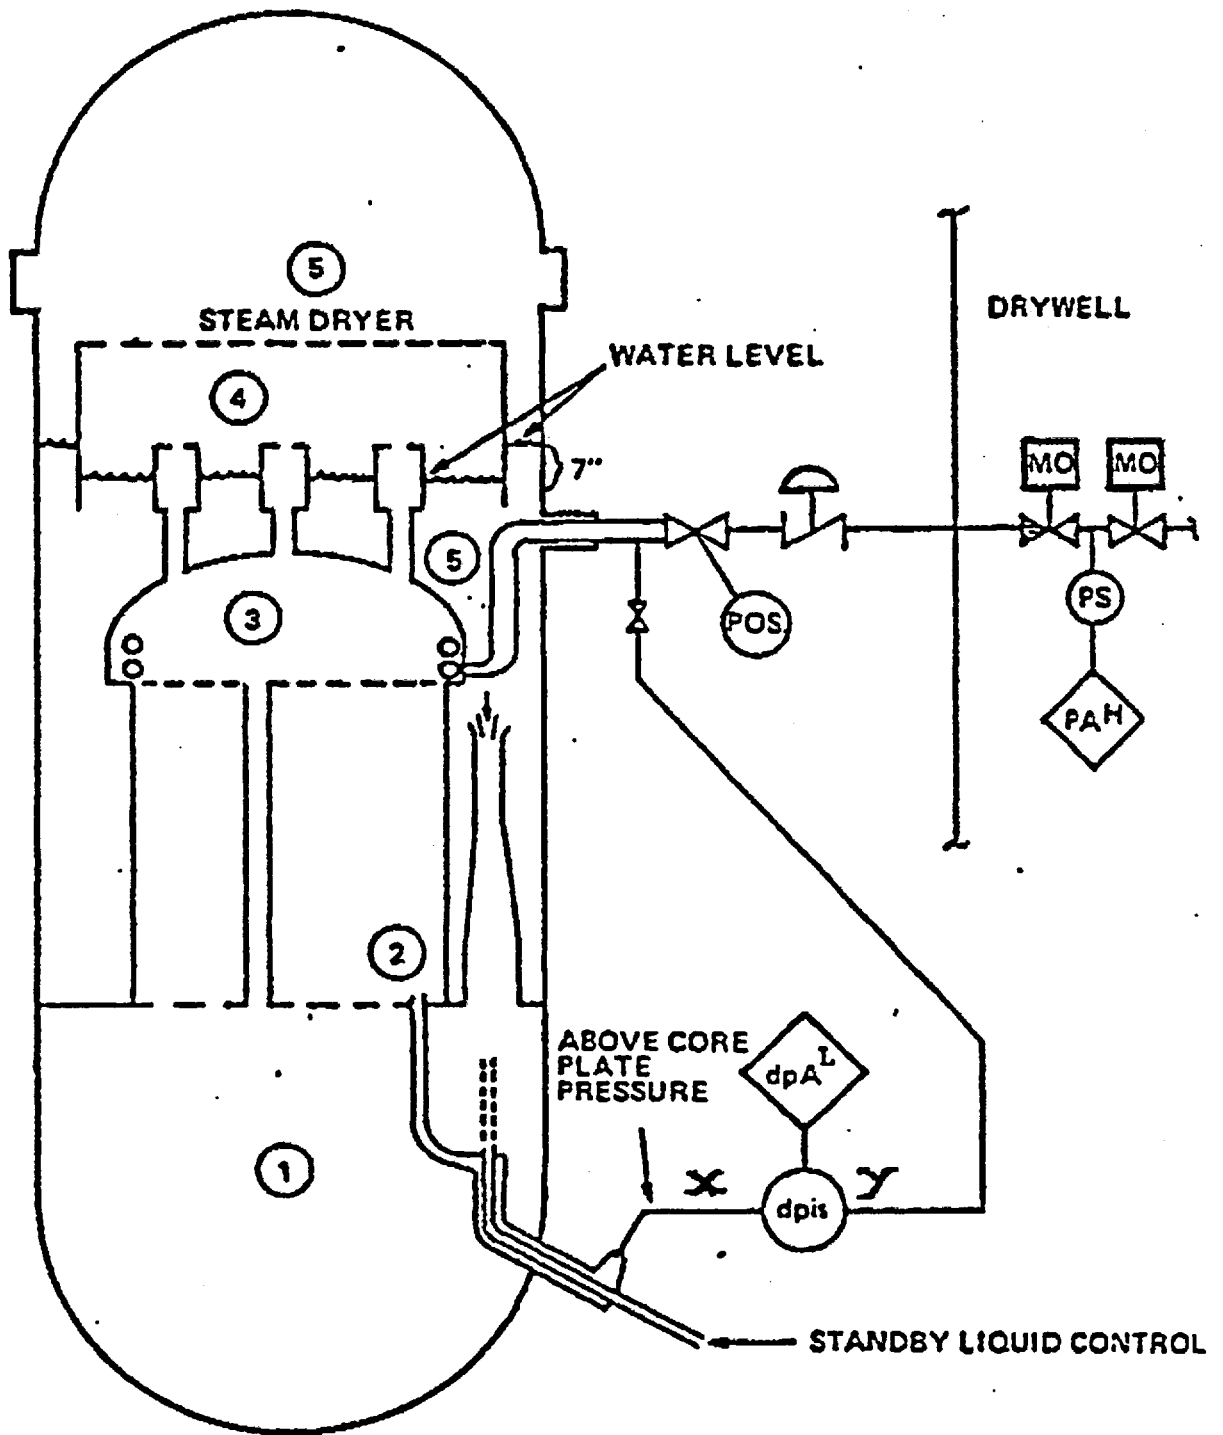
Figure 1 Core Spray System Pipe Break Detection Instrumentation

The licensee's investigation of the downscale deflection revealed that the original piping arrangement and calibration did not adequately take into account the effect of density changes of the water in the pressure leg connections. The original installation had the high pressure side of the dp instrument (see attached Figure 1) connected to the reference leg in the vessel (Figure 1 Connection X) and the low pressure side to the core spray piping outside the vessel but inside the drywell (Figure 1 Connection Y). With the piping intact, this arrangement senses the pressure difference between bottom and top of core. With a break in CS piping in the annulus area the instrument then senses the additional pressure drop across the separators ($dp \approx 7$ psi additional) and dryers ($dp \approx 7$ -inches water). This installation was in accordance with GE design requirements.

Also in accordance with GE instructions the calibration of the dp instrument was performed with the reactor in the cold condition and the alarm was set to trip at 5 psid increasing. Because of this cold calibration the dp instrument then indicated full downscale negative during operation. This negative dp was due to the heat up of the reference leg (Figure 1 Connection X) which caused the fluid density to decrease as the plant reached hot conditions. The magnitude of this dp was determined to be about 3.5 psid following completion of the modification discussed below.

Adding the 3.5 psi downscale deflection to the 5 psi alarm setpoint results in a total required deflection of 8.5 psi to initiate the alarm at the setpoint. Since the total dp available across the separators and dryer is only 7 psi (1.5 psi less than the total required deflection), the alarm would not be actuated by a CS pipe break in the annulus. Therefore, the original installation, including calibration procedure, was deficient.

To correct the problem, Iowa Electric modified the installation by interchanging the pressure leg connections and resetting the alarm to trip at 2 psid decreasing. In this orientation it was found that going from cold to hot produced a 3.5 psid positive deflection. The technical specifications were changed to reflect the revised alarm setpoint.

- "1. BWR operators, who have differential pressure (ΔP) instrumentation which reads only positive values, interchange their core spray line break instrument connections so that the high side connection is to the core spray sparger sensing line and the low side connection is to the above the core plate sensing line. This instrumentation should be calibrated for a zero ΔP reading during cold shutdown; it will then give a positive ΔP reading during normal rated power operation and a pegged zero reading for a line break indication during normal rated power operation.

Also, when this change is made, the recommended alarm setpoint (on decreasing ΔP) setting is 0.5 / 0.25 PSID; and for those plants that have a value in their technical specifications, >0 PSID is recommended as a limit.
