UNITED STATES
NUCLEAR REGULATORY COMMISSION
OFFICE OF INSPECTION AND ENFORCEMENT
WASHINGTON, D. C. 20555

June 20, 1980

IE Circular No. 80-15

LOSS OF REACTOR COOLANT PUMP COOLING AND NATURAL CIRCULATION COOLDOWN

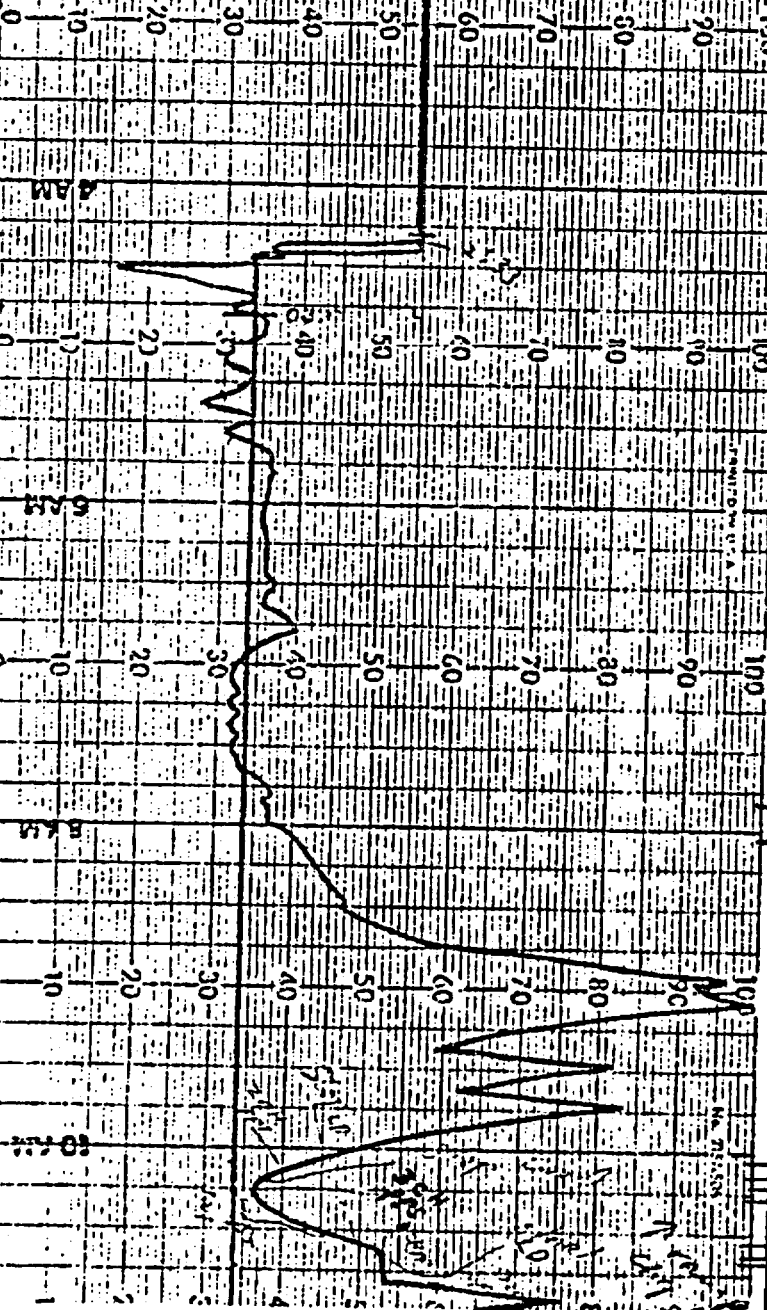
11 JUNE 1980
 ST. LUCIE
 HOT CALIBRATED
 PRESSURIZER LEVEL

The natural circulation cooldown continued uneventfully until after time 0600. The highest cooldown rate achieved was approximately 65 to 70 F per hour. Between 0600 and 0630 RCS pressure was reduced from 1140 to 690 psi by charging water through the pressurizer auxiliary spray line. Pressurizer level increased rapidly around 0700 while charging via the auxiliary spray line. Pressurizer level variations continued for approximately five hours while the cooldown and depressurization continued. When charging was shifted to the RCS loops, pressurizer level decreased at rates lower than the rates of increase in level when charging through the auxiliary spray line. During a two minute interval while charging into the pressurizer auxiliary spray line at 88 gpm, pressurizer level rose at a rate approximately ten times greater than the charging flowrate.

The cause of pressurizer level variations appears to be formation of a steam void in the reactor head area due to a temperature lag with respect to bulk coolant temperature that developed because of insufficient cooling flow in that area during natural circulation cooldown. Gas concentration in a 0730 RCS sample was determined by the licensee to be 32 cc/kg hydrogen and 16 cc/kg nitrogen. These concentrations were not high enough to cause a significant volume of gas to come out of solution. The indicated subcooling margin ($T_{sat} - T_{hot}$) ranged between 220 and 150 F when the reactor head steam void developed between 0600 and 0700. The minimum required subcooling of 50 F was not approached during the cooldown until around time 1219 at a pressurizer pressure of approximately 110 psig. An annotated record of pressurizer level is enclosed only to illustrate the high amplitudes and rates of pressurizer level variations. Insufficient information is contained in the enclosure to enable detailed evaluation of the RCS behavior.

DEPRESSURIZE
 1140 psig to 690 psig

- STOP LETDOWN
- 2 CHARGING PUMPS
- STOP FEED
- 3 CHARGING PUMPS
- START FEED
- 1 CHARGING PUMP
- START LETDOWN
