SSINS No.: 6835
IN 86-39

May 20, 1986

IE INFORMATION NOTICE NO. 86-39: FAILURES OF RHR PUMP MOTORS AND
PUMP INTERNALS

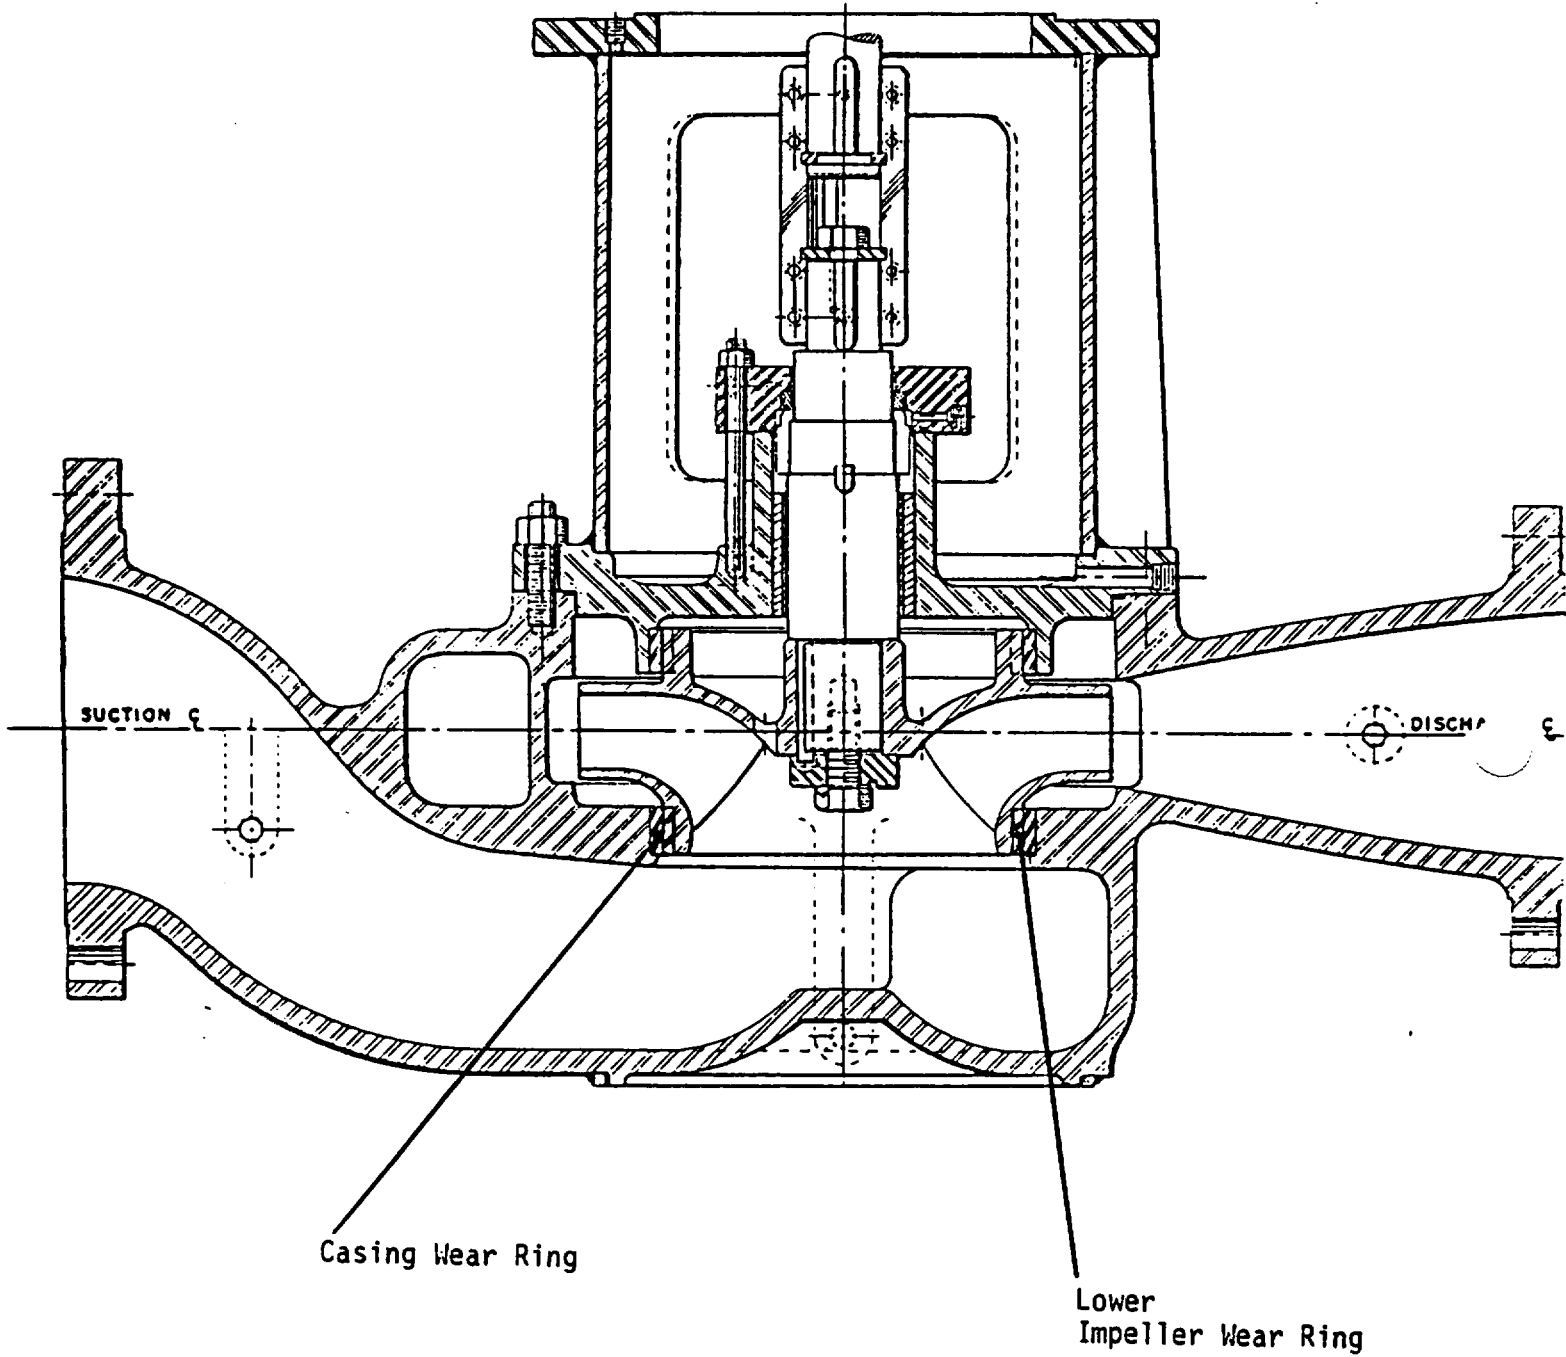
FIGURE 1 - Typical CVIC RHR Pump
Sectional Assembly

The RHR pump impeller wear rings are press fit to the impeller and attached with eight dowel pins. The wear rings provide a wearing surface on the pump impeller. The wear rings are 410 stainless steel, A 182 grade F6 with a Rockwell C hardness of 33 to 39. Metallurgical examinations of the wear ring fracture surfaces indicate the presence of intergranular stress corrosion cracking (IGSCC). PECO has classified the wear ring failures as IGSCC. On November 26, 1985, PECO made an INPO Network notification regarding these RHR pump failures. PECO has repaired all affected pumps by replacement of damaged motors and pump internals. Tennessee Valley Authority's Browns Ferry Units 1, 2, and 3 utilize the identical pumps for RHR service. Similar motor and pump impeller wear ring failures have occurred at these facilities, but not to the extent identified at Peach Bottom. Pumps of similar design, but different size, are utilized for core spray service both at Peach Bottom and Browns Ferry. However, these pumps use the "integral" impeller wear ring design, i.e., extended impeller part replaces separate wear ring and forms a single unit, and therefore are not susceptible to the type of wear ring failure previously described.
