IN 86-40

June 5, 1986

IE INFORMATION NOTICE NO. 86-40: DEGRADED ABILITY TO ISOLATE THE REACTOR COOLANT SYSTEM FROM LOW-PRESSURE COOLANT SYSTEMS IN BWRs

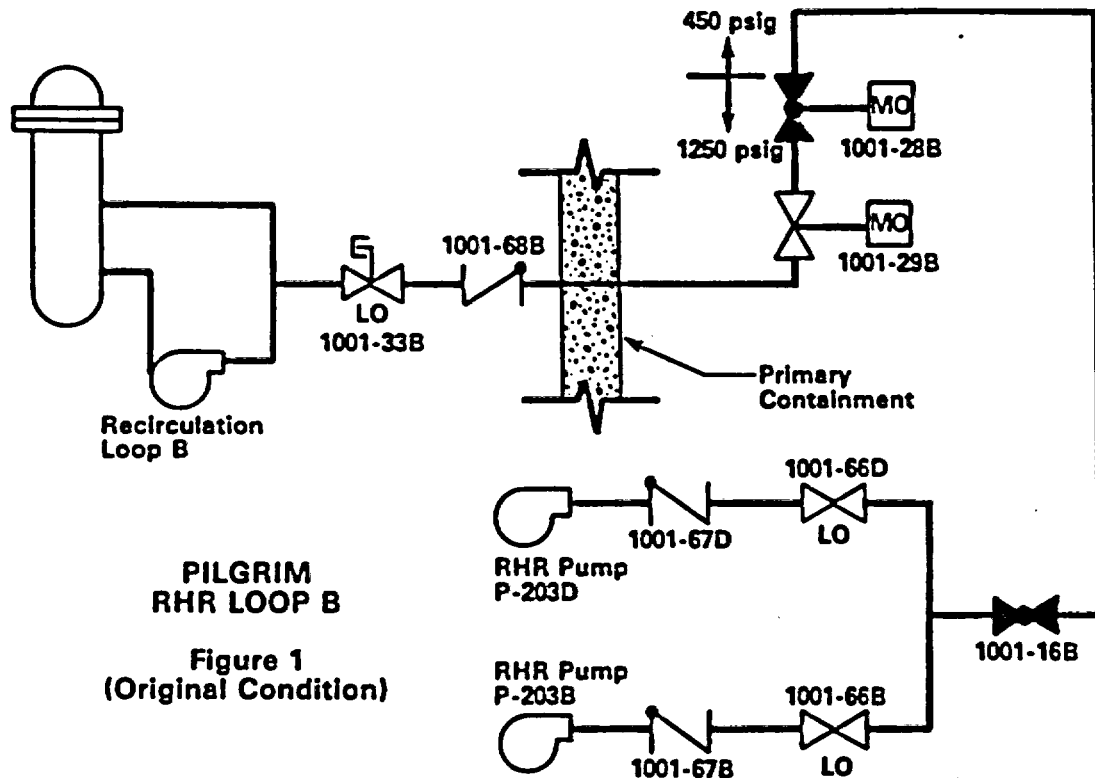
On February 13, 1986, Pilgrim experienced a "design pressure" alarm on the B loop of the residual heat removal (RHR) system because of leakage through a check valve (1001-68B) and a motor-operated isolation valve (1001-288, the outboard, normally closed, isolation valve) in the line (see Figure 1). The RHR system has a design pressure of 450 psig compared with a 1250 psig design pressure of the reactor coolant system. In addition to design pressure alarms, the piping up to the 288 valve had become warm. Several design pressure alarms had occurred during the preceding several weeks. The licensee's prior corrective action had been to vent the lines. On February 13, the licensee closed the normally open 1001-29B valve and opened the 288 valve to isolate the system. The licensee planned to operate in this configuration until a scheduled refueling and maintenance outage in September 1986.

On April 11 and 12, 1986, the closed 29B valve began leaking. Several high pressure alarms were reported. The licensee bled off the line to reduce pressure and began an orderly shutdown, but within a short period of time, the high pressure alarm was again received. The 28B valve was closed, but the leakage problem continued. The shutdown rate was then increased until the unit scrambled because of other problems. An NRC augmented inspection team was dispatched to the site to investigate these RHR valve problems and two problems in other systems.

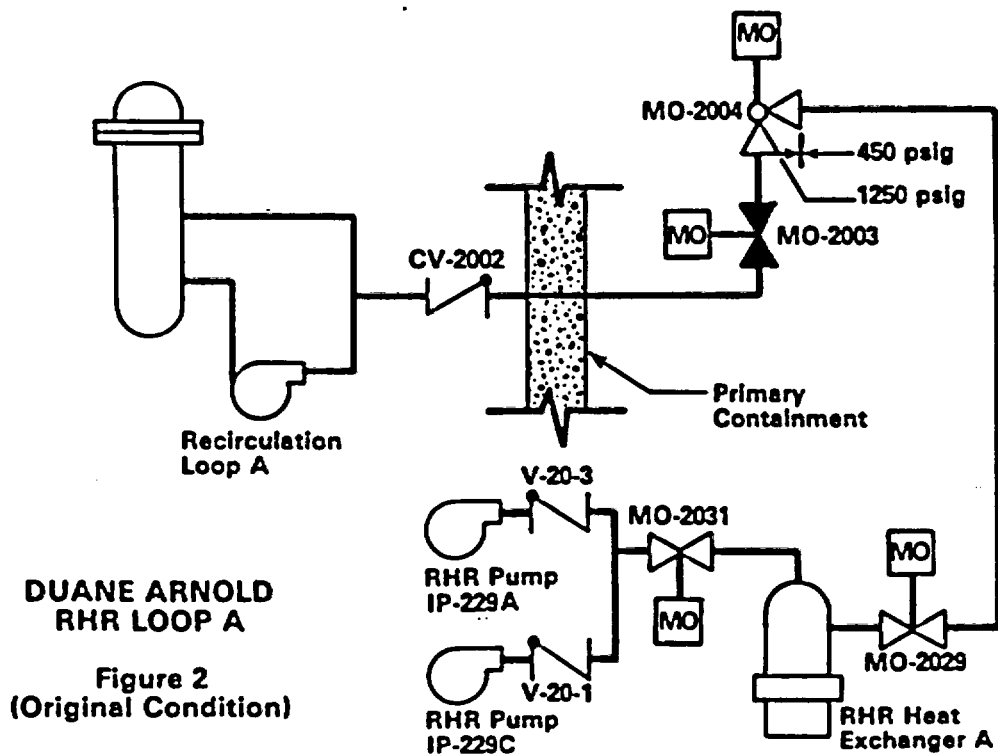
On March 15, 1986, while reducing power for an outage, Duane Arnold reported closing the outboard LPCI (low-pressure coolant injection mode of RHR) isolation valve MO-2004 due to leakage through the inboard isolation valve MO-2003 (see Figure 2).

Because the leakage flow was relatively small, the Δp across the check valve inside of containment (CV-2002) was not high enough to seat the check valve. The problem was discovered when it was noted that the pressure controllers on the RHR heat exchangers were indicating a pressure of 450 psig rather than the normal 70 psig. RHR system relief valves had lifted to keep pressure at or below 450 psig. Closing the MO-2004 valve stopped the leakage, but because the plant has loop selection logic, both loops of LPCI were rendered inoperable. The plant continued its planned shutdown and reached cold shutdown on March 16. The leaking valves were repaired during the outage.
