**PRAIRIE ISLAND NUCLEAR GENERATING PLANT  
DOCKET 50-282  
LICENSE NO. DPR-42  
TRANSMITTAL OF WESTINGHOUSE PRAIRIE ISLAND UNIT 1 – LOWER ROW  
TUBE DENT ROOT CAUSE ANALYSIS**

**WCAP-16059-NP  
Revision 0**

**Prairie Island Unit 1-  
Lower Row Tube Dent Root Cause  
Analysis**

**Prairie Island Unit 1**  
**Lower Row Tube Dent Root Cause Analysis**

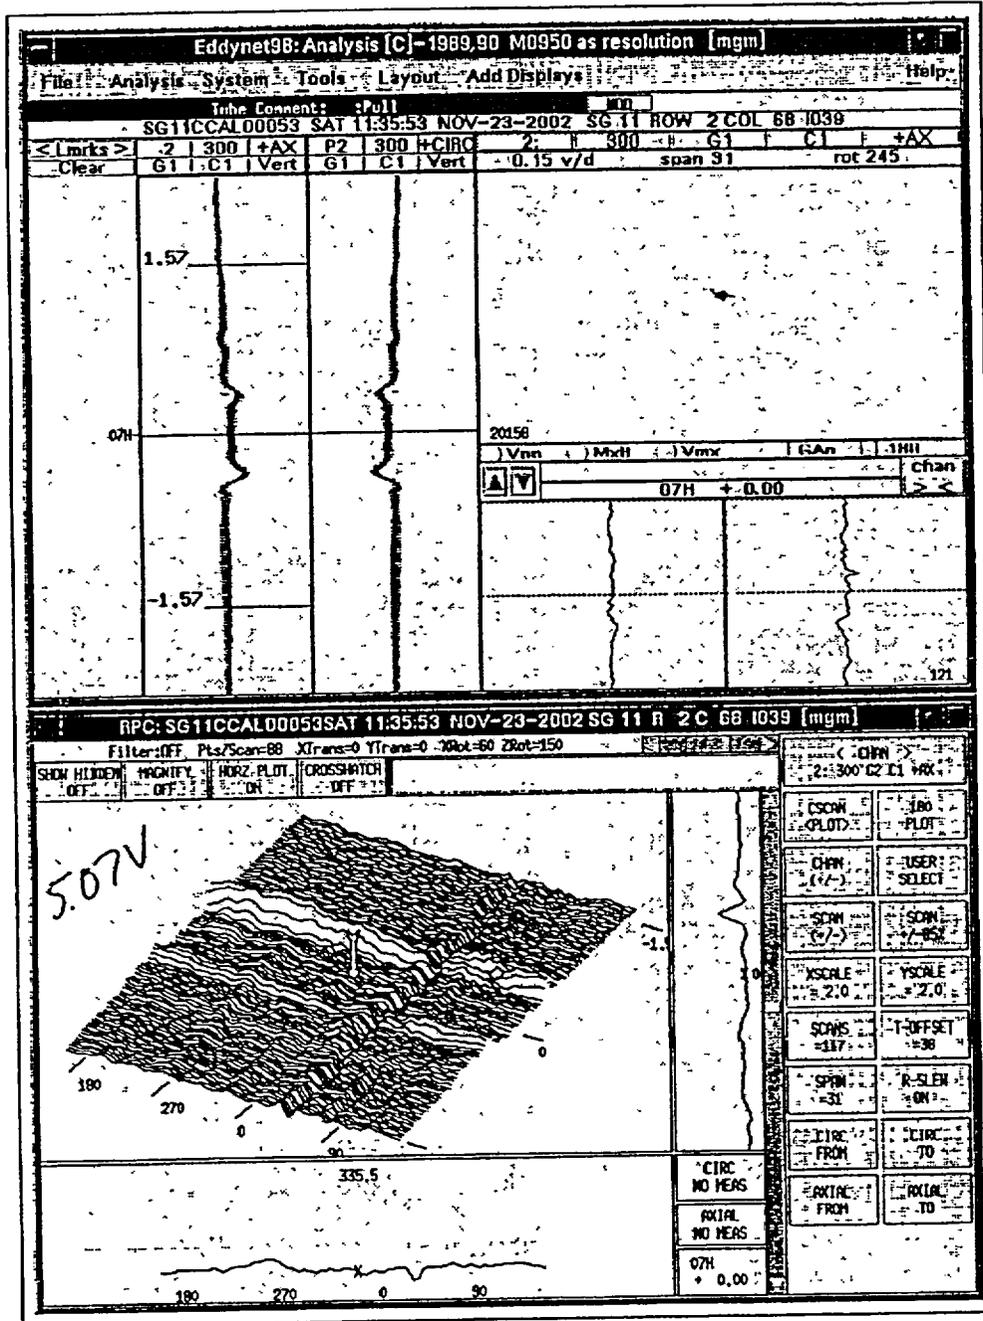
Figure 1 +Pt Eddy Current Response of a Typical Tube

Both bobbin coil and +Pt eddy current inspections were performed during the most recent Fall 2002 outage at Prairie Island Unit 1. During the bobbin coil inspection of the Row 1 and Row 2 tubes, it was determined that some tubes had indications of signals that could be classified as dents. Table 1 contains a summary of tubes found with signals greater than 2 volts near the upper tube support plates. With relatively few exceptions, signals found near TSP 7 are located near the bottom surface of the plate, and signals found near TSP 6 are located near the top surface of the plate. In addition, it was determined that there are 3 tubes with simultaneous indications on both the 6<sup>th</sup> and 7<sup>th</sup> tube support plate. All Row 1 and Row 2 tubes, both with and without dent signals, were examined using the +Pt probe as part of the normal small radius U-bend inspection program. Figure 1 contains a typical +Pt response (horizontal component only) for tube R2 C68, SG11, at 07H. A response is noted to extend for nearly 360 degrees around the tube. The vertical component for this tube shows essentially no dent-like response. The design of the +Pt coil minimizes geometry transition influences from uniformly affected conditions, such as expansion transitions at the top of tubesheet. If the bobbin signals truly represent a geometry change in the tube, the +Pt data can be used to judge that the geometry deformation is more uniform around the circumference, and does not mimic geometry patterns observed for more classical denting conditions resultant from corrosion of the carbon steel TSP. The largest of the dent signals was approximately 6 volts by bobbin. For a circumferentially uniform geometry change of approximately 1 mil, bobbin dent signals exceeding 6 volts are expected.
