SSINS No.: 6835
IN 86-70

IE INFORMATION NOTICE NO. 86-70: POTENTIAL FAILURE OF ALL EMERGENCY
DIESEL GENERATORS

On June 10, 1986, in accordance with 10 CFR Part 21, Florida Power & Light (FP&L) reported the results of a failure modes and effects analysis (FMEA). This analysis identified multiple design deficiencies in the Turkey Point Units 3 and 4 vital ac power system that could potentially result in the loss of both EDGs due to overloading. In addition, one deficiency was identified that could result in the loss of all ac power to Unit 4. Turkey Point Units 3 and 4 share two EDGs. Simplified diagrams of part of the Turkey Point 3 & 4 electrical distribution system are provided as Figures 1 and 2.

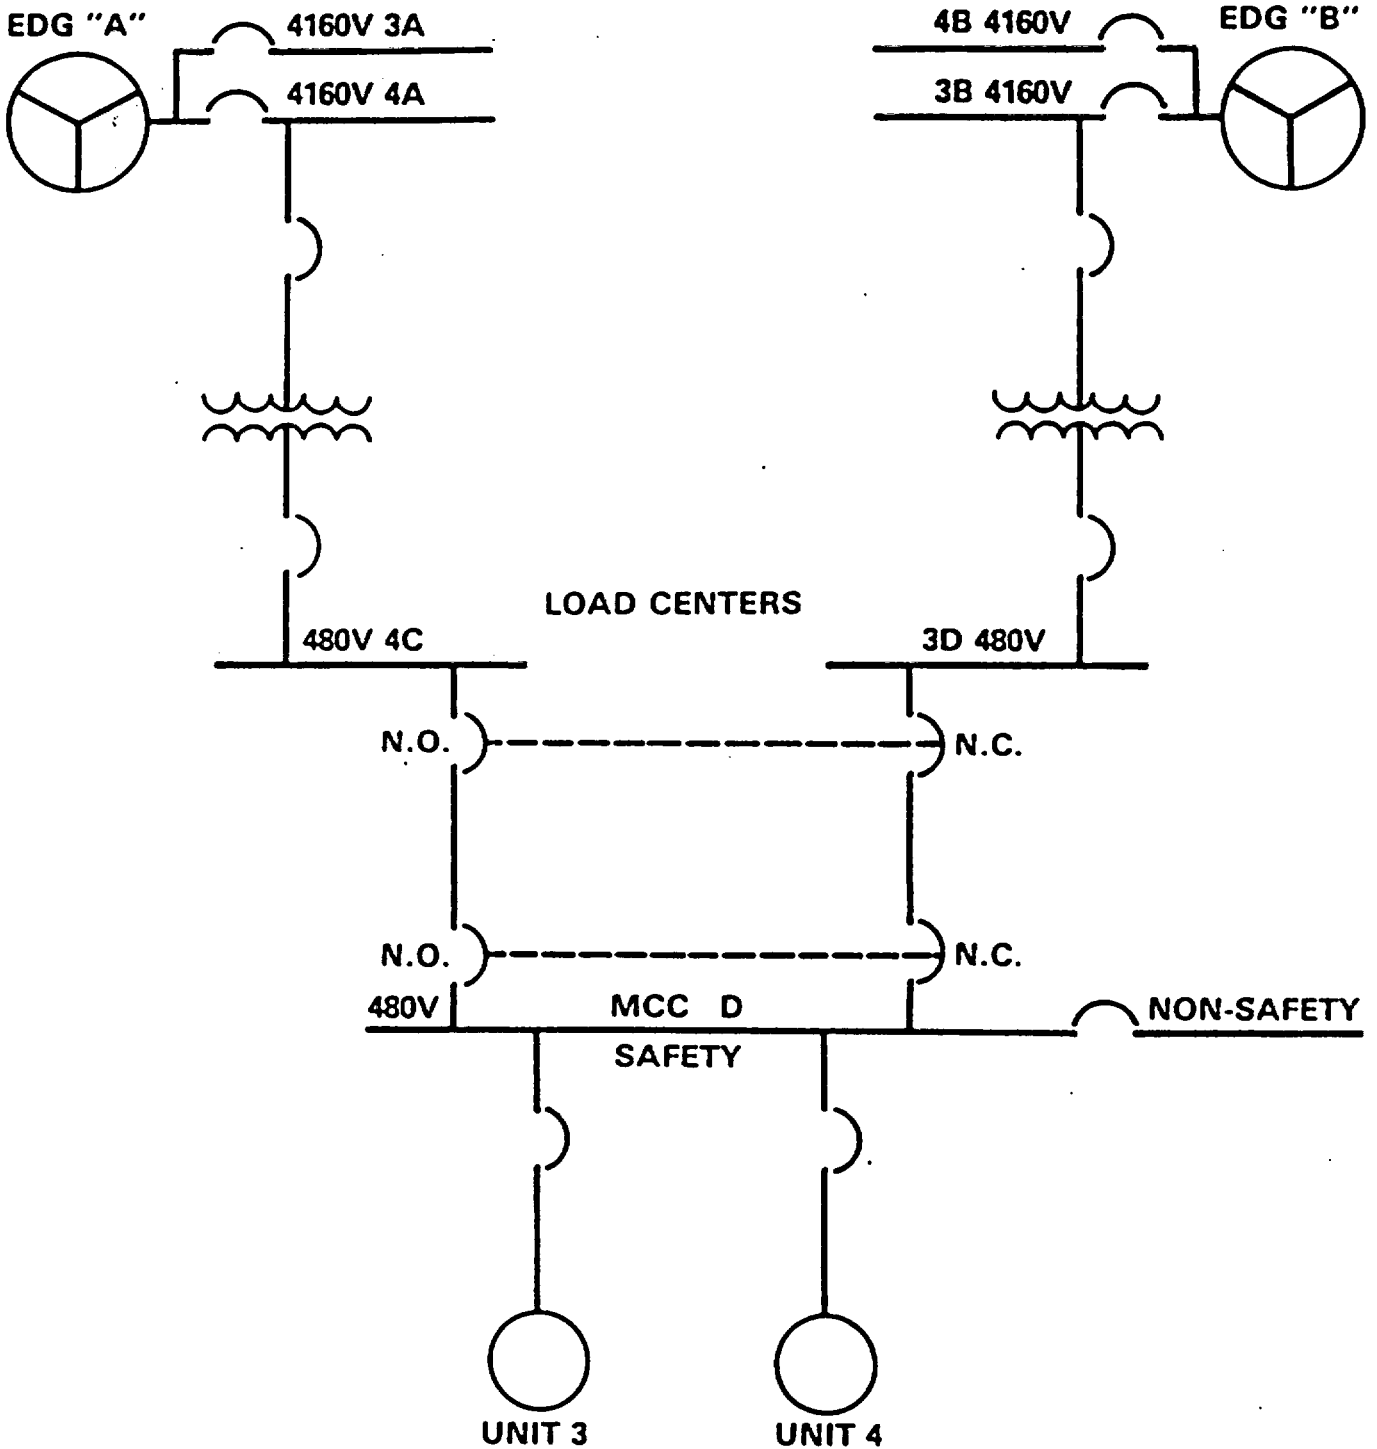
FIGURE 1
TURKEY POINT - UNITS 3 & 4 *

One design deficiency involved a "swing bus." As shown on Figure 1, 480 volt MCC "D" is normally supplied from EDG "B" but will shift its power supply to EDG "A" if needed. MCC "D" also feeds a non-safety stub bus through a single circuit breaker. This breaker is normally opened by the 4B load sequencer to isolate the non-safety loads from MCC "D" when the 4B 4160V bus is loaded on EDG "B". A single failure in that circuit breaker would leave the non-safety loads connected to MCC "D". During safety injection for one unit, the additional non-safety loads could overload EDG "B", possibly resulting in a trip of this EDG. MCC "D" would then transfer its power supply and could overload EDG "A" as well.

As an interim solution to the above design deficiencies, FP&L disabled the automatic transfer between EDGs and established a dedicated operator to take corrective action (i.e., manipulate appropriate breakers) as necessary. The licensee has now modified EDG loads, loading sequences and plant procedures. This example illustrates the importance of reviewing EDG load limits under all possible operating configurations for a range of design basis accident conditions. FP&L, through an FMEA, system testing, and evaluation of EDG load limits, found design deficiencies that may have prevented one or both EDG's from performing their required function.

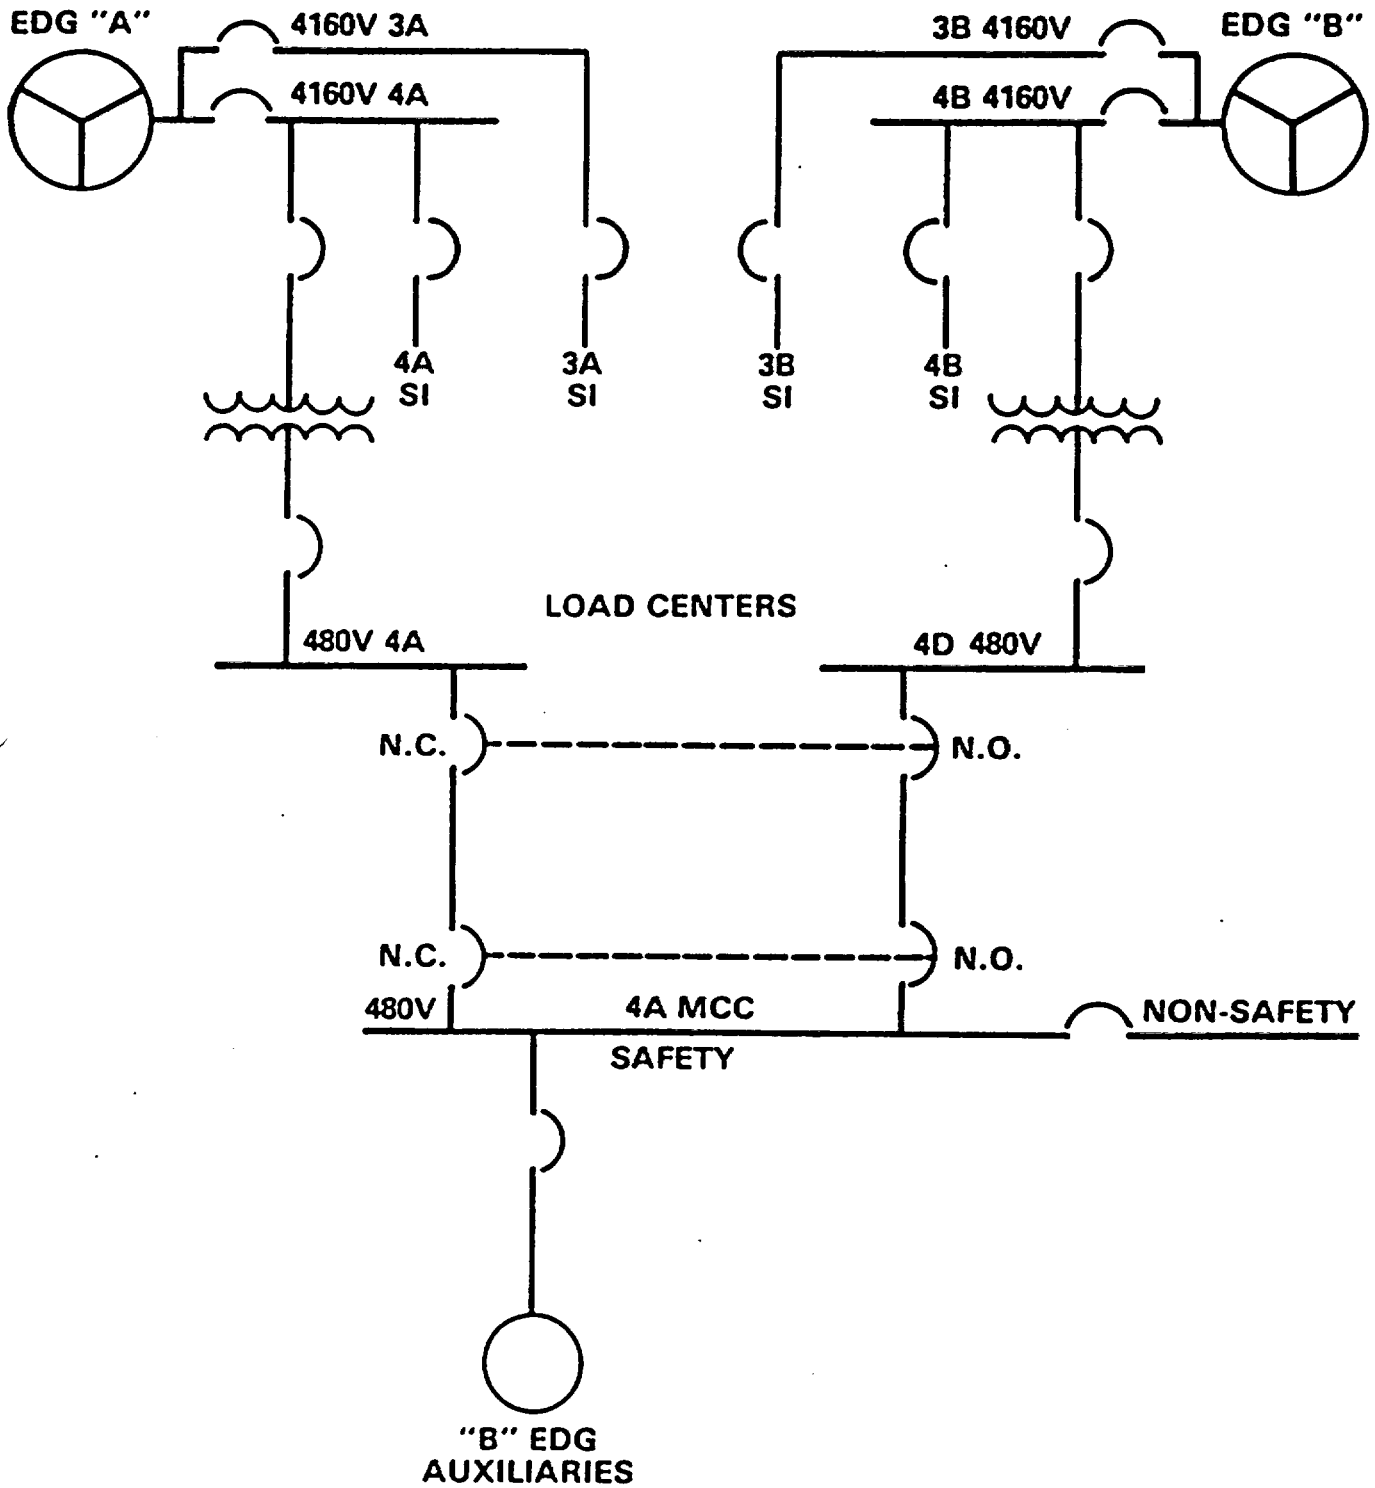
FIGURE 2
TURKEY POINT - UNITS 3 & 4*

In addition to the overloading deficiencies above, a design deficiency was found that could result in the loss of one EDG, and at the same time could result in the loss of all ac power to Unit 4 as mentioned earlier. In the event of a single failure of the 4A battery or the 4A load sequencer subsequent to a loss of off-site power, the 4A 4160V bus shown in Figure 2 would be prevented from automatically loading onto the "A" EDG. It would also prevent the transfer of the 4A MCC swing bus from 4A load center to 4B load center. The "B" EDG has a self-contained supply of fuel oil that lasts about one hour. After that time, fuel must be gravity supplied by the day tank via a solenoid operated valve. However, this valve is powered from MCC 4A. Therefore, the above mentioned single failure would also cause the loss of the "B" EDG and the loss of all ac power to Unit 4. The Unit 3 3B 4160V bus would also be deenergized, along with three of the four high head safety injection pumps and the control room air-conditioning.
