SSINS No.: 6835  
IN 86-74

August 20, 1986

IE INFORMATION NOTICE NO. 86-74: REDUCTION OF REACTOR COOLANT INVENTORY  
BECAUSE OF MISALIGNMENT OF RHR VALVES

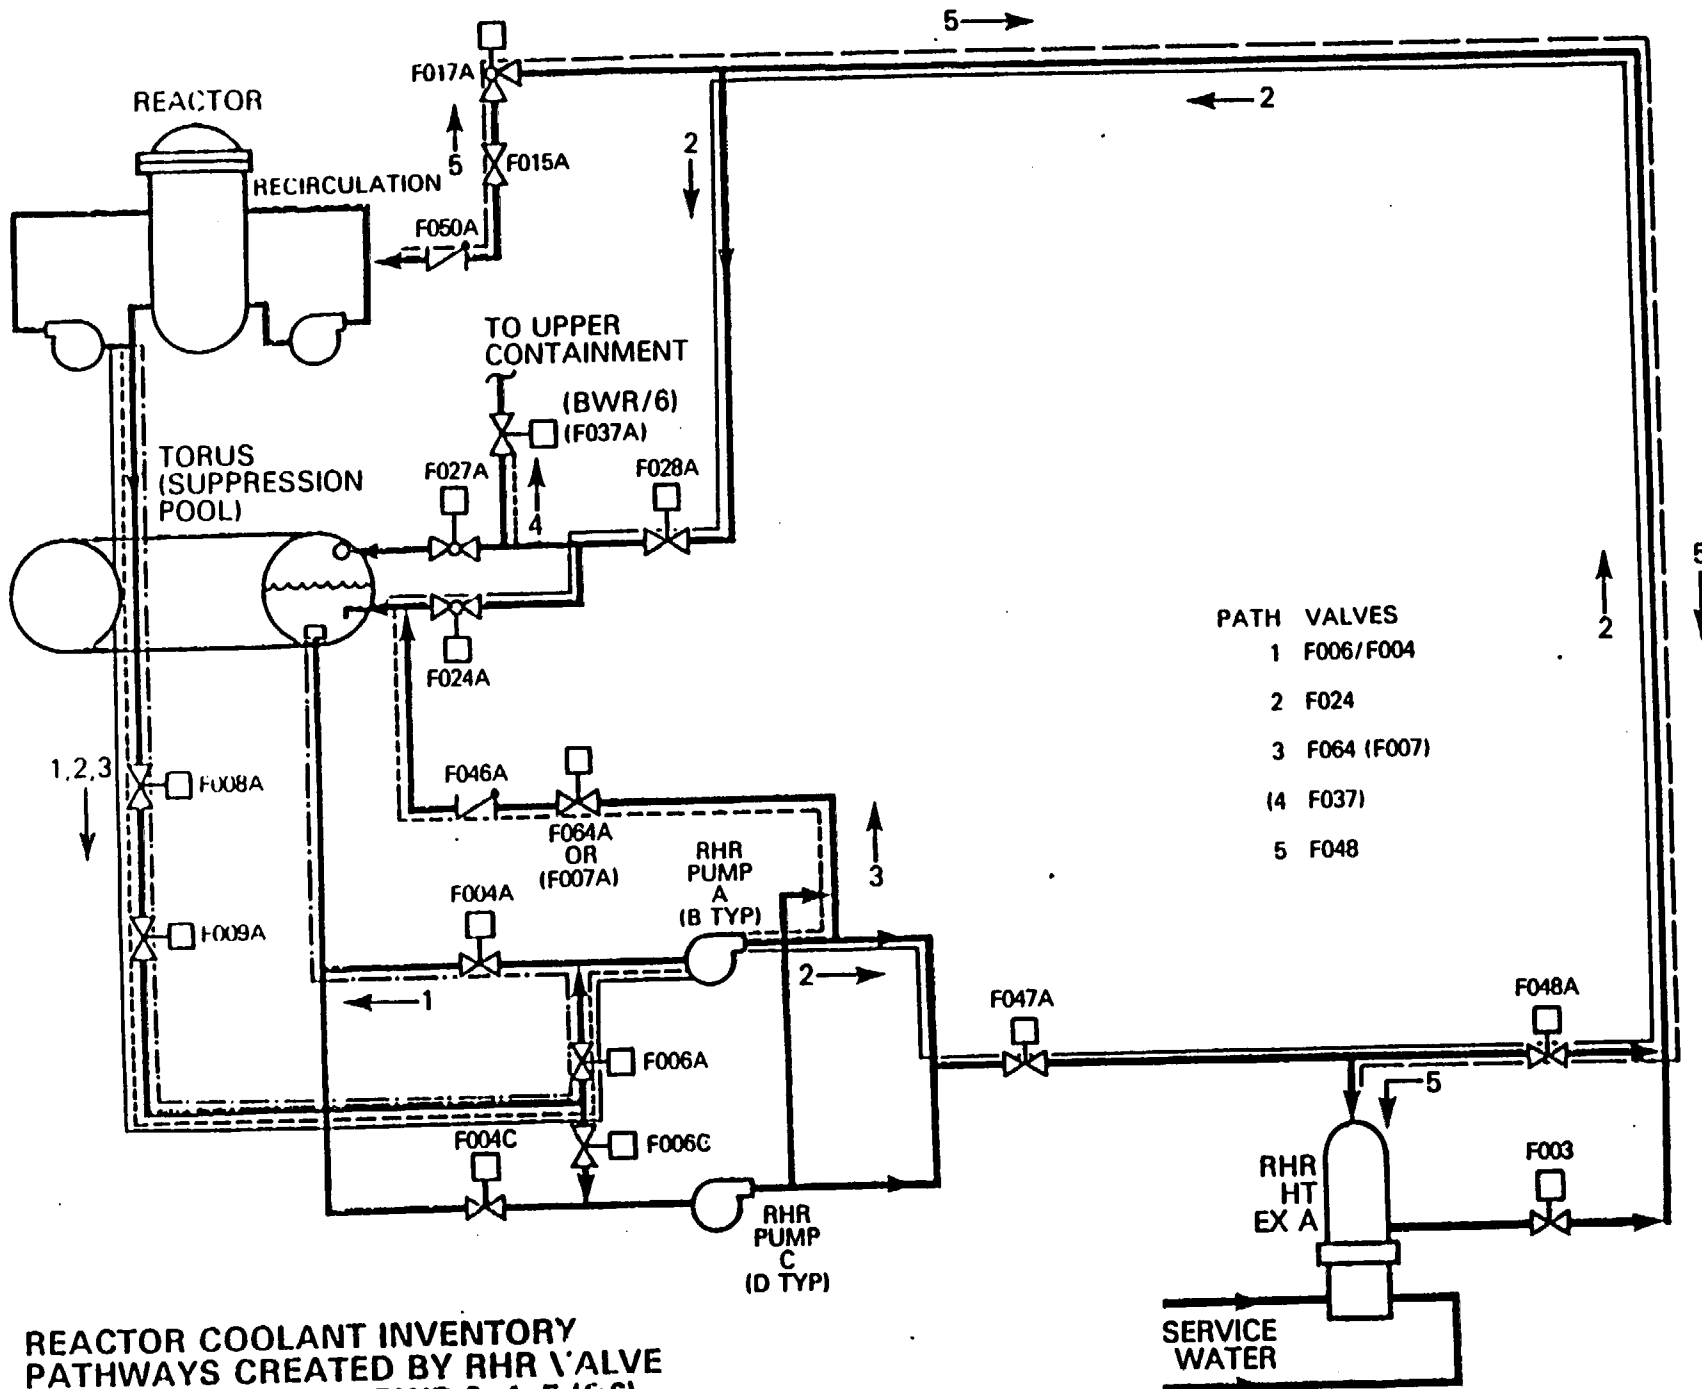
REACTOR COOLANT INVENTORY  
 PATHWAYS CREATED BY RHR VALVE  
 MISALIGNMENT BWR 3, 4, 5 (&6)

A number of events involving reduction of reactor coolant inventory because of RHR valve misalignment have occurred since the issuance of IN 84-81. Six events that occurred in 1985 have been selected for inclusion in this notice. A seventh case was included since RHR was intentionally used to drain water from the reactor cavity. (Refer to Attachment 1 for diagram and definition of pathways.)

While attempting to align B-loop RHR in the shutdown cooling mode, a portion of the RHR piping was inadvertently drained to the main condenser during the warmup process. When the operator opened the heat exchanger bypass valve F0488, water drained rapidly from the vessel, refilling the RHR piping, and waterhammer occurred. The reactor vessel level decreased 35 inches. Reactor scram and primary containment isolation system (PCIS) actuation\* occurred on the reactor low-level signal. (Pathway 5)

While shifting from shutdown cooling to low pressure coolant injection (LPCI) lineup, suppression pool suction valve F004 was opened before shutdown cooling suction valve F006 was shut (valves F008 & F009 were open). The operator did not allow for the stroke times of the valves. Water level rapidly fell to the scram and PCIS actuation set point. The final water level was +5 inches. (Pathway 1)

While shifting from shutdown cooling to LPCI lineup, the F004 valve was opened before the F006 valve shut (valves F008 & F009 were open). Approximately 7500 gallons of reactor inventory was drained to the suppression pool. The incident was terminated by PCIS actuation on the low reactor water level signal. The final water level was -10 inches as opposed to the normal level of about +39 inches. (Pathway 1)

The 2A RHR pump was being realigned from shutdown cooling to the full flow test mode. With valves F008A, F009A and F006C open, the discharge valve to the suppression pool F024A was opened in the 2A line, allowing reactor water to flow to the torus. On reaching the reactor water low-level set point, the reactor scrammed and PCIS actuated to terminate the event. The final water level was -10 inches. (Pathway 2)
