SSINS No.: 6835
IN 86-75

August 21, 1986

IE INFORMATION NOTICE NO. 86-75: INCORRECT MAINTENANCE PROCEDURE ON
TRAVERSING INCORE PROBE LINES

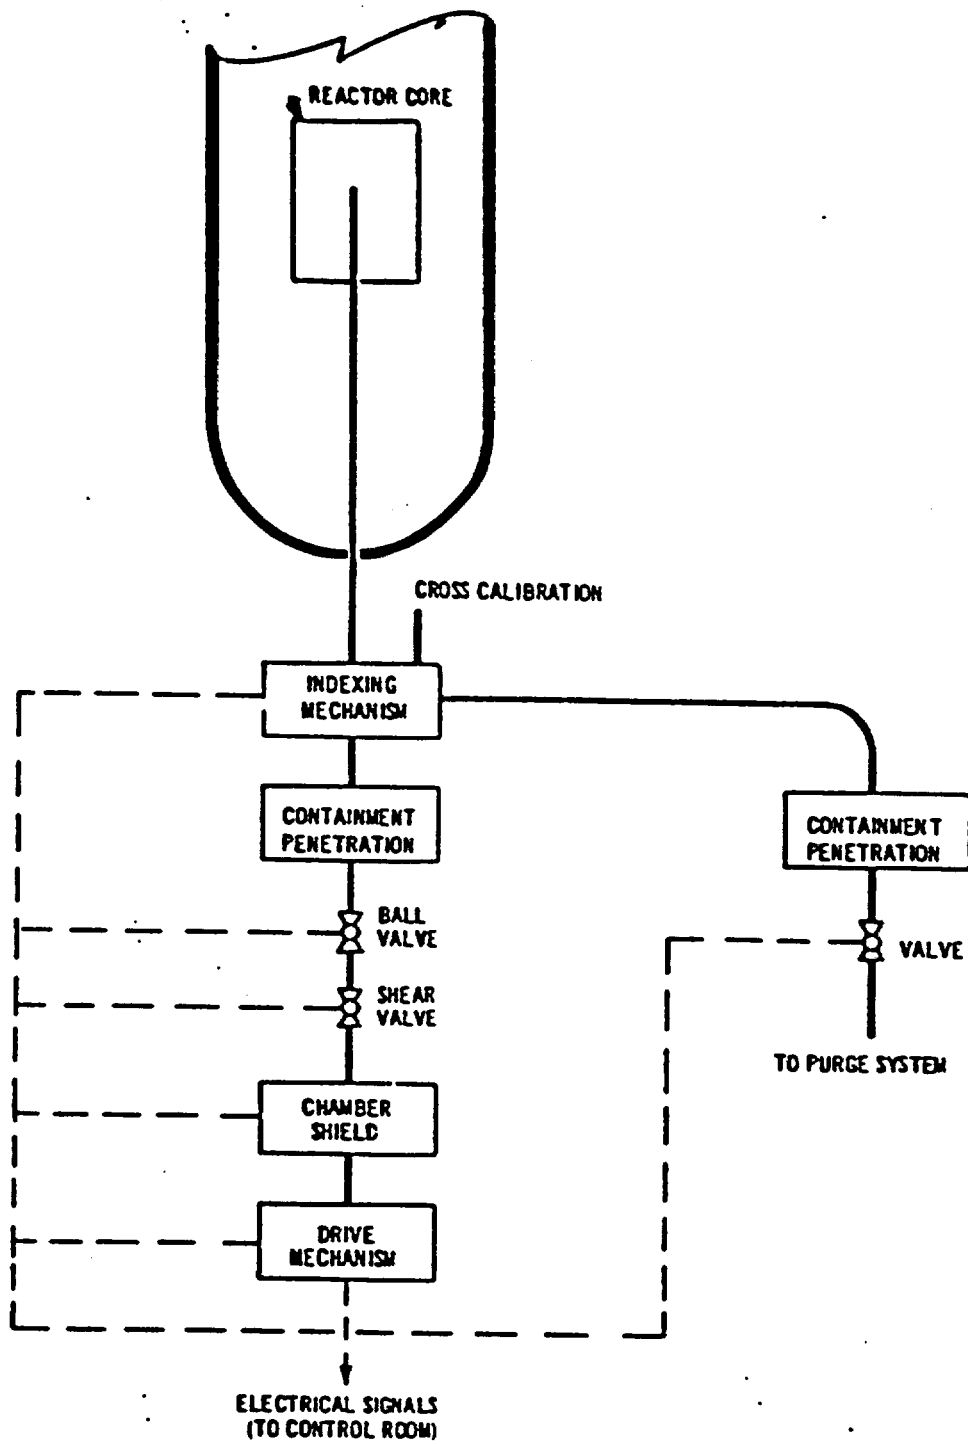
Traversing In-Core Probe
Subsystem Block Diagram

On August 9, 1985 maintenance was performed on a Duane Arnold Energy Center (DAEC) TIP isolation ball valve. The valve was not opening properly, thereby preventing the TIP from being inserted. The licensee reviewed the design and the FSAR which states in a note to Table 3.1-1: "Since the TIP system lines do not communicate freely with the containment atmosphere and since they do not comprise a portion of the reactor coolant pressure boundary [10 CFR 50, Appendix A, General Design Criteria] GDC 55 and 56 are not directly applicable to this specific class of lines." Following this review, the licensee decided that the isolation ball valve could be changed out with the plant on-line because of the closed system configuration. The indexer was positioned on a blanked off line to provide additional assurance against leakage if a TIP tube failed in the reactor vessel. The isolation ball valve was removed and replaced (see Figure 1).

In January 1986, the replacement ball valve appeared to be sticking and would not fully open. While the licensee's Operations Review Committee was reviewing the design before performing maintenance, it was concluded that the FSAR basis for the previous action was not correct. Inside the primary containment, the indexing mechanism (a revolver-like mechanism used for selecting a guide tube leading into the reactor vessel) is mounted inside a housing equipped with a pressure relief valve which communicates with primary containment atmosphere. This pressure relief valve is unique in that it will open on a negative or positive pressure inside the housing. The indexing mechanism (indexer) has a slip fitting with the guide tubes leading to the reactor vessel. If a loss of coolant accident occurred and the primary containment became pressurized, the pressure relief valve would open to reduce the pressure differential across the indexer housing and the containment atmosphere would leak past the slip fitting into the TIP line. Under these conditions GDC 56 would apply rather than GDC 57. With the ball valve removed for repair or replacement, primary containment integrity would be compromised.

In addition, if a leak from the reactor coolant system occurred or existed in any of the TIP tubes of an indexing mechanism, opening the external line from that mechanism for maintenance while the plant is in operation would result in a non-isolable LOCA. Primary coolant released into the work area would result in a hazardous steam environment and radiation exposure to maintenance personnel in the area. The consequences of a coolant-to-tube leak are potentially

The licensee is conducting a review to determine the necessary revisions to the Technical Specifications and FSAR. The subsequent required maintenance on the system was conducted such that primary containment integrity was not compromised and post-maintenance testing included Type B and C leak testing.
