SSINS No.: 6835
IN 86-99

December 8, 1986

IE INFORMATION NOTICE NO. 86-99: DEGRADATION OF STEEL CONTAINMENTS

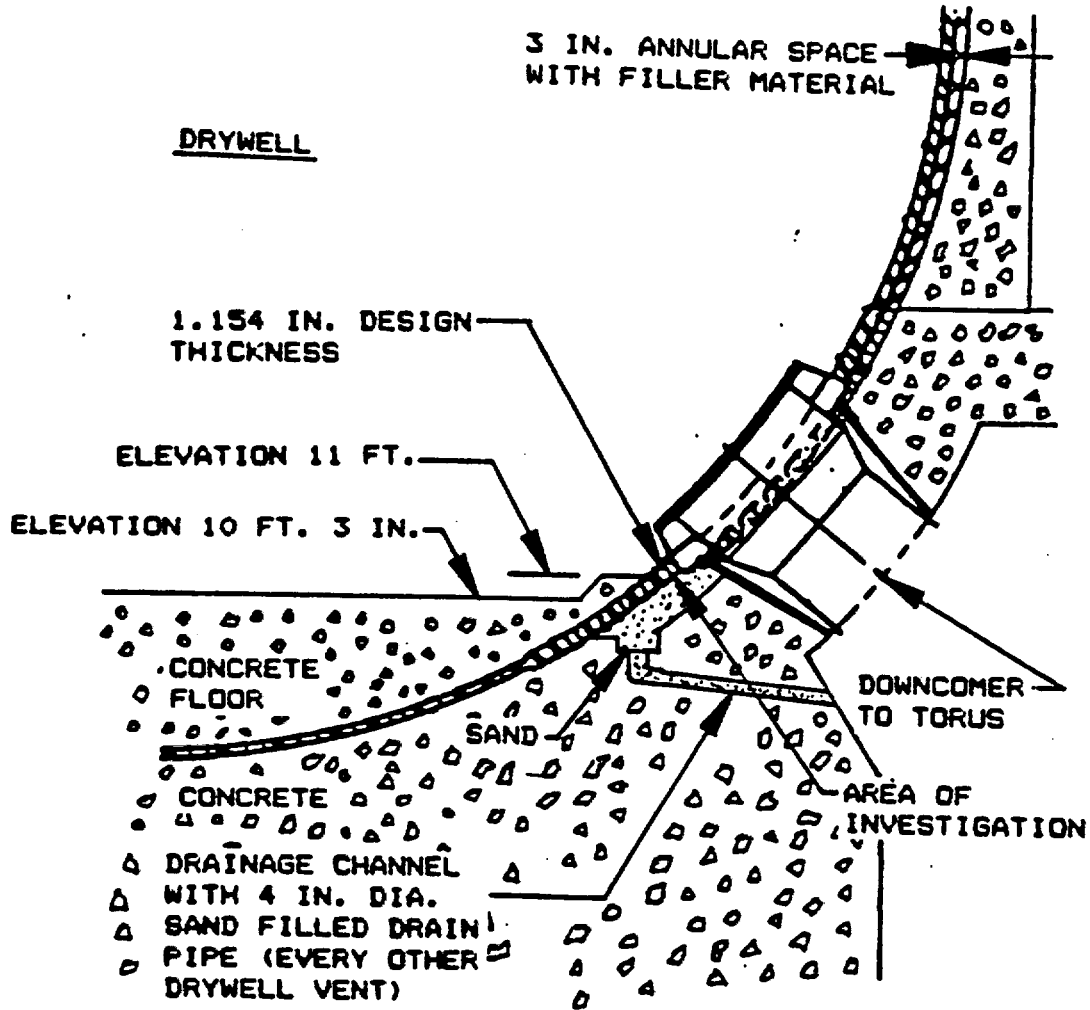
Figure 1

To determine if the water in the gap had caused damaged to the steel containment, the licensee measured the wall thickness, using an ultrasonic testing (UT) technique at two elevations. The 51-ft level near the drywell seal was sound, but there appeared to be loss of metal on the gap side at the 11-ft 3-in. level immediately above the concrete floor. In this area, the gap is packed with sand and contains five equally spaced drain pipes (see attached Figure 1). A total of 143 measurements were made at this level and 60 indicated a reduction in thickness of more than 1/4 in. from the drawing thickness of 1.154 in. These readings were found throughout seven of the ten downcomer bays. The licensee plans to cut the steel containment and remove about 12 samples to confirm and evaluate the corrosion damage.

The purpose of the sand is to act as a cushion and allow expansion of the drywell during operation. The steel containment is in contact with sand in those areas where corrosion has been detected. The containment material is ASTM A-212 Grade B carbon steel plate. The licensee stated that the outside surface was protected with a red lead coating from above the drywell down to about the 10-ft. level, which means that the interface between the lead paint and the unprotected steel was in contact with wet sand. Red lead protects steel by providing a stable and impenetrable surface, but the steel is sacrificial with respect to the lead in dilute, acidic water conditions.

It is possible that condensation during initial construction, moisture pickup through the drain line during operation, and the leaking bellows wetted the sand, thereby causing corrosion of the containment steel plates. During construction, water was seen running down the outside of containment into the sand. The five drain lines, as well as other penetrations in the concrete shield, are open during operation and would allow moist air to enter and rise up the gap and later cool and condense as water. Water also was able to enter the gap through the holes in the bellows during refueling until repairs were made.

Sketch of Possible Degraded Areas

The licensee plans to remove a section of the drain pipe to perform a visual examination of the outside of the drywell. Wipe samples will be taken from several areas and a chemical analysis will be performed. Sand samples will be taken adjacent to the core holes and will be analyzed for chemicals, bacteria, and water composition. Some channels are being cut in the concrete floor that is inside the drywell to provide access for further UT examination of the containment-sand interface.
