SSINS No.: 6835
IN 86-100

December 12, 1986

IE INFORMATION NOTICE NO. 86-100: LOSS OF OFFSITE POWER TO VITAL BUSES AT
SALEM 2

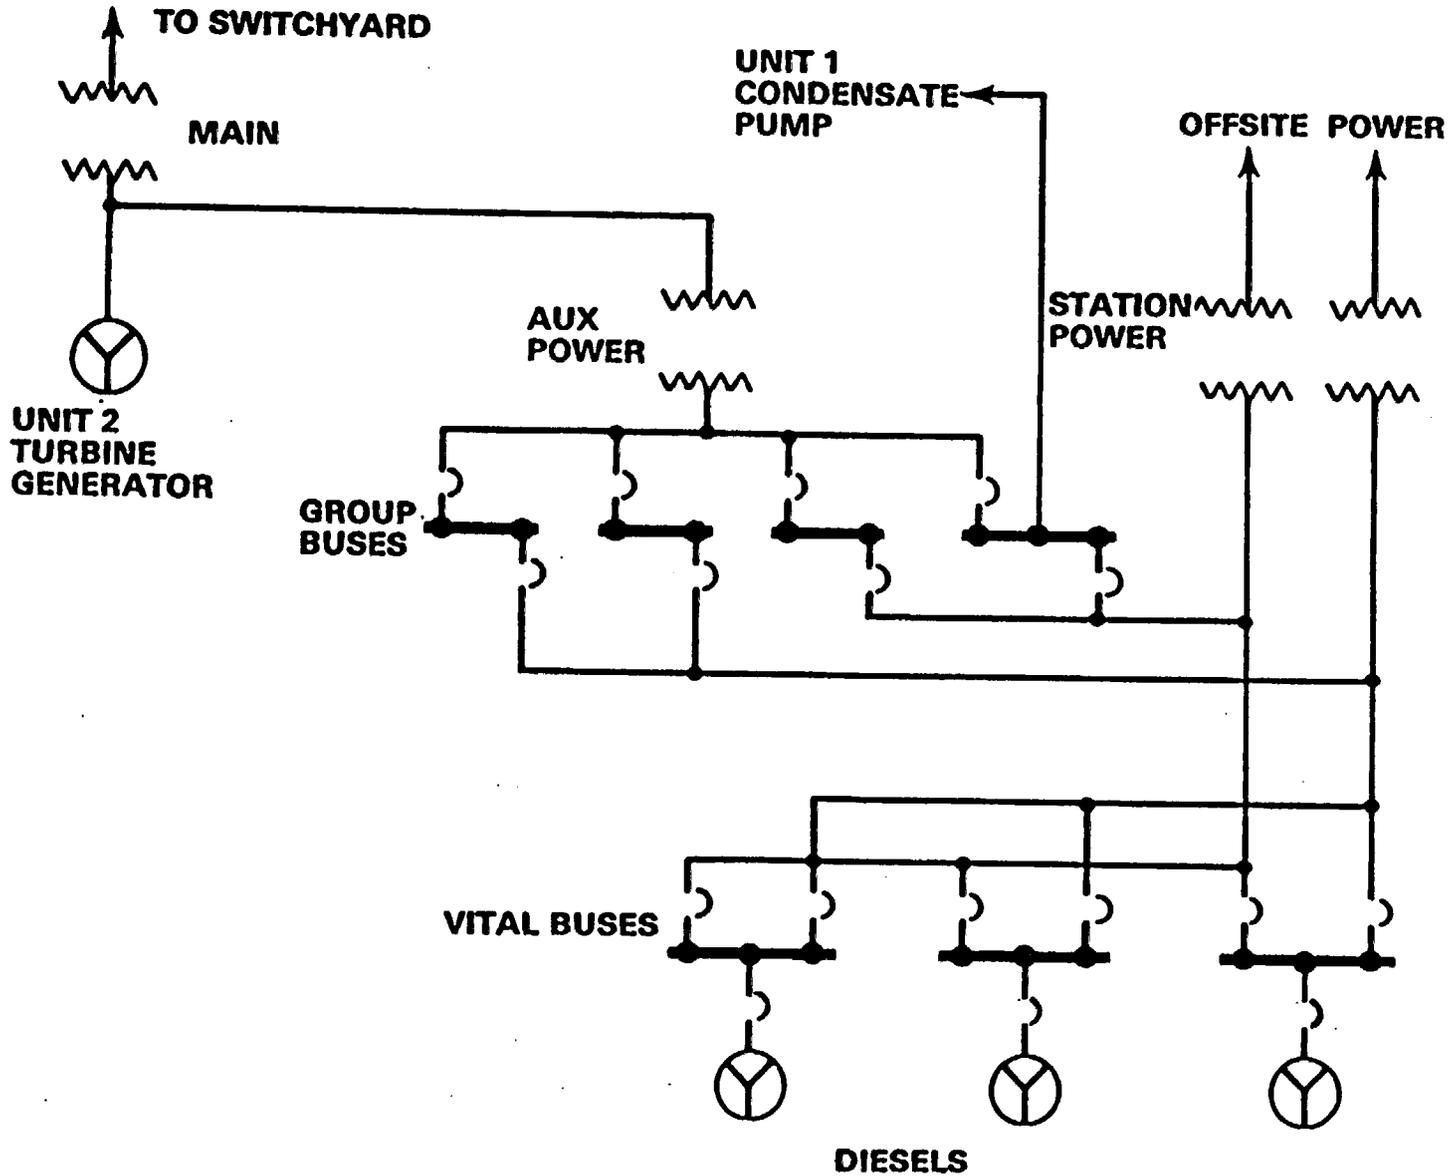
SALEM PLANT

The Salem plant has two reactor units. Each unit (see Figure 1) has four 4.16 kV nonvital (group) buses that supply power to those components that are required for normal operation of the power plant and are not required during recovery from an accident. Loads on these buses include the reactor coolant pumps. The nonvital buses can be supplied with power from either (a) the reactor via the turbine generator and the auxiliary power transformer or (b) offsite via a pair of 13.8-4.16 kV SPTs. Two nonvital buses are normally supplied by each SPT. Nonvital buses for the other reactor unit are supplied by another pair of SPTs. The usual plant practice was to supply power to the nonvital buses from the auxiliary power transformer. Therefore, turbine trips caused the nonvital buses to transfer automatically from the auxiliary power transformer to the SPTs. Block loading the SPTs in this alignment caused temporary degradation of voltage.

Each unit has three 4.16 kV vital buses that supply power to safety-related loads. Each vital bus is supplied by one of the SPTs. If voltage for a vital bus drops below 91% for 10.5 seconds, an undervoltage transfer signal is generated. The bus automatically disconnects from the SPT that is supplying power to it and connects to the other SPT. If voltage for two of the three vital buses drops below 91% for 13 seconds, then a station "blackout" signal is generated for the unit, the vital buses are automatically disconnected from the SPTs, loads are shed from the vital buses, the diesel generators are started, and loads are sequenced onto the diesel generators via the vital buses. The undervoltage transfer and station blackout signals are provided by sets of relays with time delays. If voltage drops below 70%, other undervoltage relays instantaneously initiate a station blackout signal.

Before the event and after the last dynamic analysis of SPT loads, the licensee added 8200 and 2200 kVA to SPTs 21 and 22, which normally supply Unit 2, and 3200 and 2200 kVA to SPTs 11 and 12, which normally supply Unit 1. Each of these changes includes 800 kVA added to vital buses, with the remaining loads added to the nonvital buses. The additional loads on the nonvital buses include condensate, heater drain, and circulating water pumps, which were installed to improve the performance of the plant. Further, to facilitate repairs to the Unit 1 auxiliary power transformer, a Unit 1 condensate pump was temporarily connected to a Unit 2 nonvital bus that transfers to SPT 21 on turbine trip. The static effects of these loads on the performance of the buses had been determined, but the dynamic effects had not. When the turbine for Unit 2 tripped, the heavily loaded nonvital buses were transferred without sequencing from the auxiliary power transformer to the SPTs. The SPTs were unable to maintain rated voltage and a voltage transient resulted.

The last dynamic analysis of SPT loads was performed in 1980. Before restart of Unit 2 after the recent event, the licensee reduced the loads on the SPTs consistent with that analysis, revised operating procedures based on this reduction in available equipment, and decided not to supply power to the nonvital buses from the auxiliary power transformer. Similar changes were made for Unit 1. Further, Unit 1 was derated to 85% of full power and Unit 2 to 80%. To determine the cause of the multiple vital bus transfers from SPT to SPT and to provide a basis for corrective action, the licensee has initiated a comprehensive design review of the electrical distribution system for the plant, including review of transients and analysis of the vital bus undervoltage transfer and station blackout relaying schemes.
