SSINS No.: 6835
IN 86-108

December 29, 1986

IE INFORMATION NOTICE NO. 86-108: DEGRADATION OF REACTOR COOLANT SYSTEM
PRESSURE BOUNDARY RESULTING FROM BORIC
ACID CORROSION

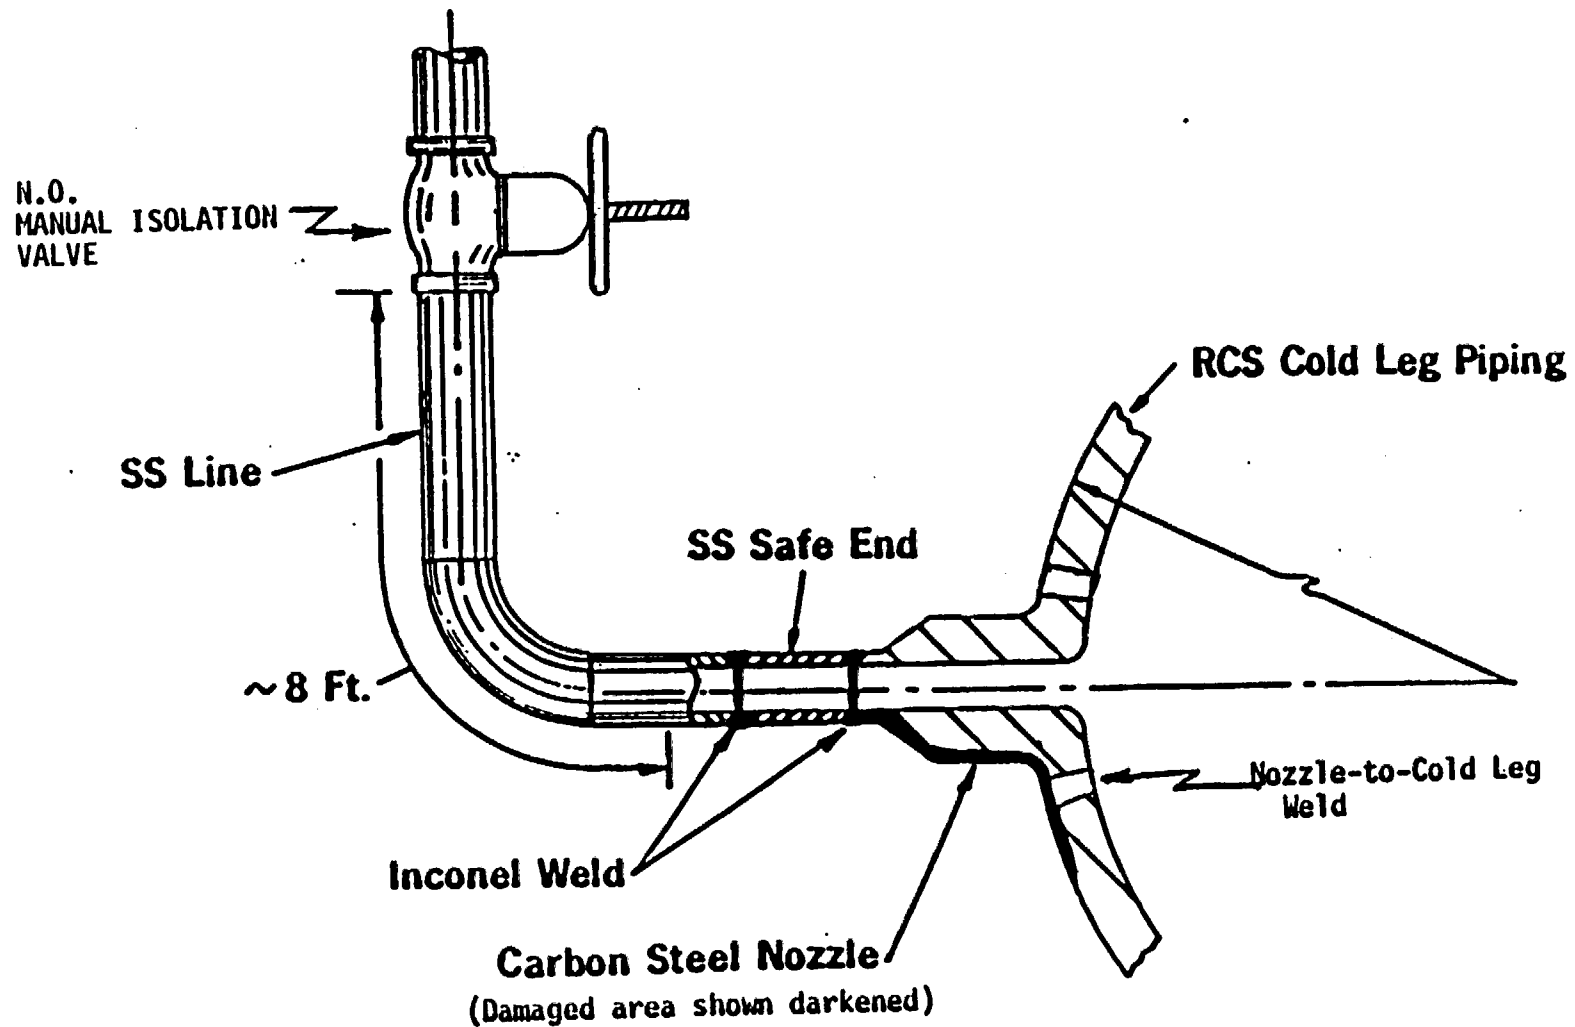
Figure 1: ANO-1 HPI Line/Nozzle Configuration

In October 1986, the Arkansas Nuclear One, Unit 1 (ANO-1) Plant was in cold shutdown and was performing nondestructive testing of the high pressure injection (HPI) nozzle thermal sleeves. An HPI nozzle is attached directly on the side of each of the four RCS cold legs. The metallic insulation was removed from the "A" HPI nozzle to allow radiographic examination. Removal of this insulation revealed severe corrosion wastage on the exterior of the HPI nozzle and some wastage on the RCS cold leg pipe. The corrosion apparently was caused by reactor coolant leakage from an HPI isolation valve located about 8 feet above the nozzle as shown in the attached Figure 1.

The wastage began adjacent to where the 3-1/2 inch OD stainless steel safe-end is welded to the carbon steel HPI nozzle. The safe-end is located between the stainless steel HPI line and the carbon steel HPI nozzle. The wastage was approximately 1/2 inch at its deepest location (adjacent to the stainless-to-carbon steel weld). The HPI nozzle (including cladding) is approximately 3/4 inch thick at this point. At the transition weld between the safe-end and the carbon steel nozzle, the wastage extended approximately 20 percent around the circumference of the nozzle in the form of several trenches. From this point, the wastage narrowed to two separate trenches that became shallower as they progressed more than 10 inches along the bottom of the HPI nozzle towards the RCS cold leg. The two trenches then continued down the cold leg for approximately 6 inches. The depth of the trenches on the cold leg were less than 1/4 inch.

Boric acid corrosion has been found to be most active where the metal surface is cool enough so that it is wetted. If the metal is sufficiently hot, then the surface will stay dry and this loss of electrolyte will slow the corrosion rate. At ANO-1, borated water leaked from the HPI isolation valve in the form of a liquid and then ran down the HPI piping on the inside of the insulation to the HPI nozzle. As the leakage approached the cold leg, the increased piping temperatures caused evaporation of the water, thus increasing the boric acid concentration and lowering the PH of the solution. It is believed that the close tolerance between the HPI nozzle and the insulation, aided by boric acid crystallization, caused pooling of the solution at the nozzle. This pool of highly acidic solution wetted the nozzle and resulted in accelerated corrosive

The damaged HPI nozzle has been repaired by grinding out all indications of corrosion and rebuilding by welding in those areas with less than the minimum required wall thickness. Repair to the cold leg required only grinding out the corrosion. All repairs were in accordance with ASME codes. The other HPI nozzles were inspected and no evidence of corrosion wastage was found. The licensee continues to evaluate methods and procedures to minimize recurrence of this type of event. The primary defense is to minimize leaks, detect and stop leaks soon after they start, and promptly clean up any boric acid residue. Detection of leaks will be enhanced by an evaluation of any iron oxide stains on insulation.
