Re: Turkey Point Unit 3
Docket No. 50-250
Reportable Event: 2003-005-00
Date of Event: March 1, 2003
Disabling Both Auxiliary Feedwater Trains Inadvertently During Mode 3

1. FACILITY NAME Turkey Point Unit 3	2. DOCKET NUMBER 05000250	3. PAGE Page 1 of 8
--	-------------------------------------	-------------------------------

4. TITLE
Disabling Both Auxiliary Feedwater Trains Inadvertently During Mode 3

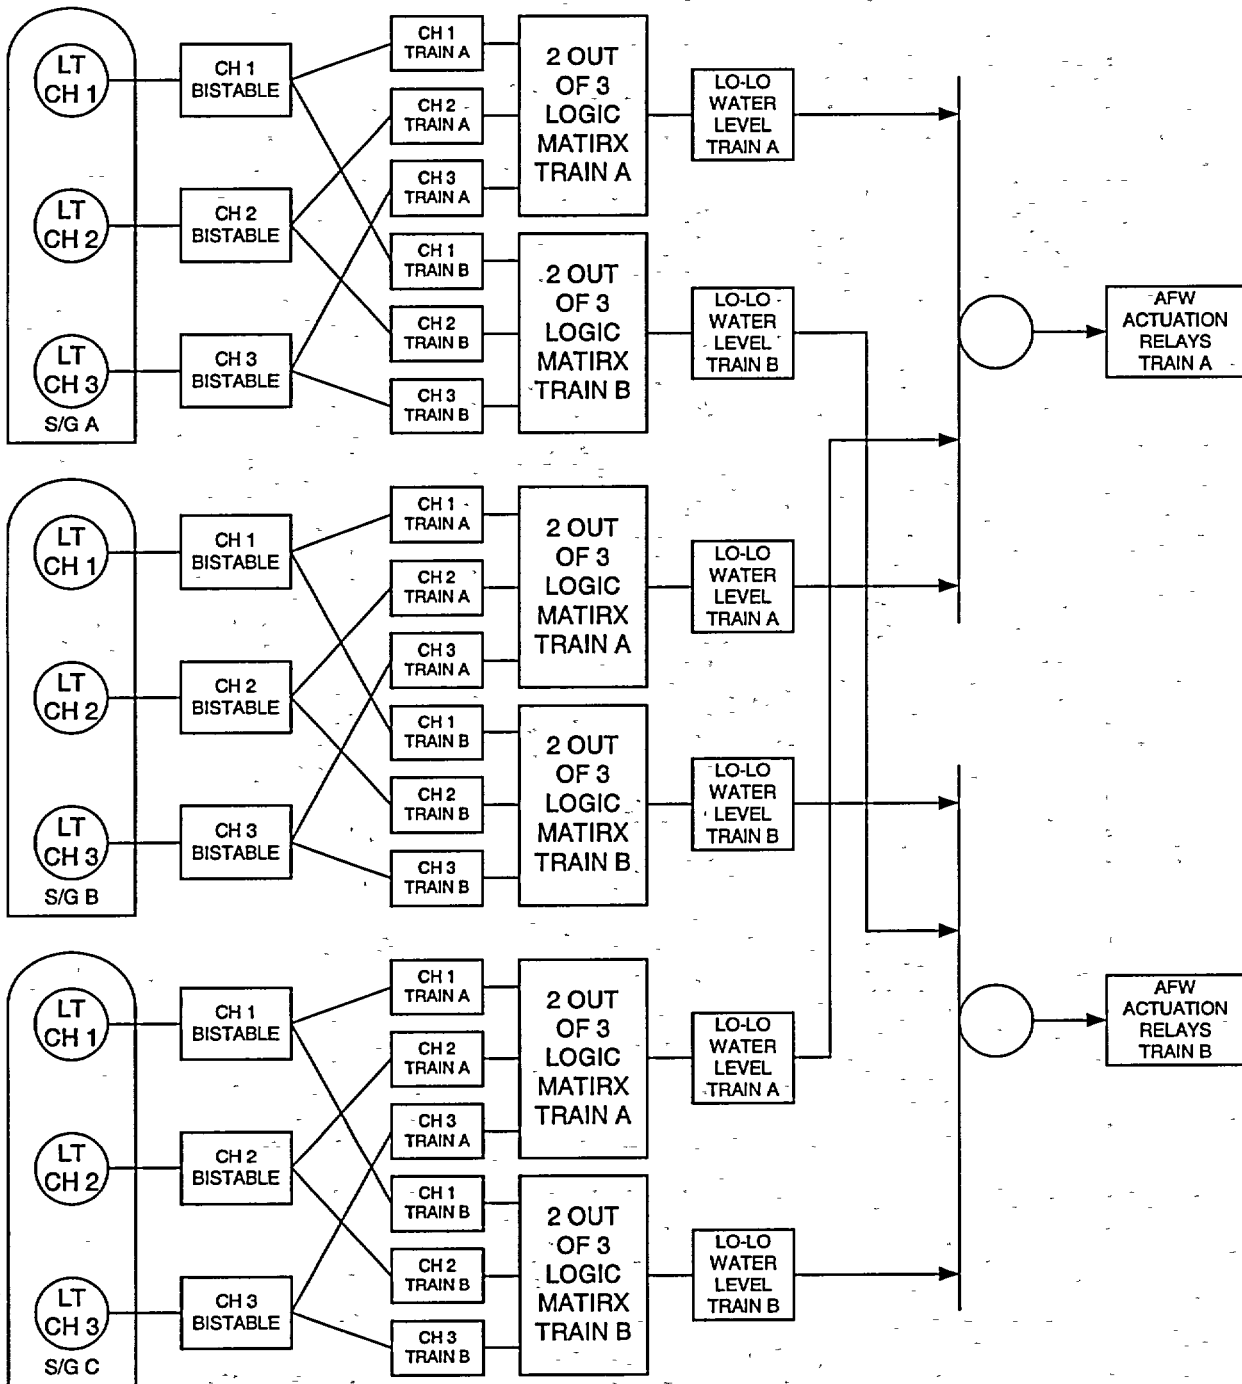
Figure 1
STEAM GENERATOR LOW-LOW WATER LEVEL AUXILIARY FEEDWATER ACTUATION
 LER 2003-005-00 Page 7 of 8

For the low-low Steam Generator water level signal, the actuation of AFW requires that two out of three level transmitters [LT] on a single Steam Generator measure water level below 10%. If this condition occurs, each affected Steam Generator level comparator [CPT] will trip a bistable. The output of these bistables energizes relays in the AFW actuation logic matrix and AFW automatic start actuation relays. The output of the AFW actuation relays provides a start signal to the AFW pump steam admission valves. A simplified diagram, Figure 1; of this process is provided.

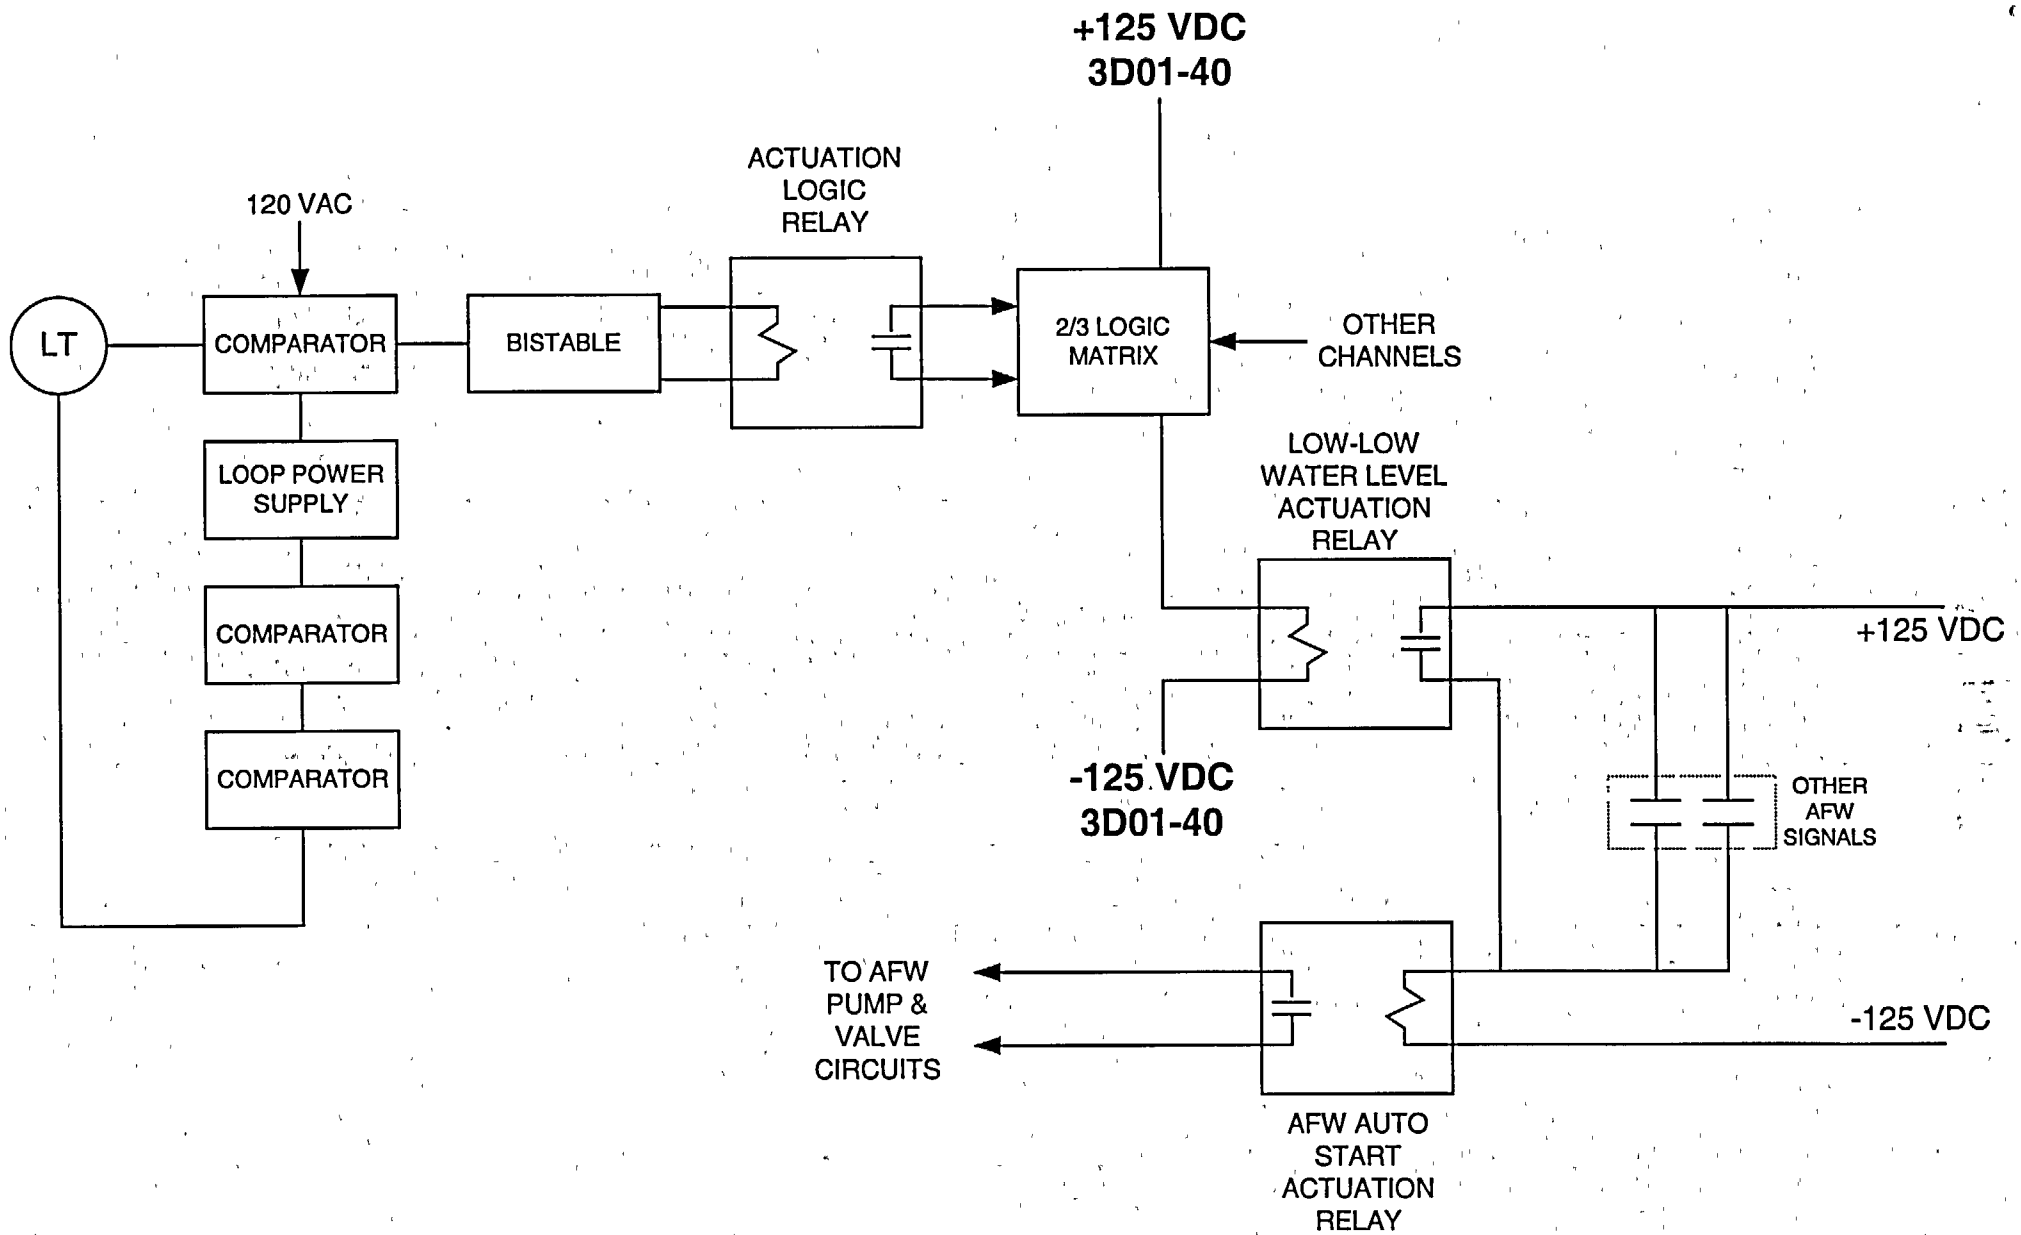
Figure 2
STEAM GENERATOR LOW-LOW WATER LEVEL AUXILIARY FEEDWATER ACTUATION
 LER 2003-005-00 Page 8 of 8

Furthermore, a simplified overview of the Steam Generator low-low water level AFW initiation circuit is provided in the attached sketch, Figure 2. The sketch reflects one transmitter on one Steam Generator and one train of actuation logic and actuation relays. Each of the three Steam Generators has three level transmitters. These nine transmitters are connected to two trains of logic and actuation relays such that the AFW is initiated if a low-low level is sensed on two out of three channels on any Steam Generator.

Technical Specification Table 3.3-2, Item 6 addresses operability requirements for the AFW ESFAS Instrumentation. Item 6.b of Table 3.3-2 is specific to the AFW low-low Steam Generator water level instrumentation. This is considered to encompass the level transmitter, level comparator and bistable. This instrumentation is powered from 120 VAC vital instrumentation power and was not part of the subject clearance. Item 6a of Table 3.3-2 is specific to AFW automatic actuation logic and actuation relays. This is considered to encompass the remainder of relays. As shown in the sketch, the actuation logic relay coil is powered from the 120 VAC vital instrumentation power, which was not part of the subject clearance. The opening of Breaker 3D01-40 removed power from the Train 3A low-low level actuation relays for all three Steam Generators. Breaker 3D23-08 removed power from the Train 3B low-low level actuation relays for all three Steam Generators. As shown in the attached sketch, the opening of the subject breakers only disabled the low-low level actuating relays. Power to

the AFW automatic start actuating relays was not affected by opening the subject breakers. Therefore, only the low-low Steam Generator water level AFW auto start was affected by the subject incident. All other AFW automatic start signals (safety injection, bus stripping, and trip of Last Running Main Feedwater pump, AMSAC) remained available.
