SUBJECT: TRANSMITTAL OF REPORTS REGARDING FOREIGN REACTOR OPERATING EXPERIENCES

1. Technical Report on Beznau Unit 1 Incident of August 20, 1974: TG-1 Trip/Reactor Trip/Safety Injection Actuation
2. Memorandum dated May 15, 1979; Ashok Thadani to D. F. Ross, Jr.
3. Memorandum dated September 13, 1979; Darrell G. Eisenhut to Multiple Addressees.

STEAM DUMP FAILURE INCIDENT

PRESSURIZER RELIEF LINE

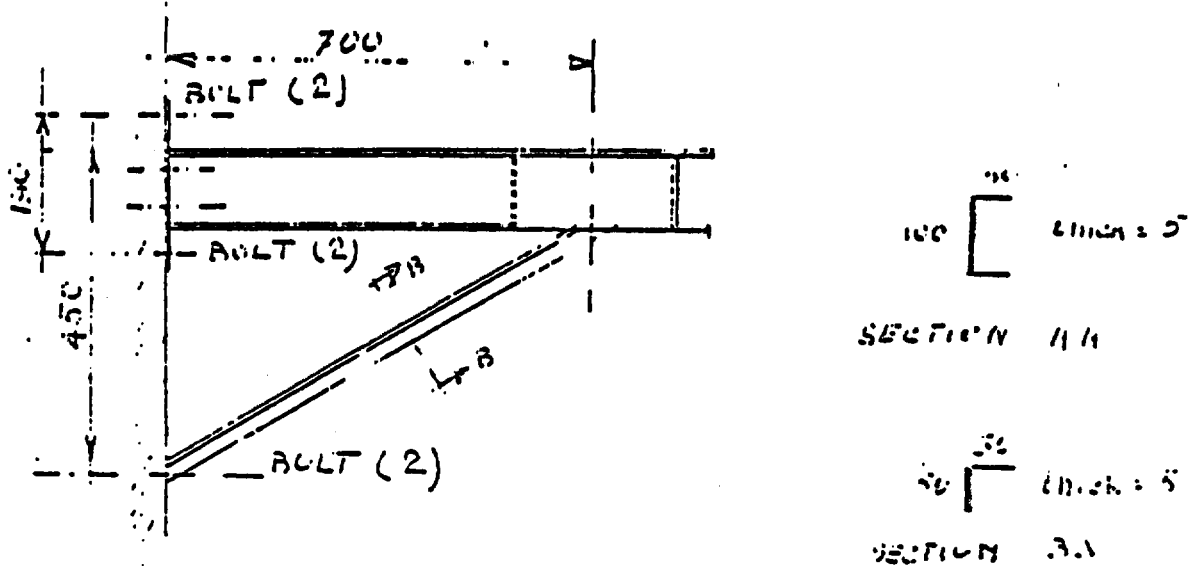
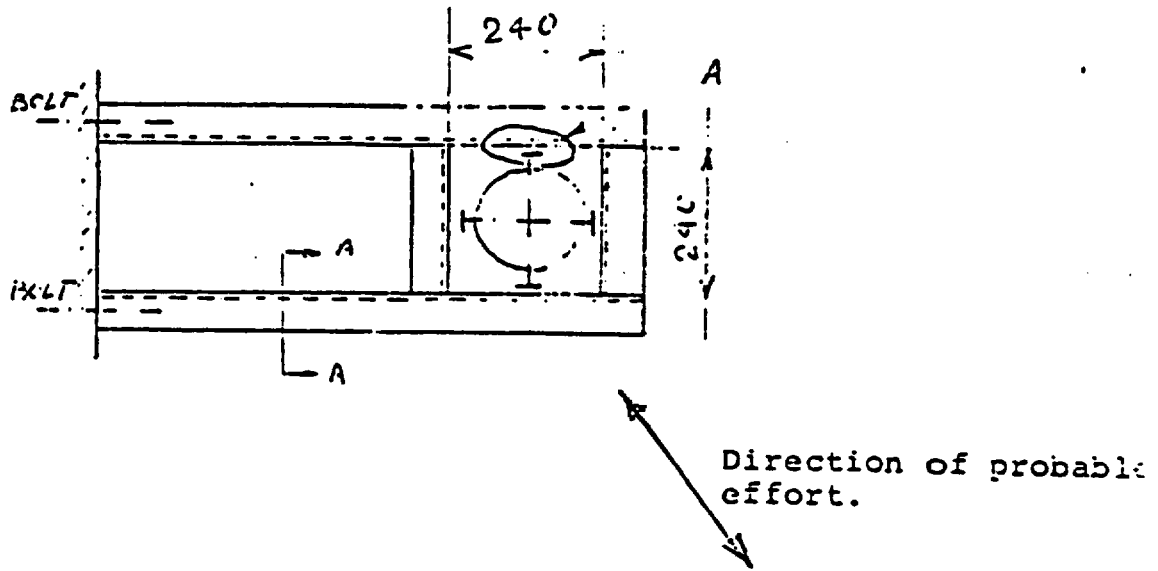
Figure 2 - Restraint R-1

The relief line to the power relief valves comes out of the pressurizer top and runs directly down (vertical run of 6.8 m). It passes through a grating floor. No impact evidence between the floor and the pipe insulation exists. (Gap about 25 mm). At the bottom of the vertical run there is a console type restraint. (Location 1 in fig. 1). The main dimensions are given in fig. 2. There is contact evidence, as shown on the figure, but no damage.

Bolts (6 total) : Hexagonal head = 25 mm

- Damage :
- no general distortion
 - no rubbing evidence
 - contact evidence in A

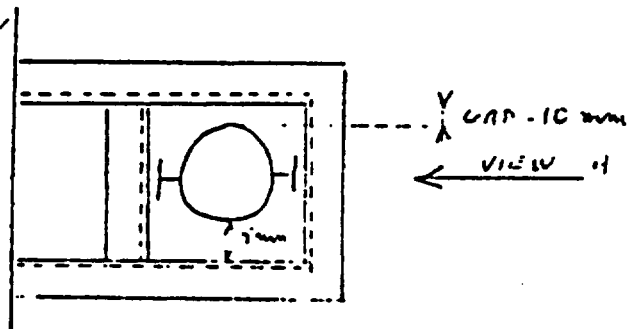
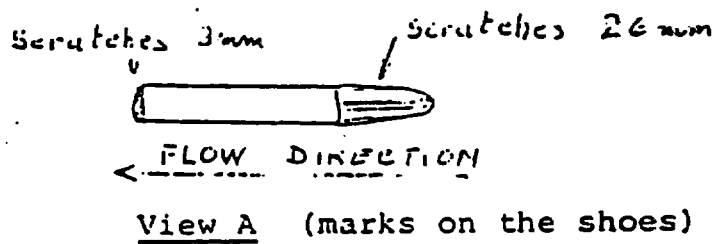
Figure 3 - Restraint R-2

The two bolts on the right side on figure 3 were strained about 3 mm. The two bolts on the left side were also strained but only to the point of getting loose.

Damage : - top of insulation slightly smashed
 - scratches on shoes as shown on view A

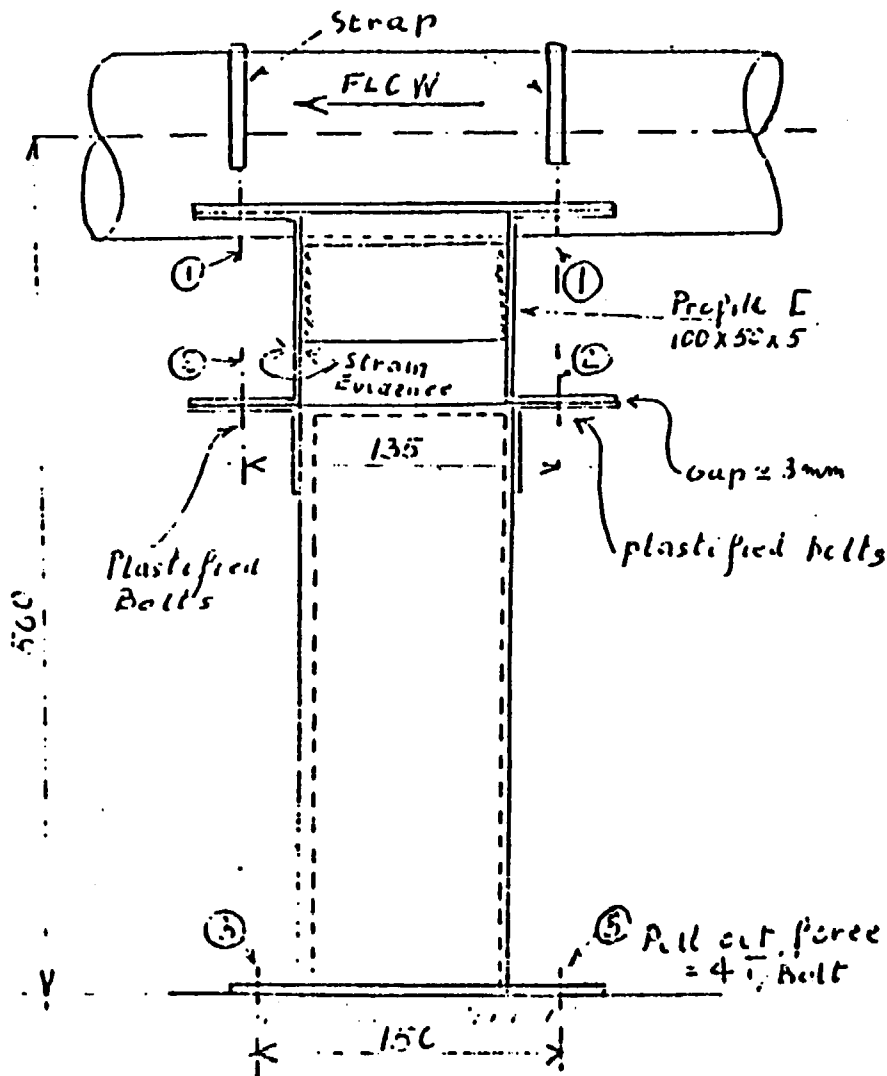
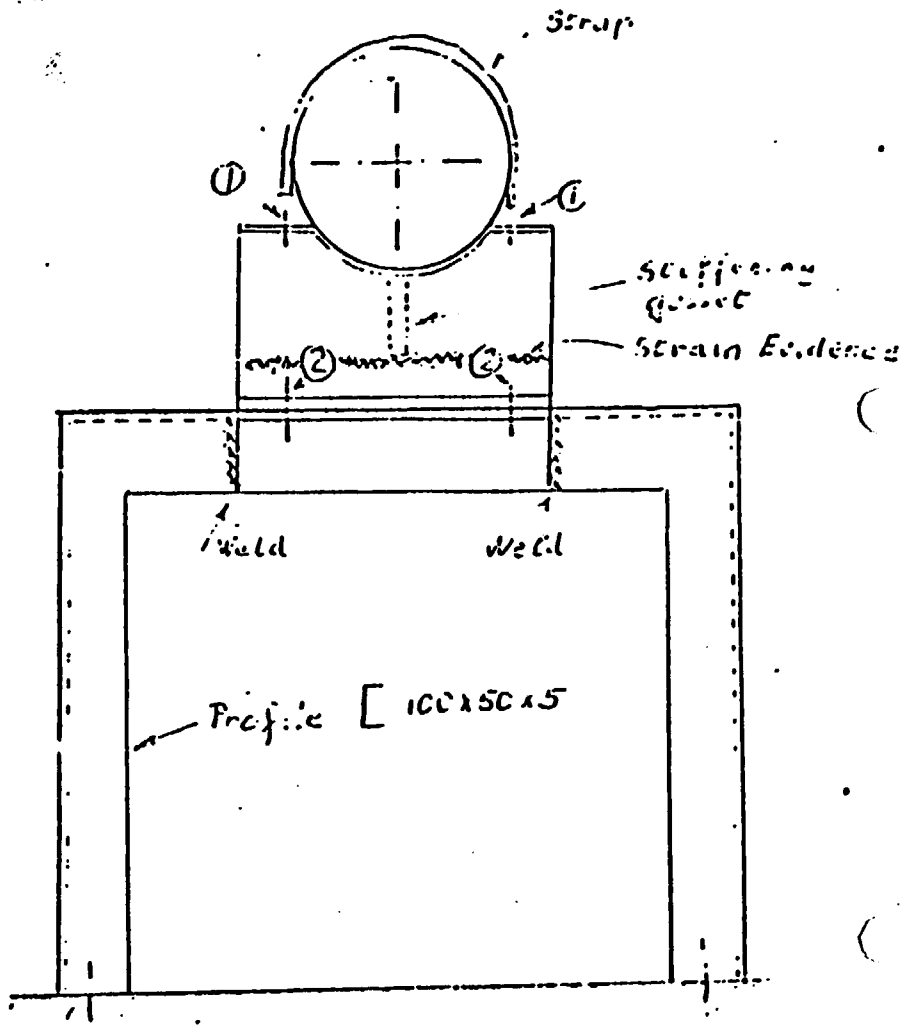
Figure 4 - Restraint R-3

Fig. 6 and 7 show the pedestal of the support between the two valves. Fig. 4 is a sketch of the support and details the damage.

The damage corresponds to a rotation of the pipe around a horizontal axis perpendicular to the pipe axis. No evidence of translation has been found. Considering fig. 7, the back bolts were strained much more than the front ones.

- Bolts 1 (4 total) M-10
- 2 (4 total) M-10
- 3 (4 total) pull out

force = 4T/bolt

- Damage :
- no evidence at straps, pipe and bolts (1) and (3)
 - all 4 bolts (2) have been strained
 - gap measured as shown
 - strain evidence in the [profile as shown

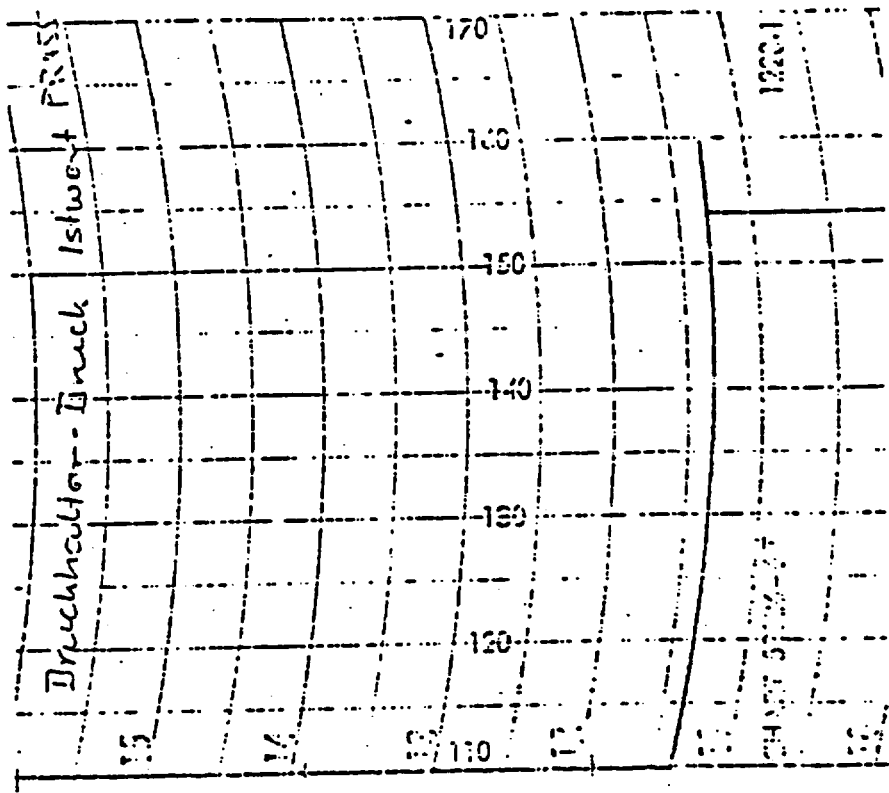
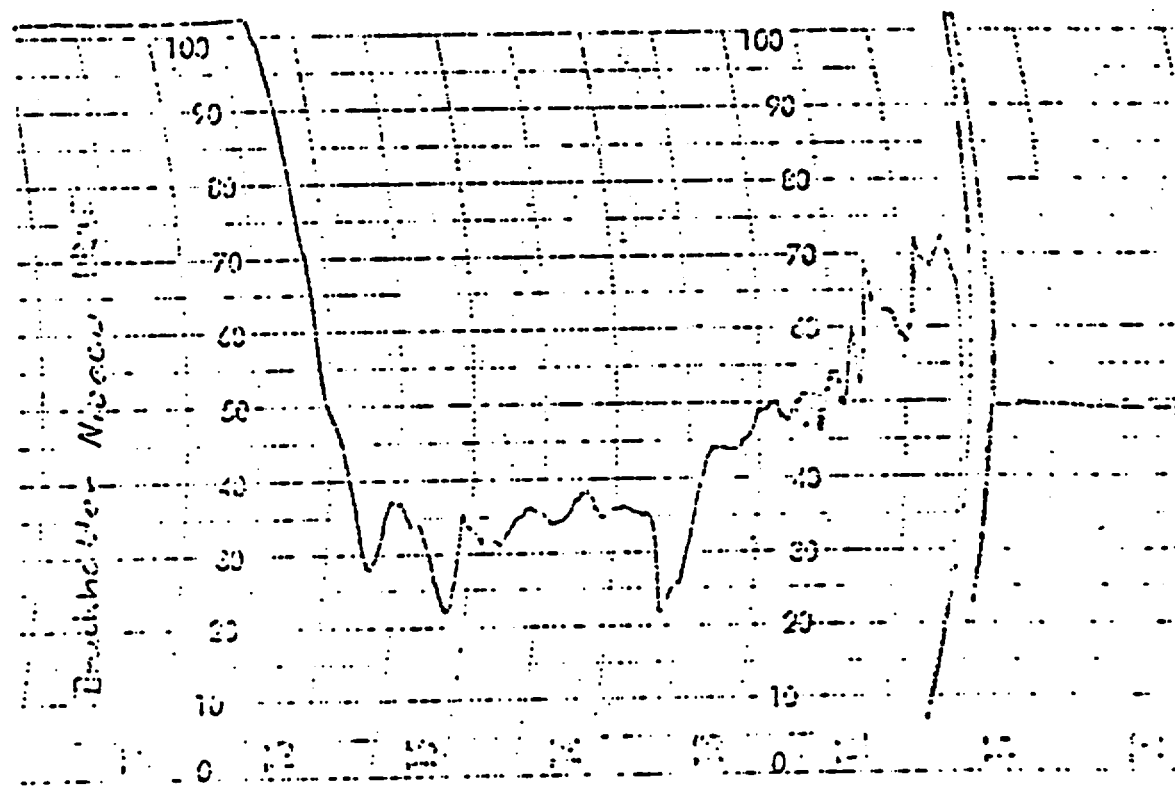
Figure 18 : Record of Pressurizer Pressure and Level Transients following incident initiation.

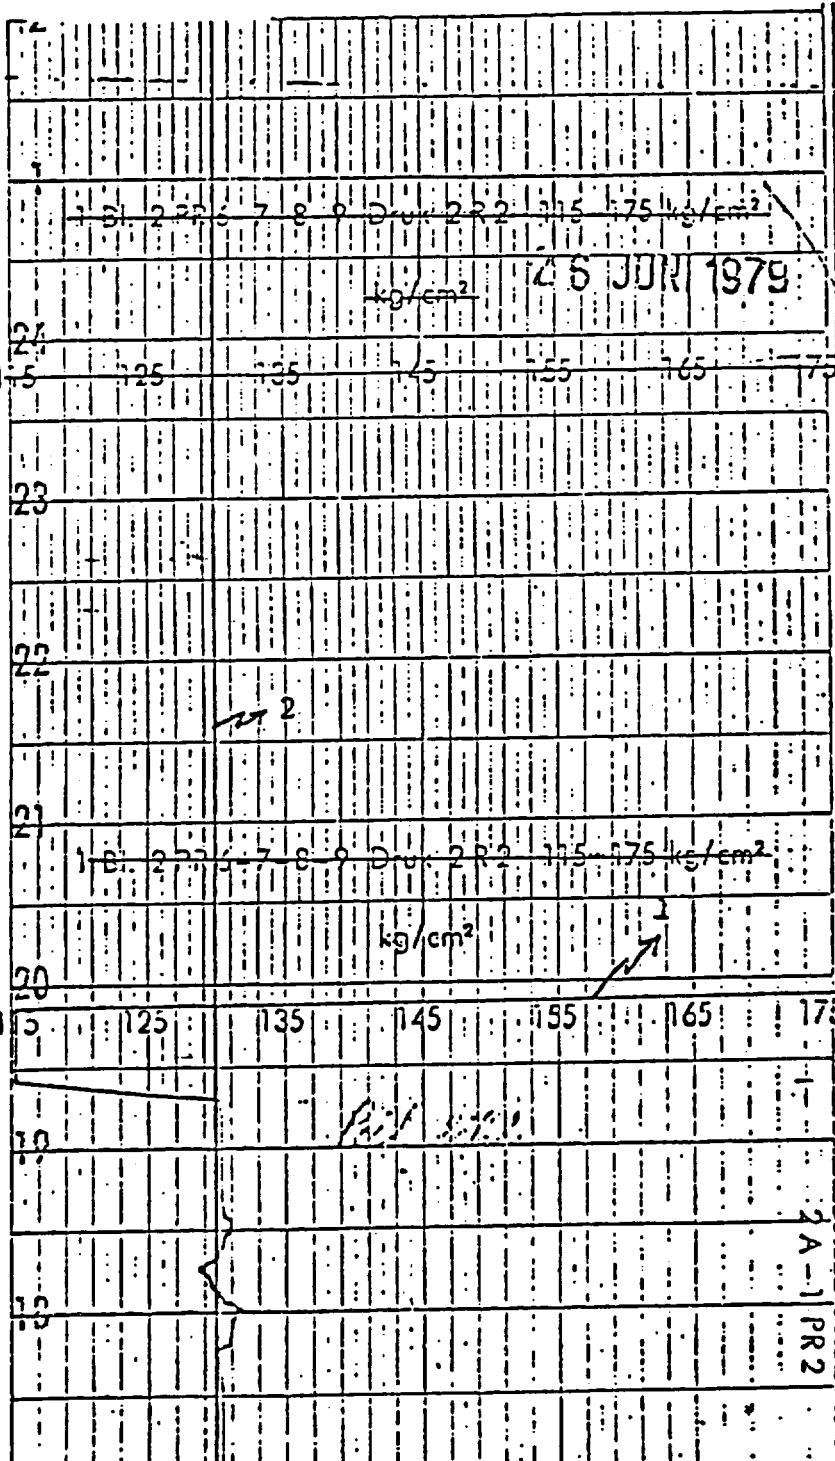
verkeerde schaal
vervangen door
0 - 100 %

Wrong scale
Replaced by
0 - 100 %.
