UNITED STATES
NUCLEAR REGULATORY COMMISSION
WASHINGTON, D. C. 20555

GL-79-15

ALL PRESSURIZED WATER REACTOR LICENSEES

Enclosure:
Summary of Operating Experience
with Recirculating Steam
Generators, January 1979,
NUREG 0523

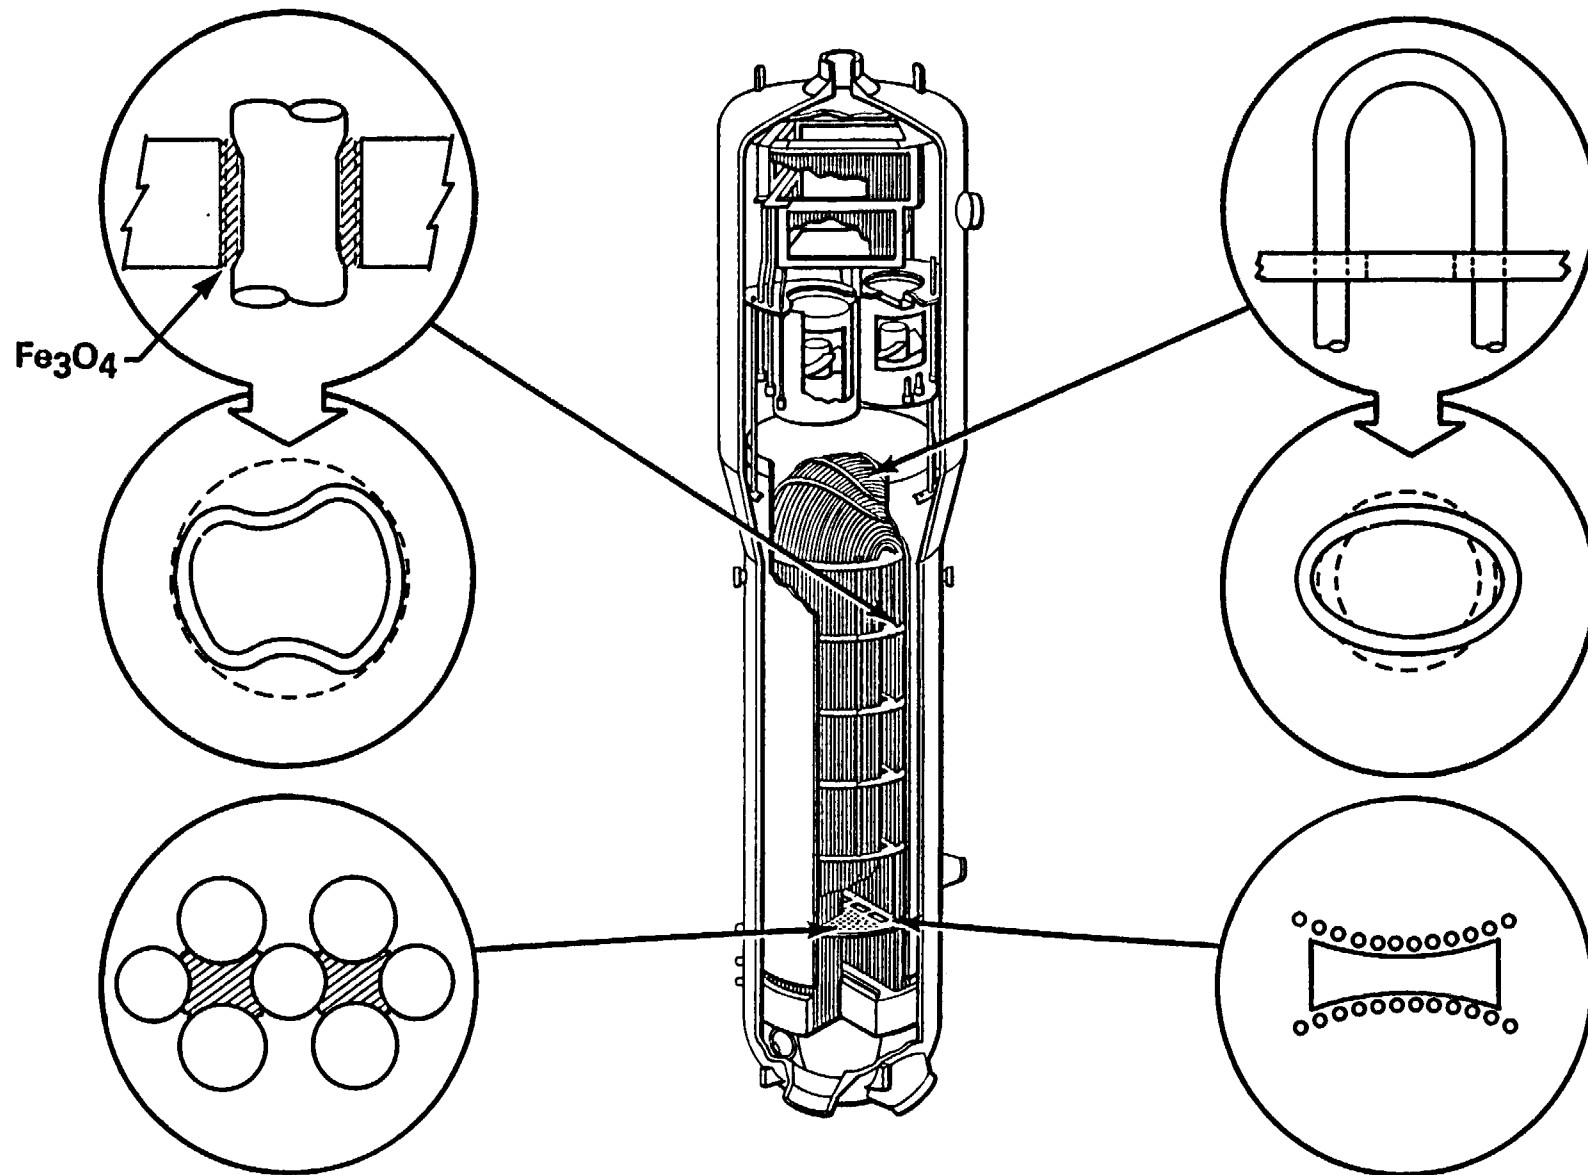
FIGURE 1. PROBLEM AREAS IN PWR STEAM GENERATOR

The principal cause of serious corrosion damage from either wastage or caustic stress corrosion cracking is the local concentration of aggressive chemicals within the secondary side of steam generators. The major source of these impurities is in-leakage of condenser cooling water. Because of this, the boundary between the secondary coolant system and the condenser cooling system is of significance. The concentration of these impurities is affected by thermal and mechanical design parameters of steam generators, by accumulations of chemicals and corrosion products within the steam generators as plants age, and by the nominal and transient variations in water and air environments to which steam generator internals are exposed. Both types of corrosion generally occur where regions of restricted water flow and high heat flux tube surfaces cause impurities to concentrate or phosphates to precipitate (hideout). These high concentrations may occur at crevices between the tubing and the tube support plates or the tube sheet, and in areas where sludge deposits have built up on the tube sheet or tube support plates.

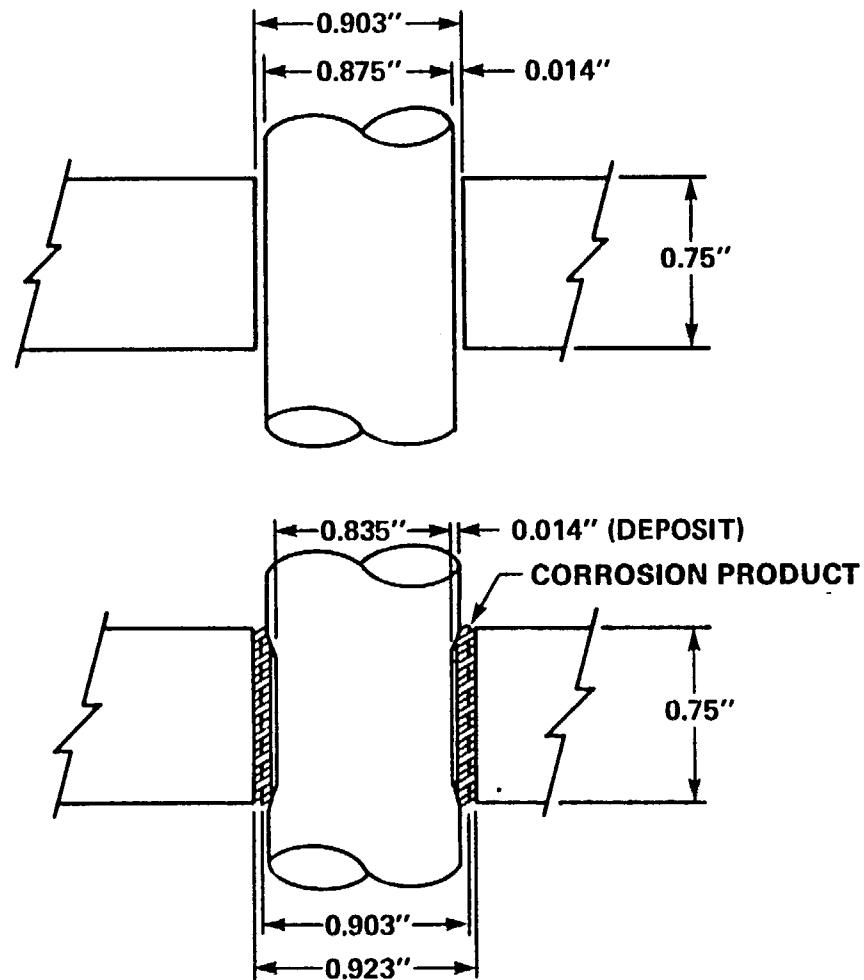
FIGURE 2. TYPICAL DENTING MECHANISM

Later laboratory reports of dented tubes indicated that the annulus between tubes and support plates was filled with hardened corrosion products (as shown in Figure 2) that continue to form by the corrosion of the support plates and, therefore, exert sufficient forces to "dent" the tube diametrically. Severe buildup of corrosion products has caused cracking of the tube support plate ligaments between the tube holes and the water circulation flow holes. The phenomenon of denting in Westinghouse plants has been attributed to acid chloride salts that concentrate in the annulus between the tubes and the tube support plates. The first incidence of denting occurred shortly after steam generator secondary water chemistry control was switched from phosphate treatment to an all-volatile treatment (AVT). Contamination of the secondary coolant by inleakage of condenser cooling water was believed to have caused a catalytic reaction with residual phosphates.

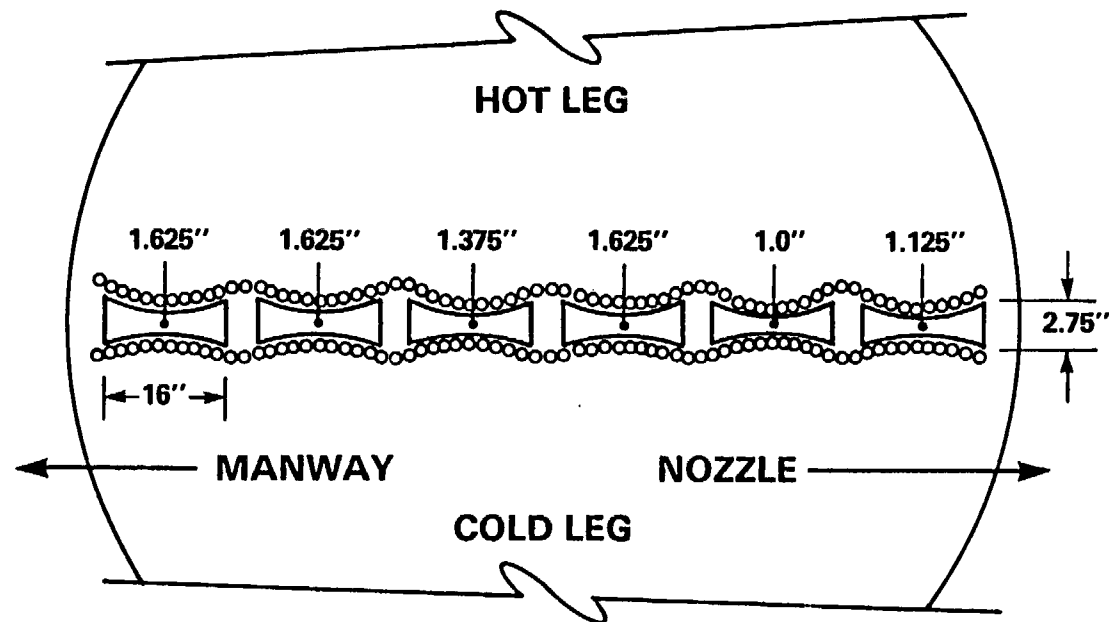
FIGURE 3. FLOW SLOT DEFORMATION

Along the chord of the innermost rows of tubes in Westinghouse-designed steam generators, there is a row of rectangular flow slots in the tube support plate. These slots are approximately 16 inches long by 2-3/4 inches wide and are spaced about 20 inches center to center (see Figure 3). Because of the pressure built up in the tube support plate due to the denting phenomenon, the flow slots in the tube support plates have been observed to deform (the "hourglassing" effect); that is, the central portion of the parallel flow slot walls has moved closer, so that some flow slots are now narrower in the center than at the ends. Figures 4 and 5 are photographs of hourglassed flow slots from San Onofre Unit 1 and Indian Point Unit 2, respectively. Because the initial parallel slot walls have moved closer, the tube support plate material supporting the

tubes nearest this central portion of these flow slots has also moved inward, which consequently forces an inward displacement of the legs of the tubes at these locations. When this inward movement of the legs of the tubes has occurred at the upper support plate, it has been shown to cause an increase in the hoop strain at the tube U-bend apex. This effect is shown in Figure 6. It is this additional increase in strain at the apex of the U-bend that is believed to be the additional factor required to initiate and increase the susceptibility of Inconel-600 alloy tubing exposed to PWR reactor coolant to stress corrosion cracking at the top of the U-bend.

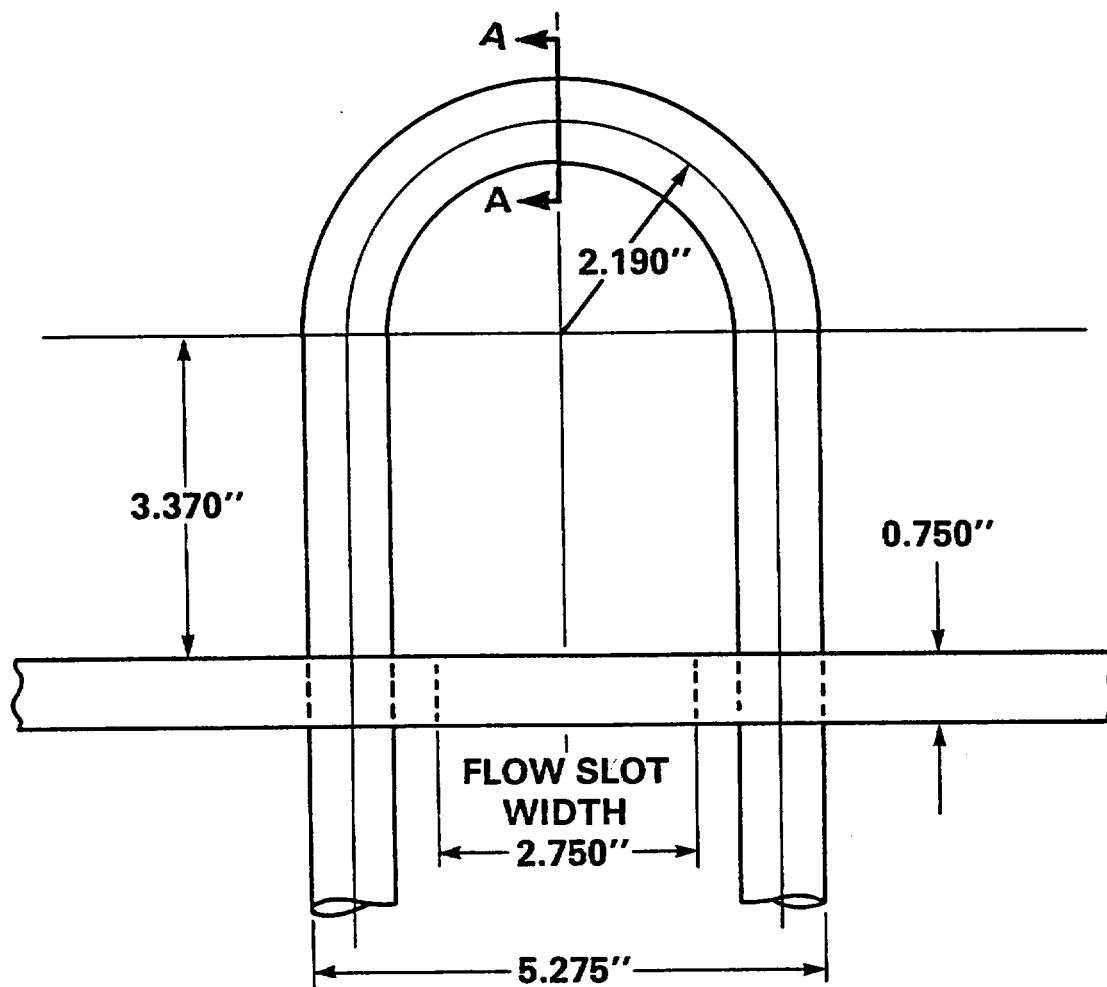
FIGURE 6. SCHEMATICS OF U-TUBE OVALIZATION

The Surry Units 1 and 2 have experienced severe denting and support plate deformation throughout their steam generators. On September 15, 1976, during normal operation, one U-tube in steam generator "A" at Surry Unit 2 suddenly developed a primary-to-secondary leak of about 80 gpm. Subsequent investigations revealed that the leak resulted from an axial crack, approximately 4-1/4 inches in length, in the U-bend apex of an inner-row tube. It was also established that the crack initiated from the primary side of the tubing. Hourglassing of the flow slots in the upper tube support plate "pulled the legs" of the U-bend closer together thereby causing

higher stresses in the tube material in the "U" area, which resulted in stress corrosion cracking. This ovalization phenomenon is shown in Figure 6. As a result of the event, the innermost row of tubes was removed from service by plugging. This action was taken in all Surry Unit 2 steam generators that exhibited a large degree of hourglassing in the upper support plate flow slots. The potential for dent-related cracking (at U-bends and support plates) has necessitated the preventive plugging of over 20 percent of the tubes in the Surry Units 1 and 2 steam generators (as of this report). The approach of removing the innermost row of tubes from service by plugging because of hourglassing has also been used at other facilities.

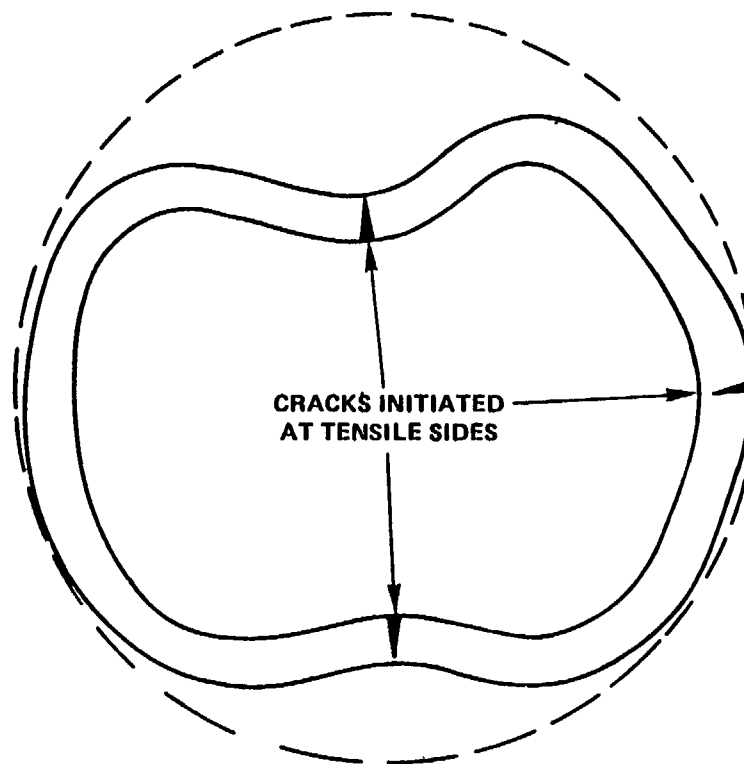
FIGURE 7. CROSS SECTION OF DENTED TUBE SHOWING LOCATION OF LEAKAGE
(TURKEY POINT UNIT 4, 4TH TUBE SUPPORT PLATE ELEVATION).

Because of tube denting or ovalization (non-uniform denting, see Figure 7), tubes at tube/tube support plates have developed small stress corrosion cracks in the longitudinal direction of the tube. These small cracks are masked by the support plates. During normal operation, small leaks through these cracks have occurred in a few plants where severe tube denting has occurred.

Denting has resulted in greater than about 0.25 inches reduction in tube diameter in the most severely affected units (3/4- and 7/8-inch tubes). The reduction in tube diameter is generally not concentric. This is dramatically illustrated in Figure 7, which shows the cross section of a dented tube removed from an operating facility. Areas of high tensile stress on either outside or inside surfaces in dented tubes are susceptible to stress corrosion cracking, and small leaks have occurred in steam generators with severe denting.

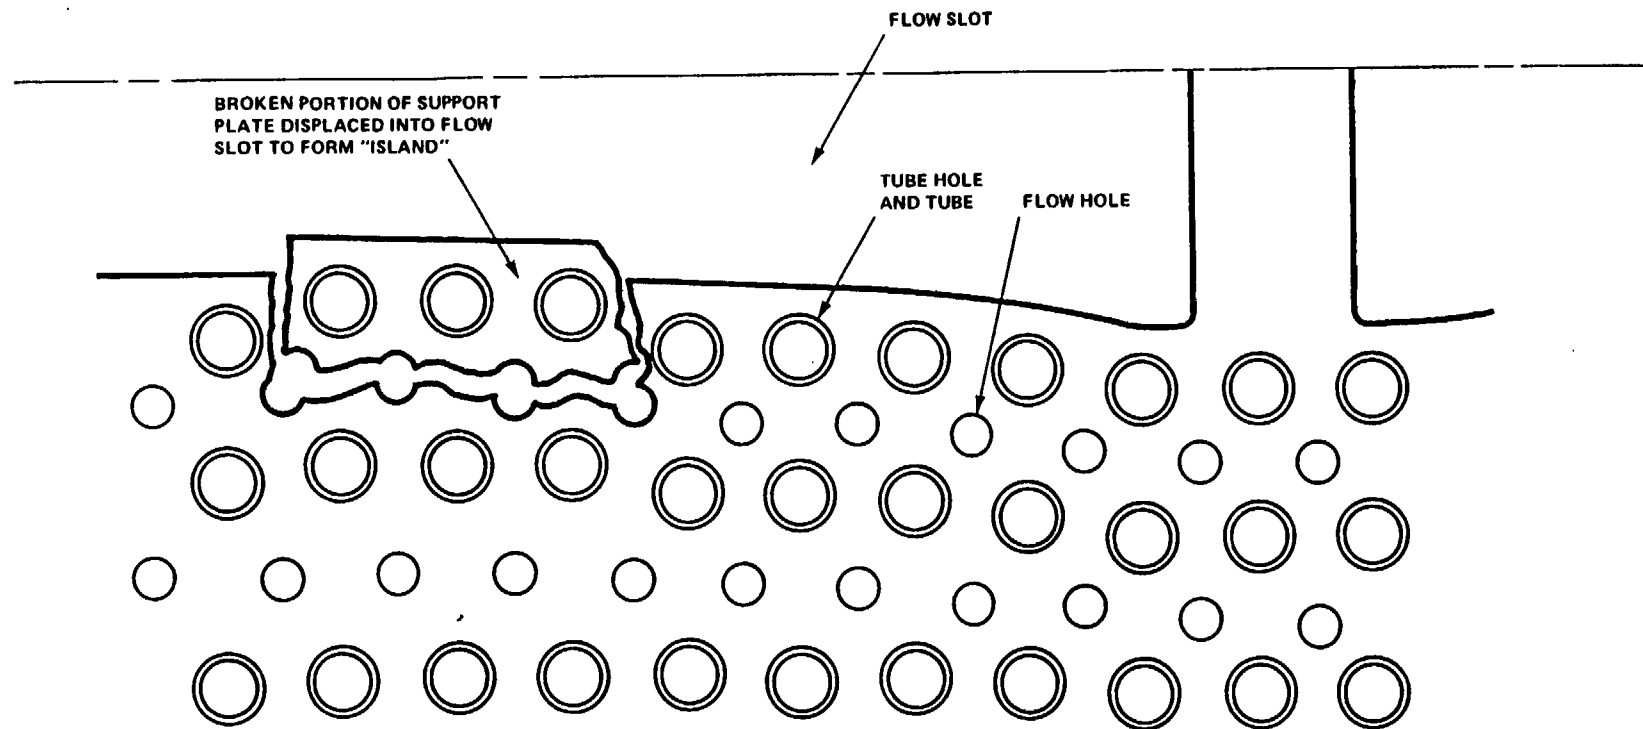
FIGURE 8. STEAM GENERATOR SUPPORT PLATE "ISLANDING"

As a consequence of continuing magnetite growth in the tube-to-tube support plate annulus and the subsequent cracking of support plates, portions (small pieces) of the support plate material in Westinghouse-designed steam generators have moved with tubes into the flow slots to cause the so-called "islanding" phenomenon; i.e., broken support pieces moving into flow slots (see Figure 8).

Areas of the tube support plates located near the edges of flow slots and the support plate periphery, which do not have flow holes, are stiffer than the rest of the plate. These areas, termed "hard spots," have experienced more severe denting than other regions of the steam generator. These areas are shown in Figure 13. In less-stiff areas of the support plate, it is somewhat easier for the plates to deform than it is for the tubes to be dented. Distortion of the flow holes, flow slots, and plate periphery have occurred as the volume of the corrosion products and tube support plate increases. Figure 4 shows the hourglassing (see Section 2.2) type of deformation of the support plate in the flow slot area. In some instances, extreme support plate deformation has resulted in cracking of the support plates. Figure 5 is a photograph of cracking that occurs at the flow slot edge. Cracking of the support plate behind the first row of tubes has also been observed. This form of cracking (also known as islanding, see Section 2.3) causes a portion of the support plate and the tubes contained in it to move into the slot (see Figure 8).
