Central Files

Docket No. 50-263

IE Bulletin No. 80-01

**OPERABILITY OF ADS VALVE PNEUMATIC SUPPLY**

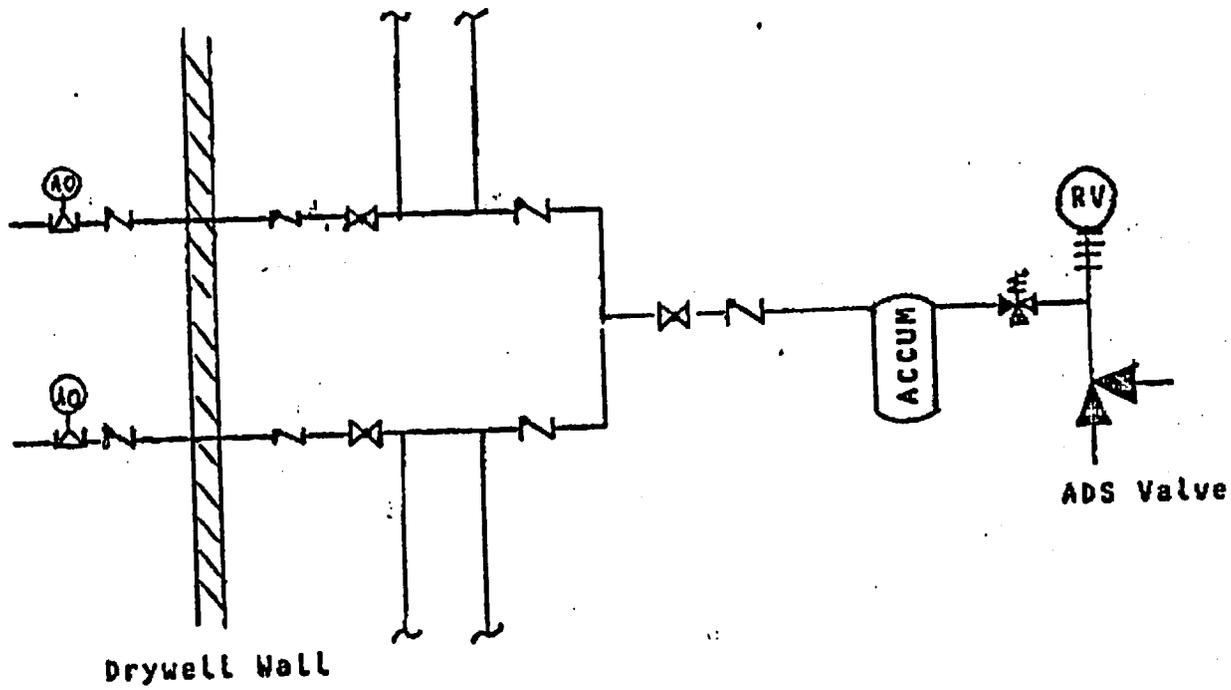
N<sub>2</sub> Air Supply To ABS Valves

On January 10, 1980, the NRC was informed by Philadelphia Electric Company that engineering evaluation for Peach Bottom 2 and 3 has disclosed that the Automatic Depressurization System (ADS) pneumatic supply (either nitrogen or air) may not be operable for all possible events because of a combination of misapplication of check valve, a lack of leak testing of the accumulator system backing up each ADS valve operator and questions about the continued operability of the pneumatic supply in a seismic event. Attached is a simplified schematic of the pneumatic supply. The check valve nearest to the accumulator is a PAL, three-quarter inch, stainless steel, socket welded check valve with a hard seat (valve identification-B-1376 on the upper flange). Plant information at Peach Bottom shows substantial supports for the pneumatic supply inside the drywell, but seismic qualification has not been verified. The licensee has stated that the pneumatic supply is not seismically qualified outside the drywell.

Unit 2 was shutdown on 1/10/80 because of questions of ADS operability and Unit 3 has been provided a seismically qualified nitrogen supply at the containment penetration pending confirmation of seismic qualification of piping inside Unit 2 containment. The licensee is changing their valve to one with a soft seat to reduce leakage.

1. Determine if your facility has installed hard-seat check valves to isolate the ADS accumulator system from the pneumatic supply system.
2. Determine if periodic leak tests have been performed on your ADS accumulator systems to assure emergency pneumatic supply for the FSAR-required number and duration of valve operations.
3. Review seismic qualifications of the ADS pneumatic supply system:
  - (a) from accumulator system isolation check valve to ADS valve operator,
  - (b) from isolation valve outside containment up to ADS accumulator check valve.
4. Based upon determination of items 1, 2 and 3 above, evaluate operability of the ADS for the conditions under which it is required to be operable including a seismic event. If operability cannot be established adhere to appropriate Technical Specification action statement.

5. Provide an immediate notification to the NRC in the event the ADS is found to be inoperable.
6. Provide a response in writing by January 18, 1980, for those facilities which use a pneumatic operator for ADS function.
