Docket Nos. 50-458/IE Bulletin No. 80-07
50-459/IE Bulletin No. 80-07

IE Bulletin No. 80-07
Date: April 4, 1980
Page 1 of 4

BWR JET PUMP ASSEMBLY FAILURE

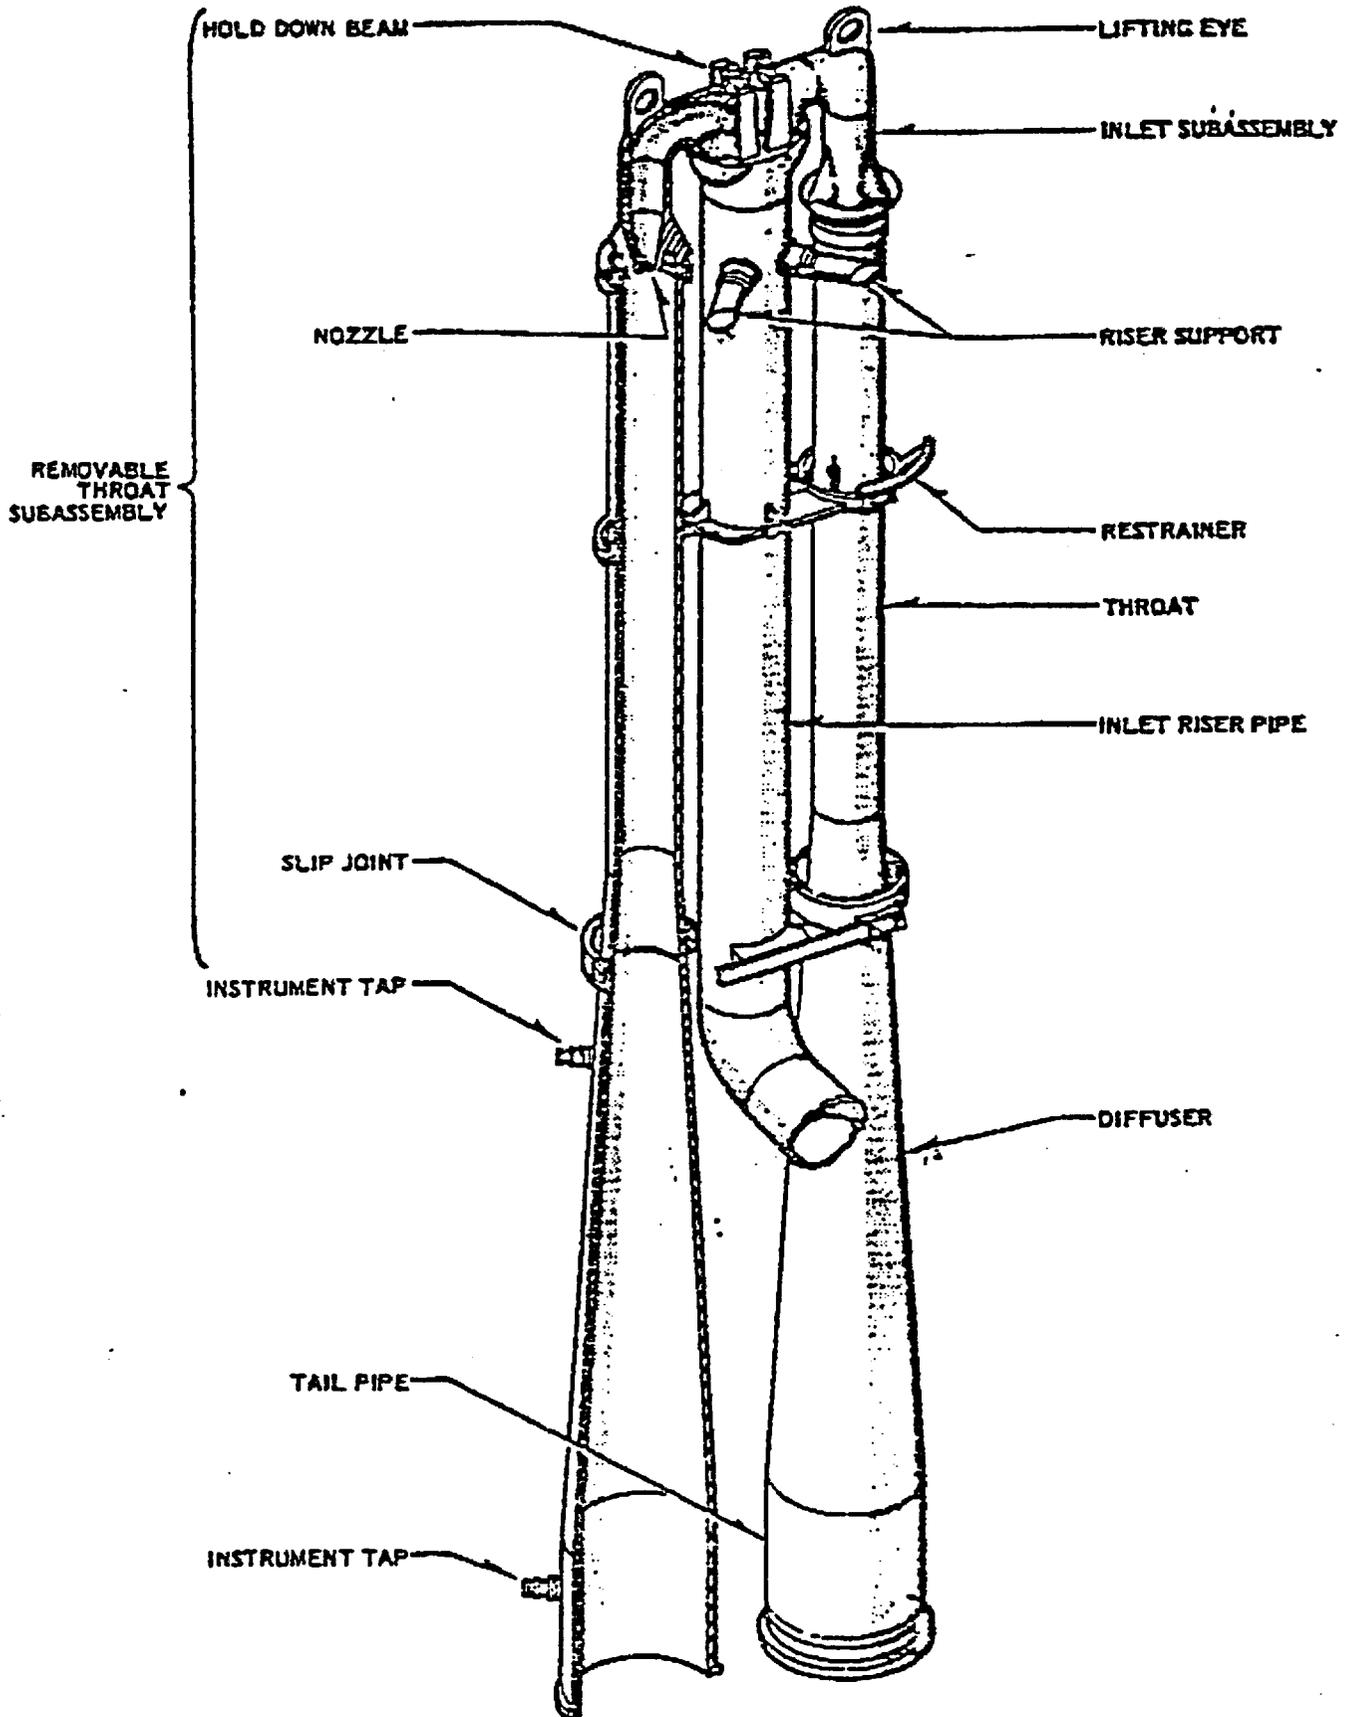
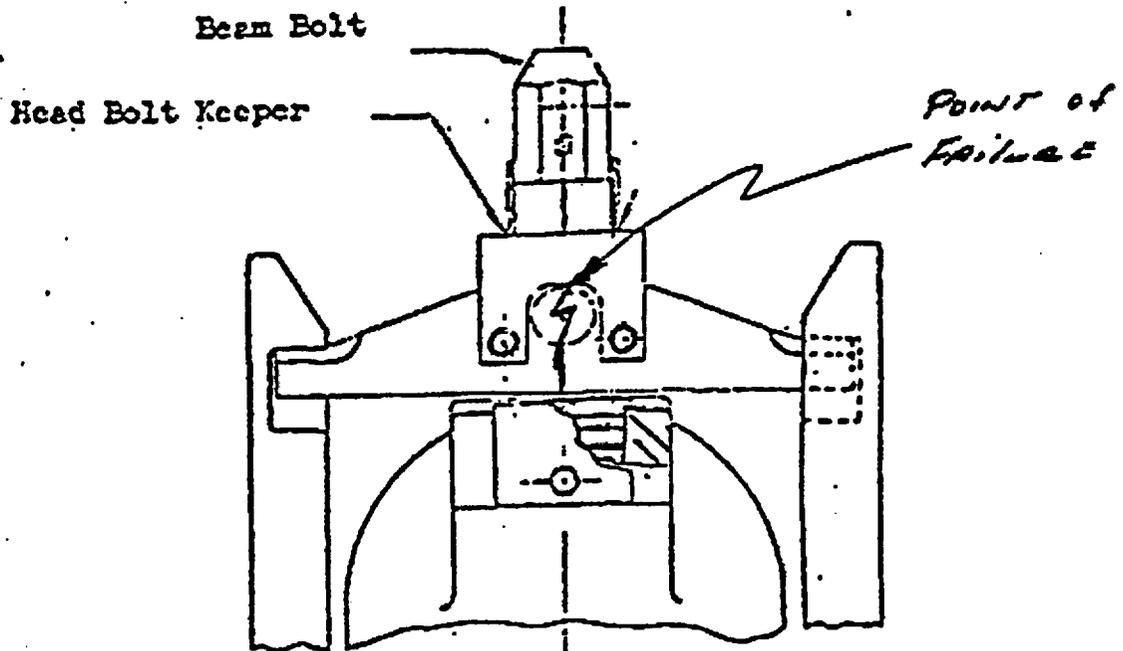
FIG. 1

Following vessel head removal and defueling, TV camera and visual inspections of the jet pumps and vessel annulus revealed the hold-down beam assembly of the suspect jet pump had broken across its ligament sections at the mean diameter of the bolt thread area. Failure of the beam assembly resulted in pump decoupling at the diffuser connection. Subsequent insitu ultrasonic examination of all other jet pump hold-down beams, using a special UT technique developed by General Electric (GE), revealed ultrasonic indications of cracking at the same location in 6 of the remaining 19 beams examined. Initial estimates of crack depth ranged from 6 to 20 mils. A sketch of the typical jet pump assembly is shown in Figures 1 and 2.

1. Visual inspections assisted by TV camera shall be conducted to assess the integrity of the jet pump structures, the hold-down beam assembly, hold-downs, wedge and restrainer assembly. Particular attention should be given to areas of unusual wear, failed keeper welds or other evidence of distress that could be indicative of loss of beam assembly preload.

2. Ultrasonic examinations, utilizing GE procedure TP-508.0642 (Rev. A) or equivalent, shall be conducted to assess the integrity of the jet pump hold-down beams at the mid-length ligament areas bounding the beam bolt.

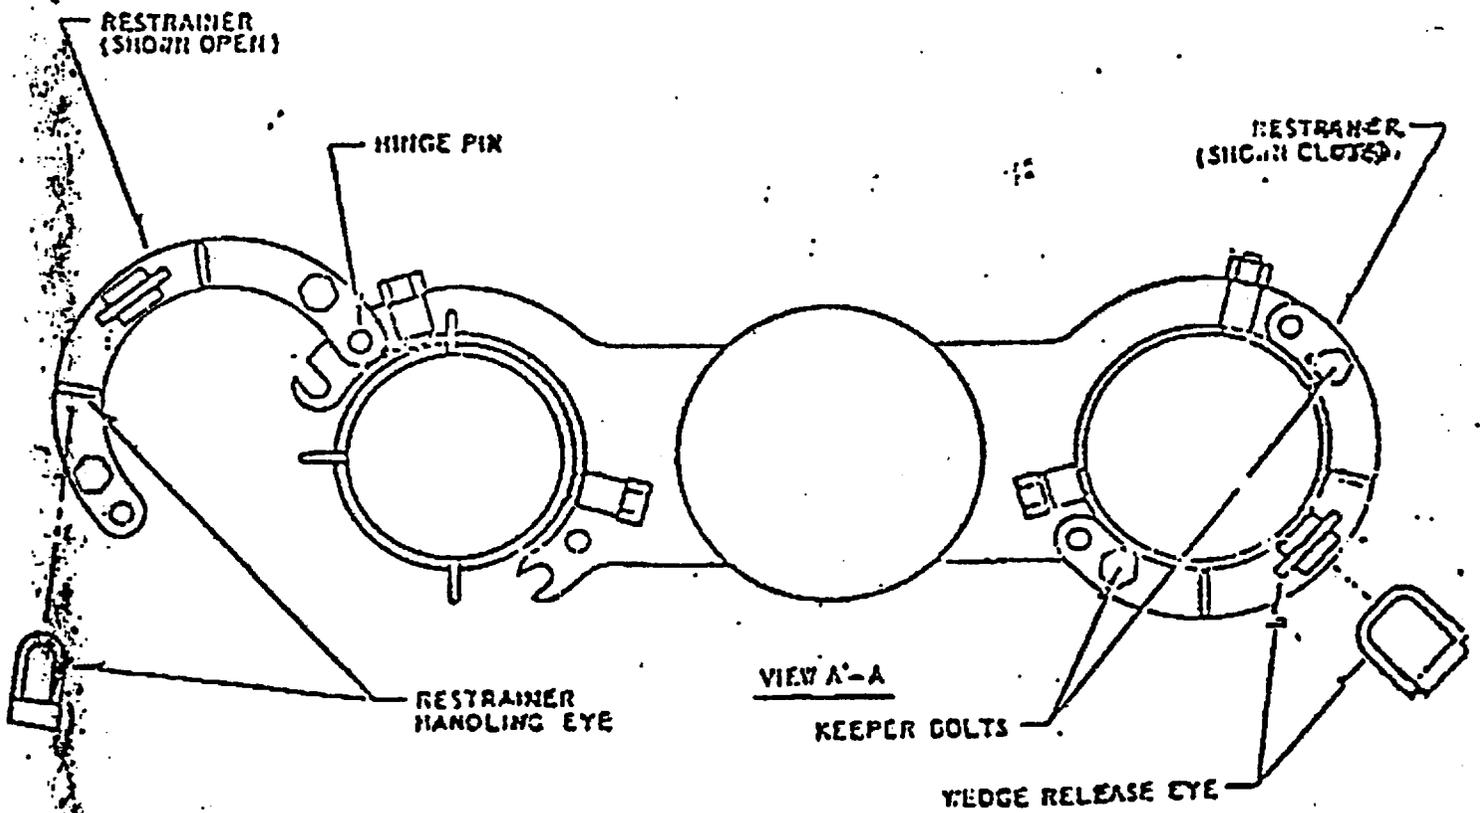
View B
Jet Pump Beam Details

On March 15-16, 1980, insitu ultrasonic examination was performed on all 20 jet pump hold-down beam assemblies at Quad Cities 2 (currently shutdown for refueling). One beam was found to contain a crack indication estimated to be in excess of 100 mils depth in the same location on the beam as found at Dresden.
