UNITED STATES
NUCLEAR REGULATORY COMMISSION
REGION I
631 PARK AVENUE
KING OF PRUSSIA, PENNSYLVANIA 19406

UNITED STATES
NUCLEAR REGULATORY COMMISSION
OFFICE OF INSPECTION AND ENFORCEMENT
WASHINGTON, D.C. 20555

IE Bulletin No. 80-20
Page 1 of 2

FAILURES OF WESTINGHOUSE TYPE W-2 SPRING RETURN TO NEUTRAL CONTROL SWITCHES

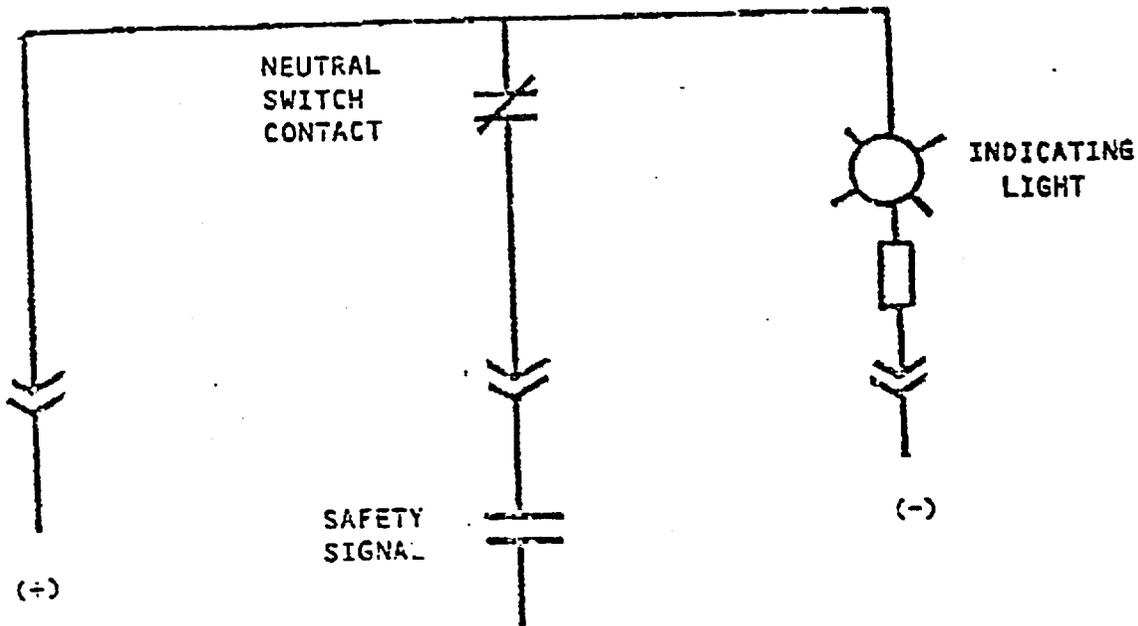
EXISTING INDICATING LIGHT CIRCUIT (TYPICAL)

Depending on how the indicating light circuit is wired, loss of continuity thru the neutral position contact of a W-2 switch could remain undetected until the equipment associated with the switch were called upon to operate. Since such a failure would be equivalent to by-passing the system associated with the switch, consideration should be given to rewiring the switches used in safety-related applications as shown in Figure 1. Such rewiring would provide an acceptable means for detecting contact failure, provided the indicating light is in the control room and readily visible by the operator. If the indicating light is not so located, consideration should be given to annunciating the neutral position contact failures at the control room to alert the operator of the inoperable status of a safety-related system. In addition, consideration should be given to adding redundant contacts to the W-2 switches or to replacing the W-2 switches with others having a more positive contact wiping action.

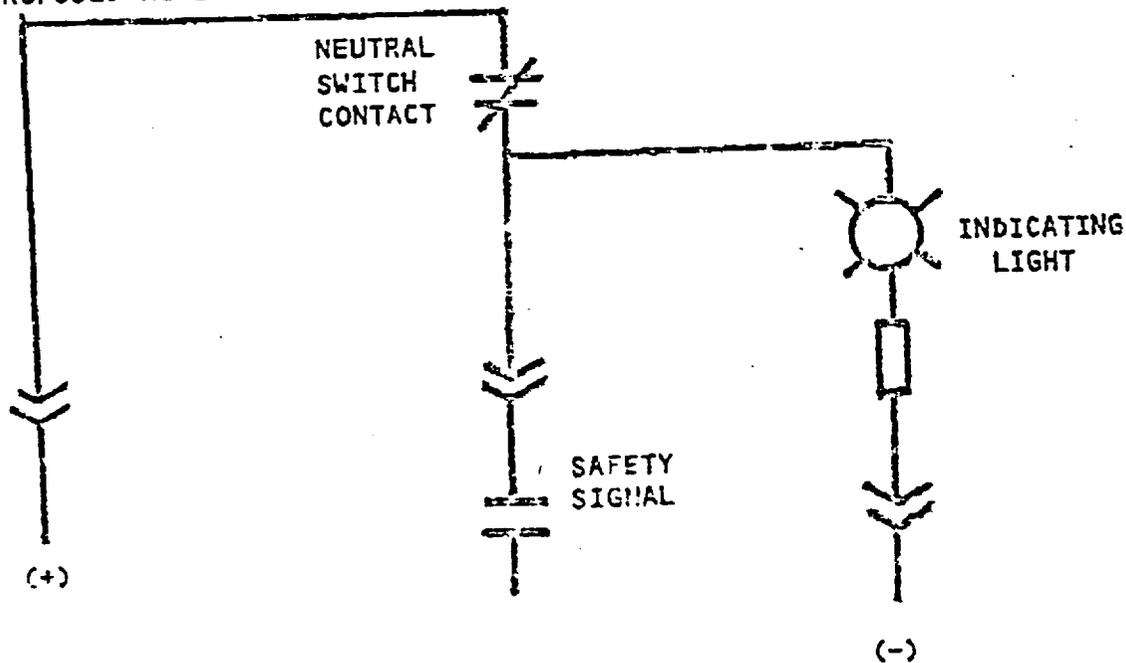
PROPOSED REWIRING OF INDICATING LIGHT CIRCUIT (TYPICAL)

REWIRING OF INDICATING LIGHT CIRCUIT OF W-2 SWITCHES
AS RECOMMENDED BY WESTINGHOUSE TECHNICAL BULLETIN NSD-TB-80-9

A review of this matter by Westinghouse led to the issuance of NSD Technical Bulletin No. NSD-TB-80-9 to the utility owners of all Westinghouse operating plants. The recommendations contained in the Westinghouse technical bulletin include: (i) testing the neutral position contacts of the subject W-2 switches for continuity, and (ii) rewiring of the indicating light circuit to permit the early detection of a neutral contact failure as shown in Figure 1.

3. Licensees of operating plants and holders of construction permits shall describe the longer term corrective measures planned and the date by which such measures will be implemented by actual installation or by design change, as appropriate. As a minimum, the longer term corrective measures should include rewiring the indicating light as shown in Figure 1 provided the light is readily visible to the control room operator. If not, failures of the neutral position contacts should be annunciated in the control room.
