**UNITED STATES
NUCLEAR REGULATORY COMMISSION
REGION IV
611 RYAN PLAZA DRIVE, SUITE 400
ARLINGTON, TEXAS 76011-4005**

**SUBJECT: GRAND GULF NUCLEAR STATION – NRC SPECIAL TEAM INSPECTION
REPORT 50-416/03-07**

Enclosure:
NRC Inspection Report
50-416/03-07

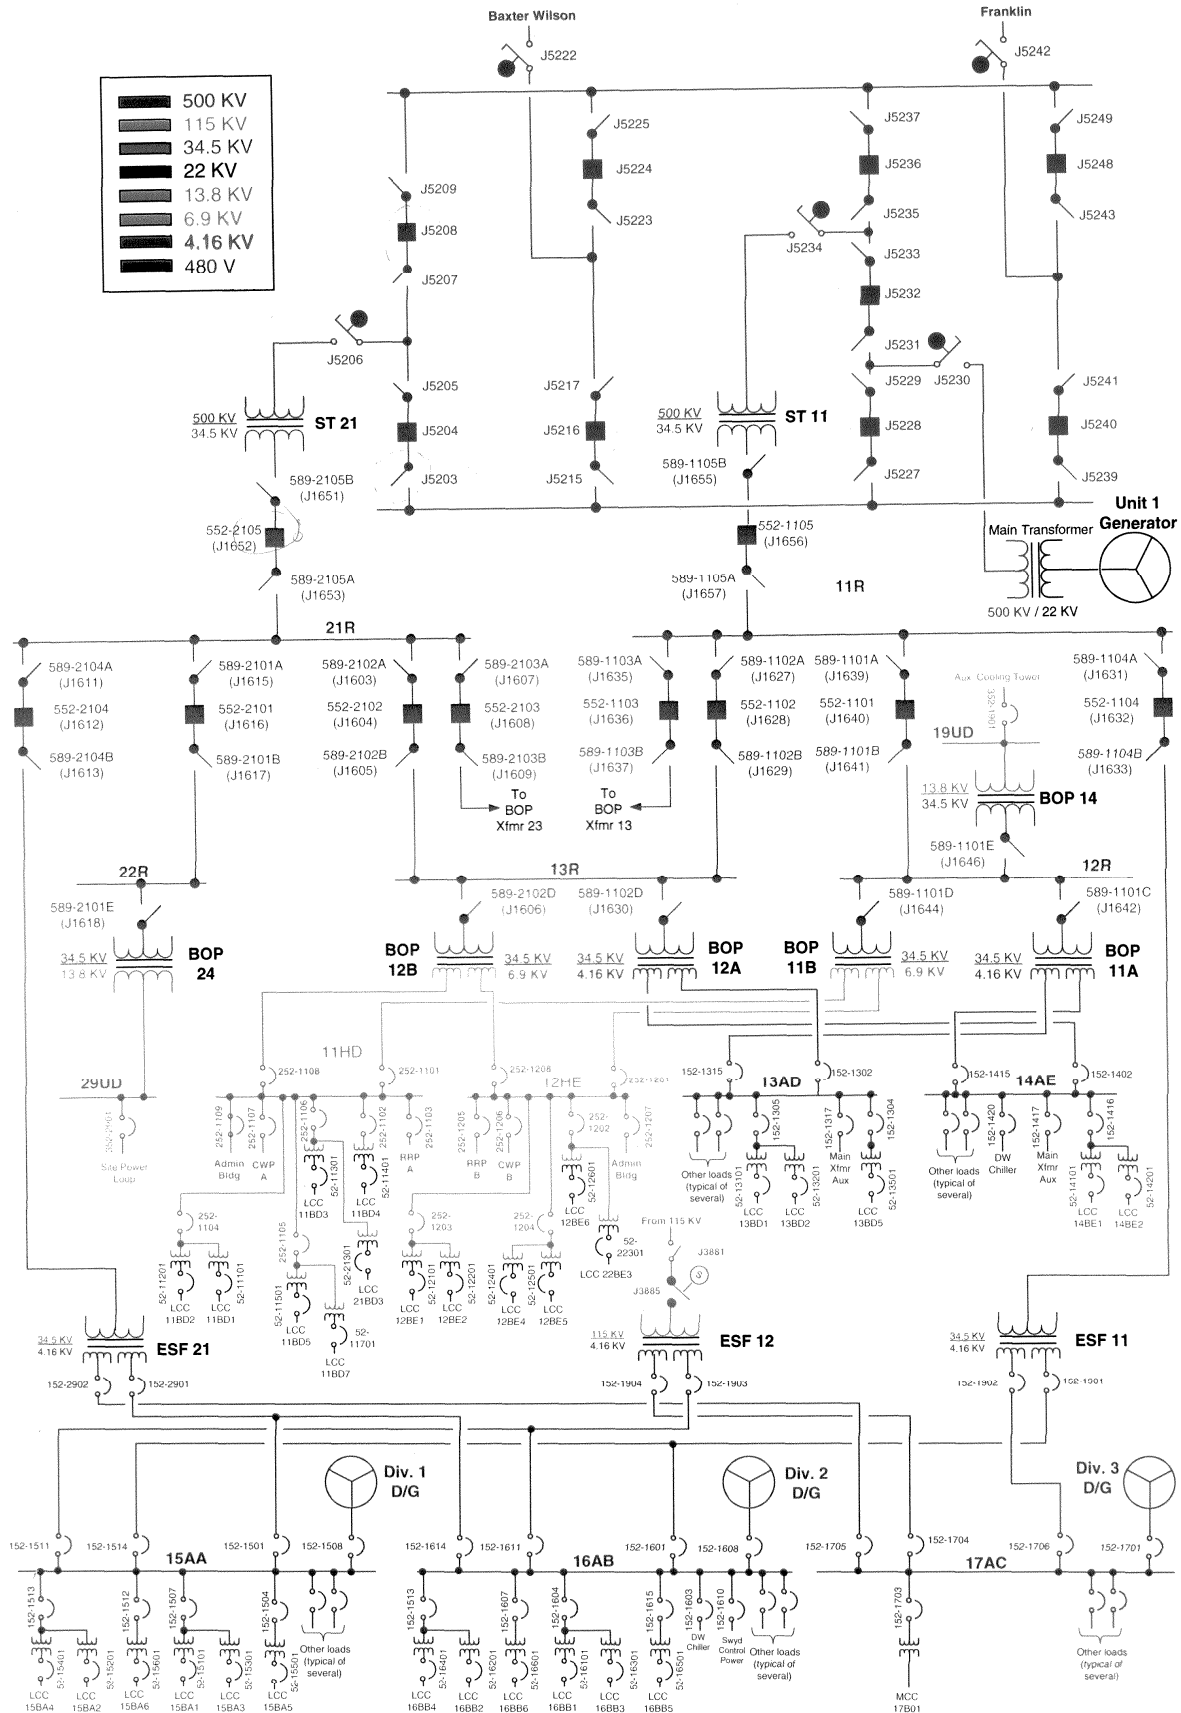
GGNS SWITCHYARD ELECTRICAL DISTRIBUTION DRAWING

2003, to repair the leak. The breaker was electrically isolated by open Disconnects J5203 and J5205. Breaker J5204 was also equipped with grounding straps on both sides of each of its three phases as a standard maintenance practice. At the time of the disconnect closure, maintenance personnel had Breaker J5204 closed, which allowed the fault current which passed through Disconnect J5205 to flow to ground on both sides of the breaker.

The first path was through Disconnect J5205 from the 500 kV line and then through the installed grounding strap to ground. The team determined that this first current path served to isolate ST21 as expected. The ground fault conditions actuated relays for differential current on all three phases of both the primary and backup detection circuits, which triggered the ST21 primary and backup lockout relay trips. These trips fed logic to open Breakers J1652, isolating ST21 from the GGNS, and J5208, isolating ST21 from the east bus and completely electrically isolating ST21 and clearing the electrical fault from the 500 kV system. The team determined that the ST21 isolation was per design.

The second path for current was through Disconnect J5205 and Breaker J5204, then through the grounding strap on Disconnect J5203 of the breaker-to-ground. The second current path served to isolate the west 500 kV bus. The fault conditions actuated relays for differential current on Phase C of both the primary and backup detection circuits, which triggered the west bus primary and backup lockout relay trips. These trips fed logic to open Breakers J5216, J5228, and J5240, which isolated the west GGNS 500 kV bus from the remainder of the incoming 500 kV grid and GGNS. The team determined that the west bus isolation was per design for the ground fault in the switchyard.

The team determined that failures in the carrier blocking network between the GGNS switchyard and both the Baxter Wilson and Franklin switchyards led to isolation of power to the GGNS 500 kV switchyard. The carrier blocking system was designed to give time for local breakers to isolate faults before more distant breakers isolated larger portions of the grid. Specifically for these cases, this carrier blocking system should have acted to block the trips of the Baxter Wilson and Franklin switchyard breakers feeding the GGNS 500 kV switchyard for 34 cycles (about 0.5 seconds), giving time for the fault to be cleared by breakers in the GGNS 500 kV switchyard. Malfunctions of the carrier blocking systems prevented these blocking signals from occurring, allowing the Baxter Wilson and Franklin breakers to trip and isolate 500 kV power to the GGNS switchyard.
