INVESTIGATION OF SIX WIRE
CLADDING DEFECTS IN B&W
REACTOR VESSEL
620-0014-51

REPORT NO. 14
BY: I. BARNES
AUGUST 15, 1973

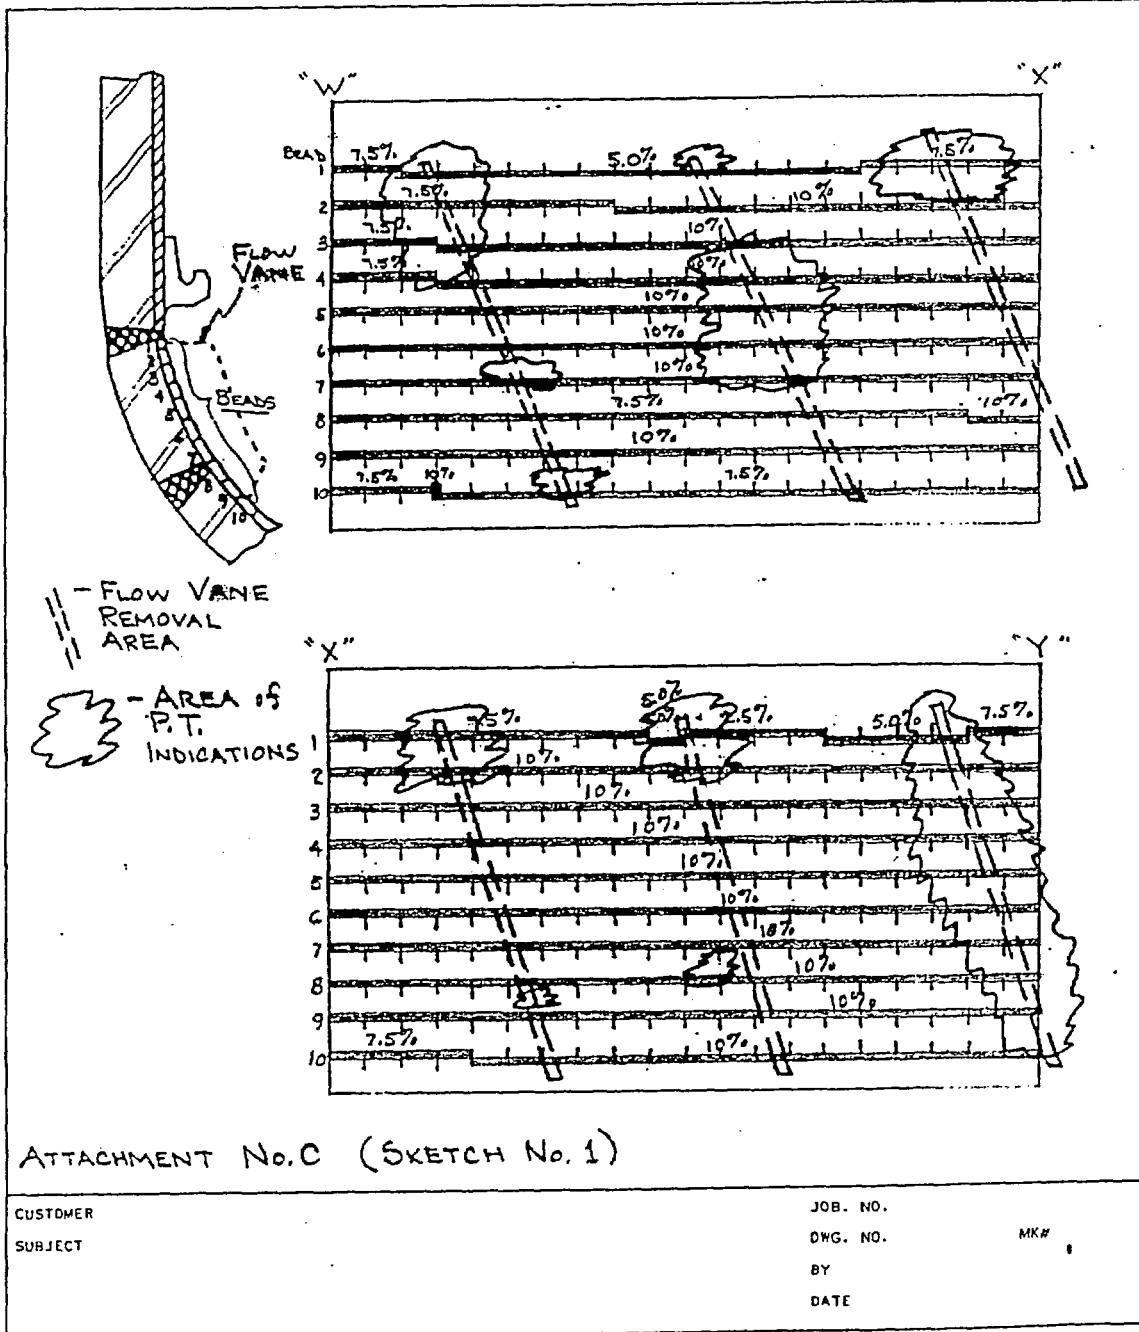
ATTACHMENT No. C (SKETCH No. 1)

On discovery of linear penetrant indications over 90% of the cladding surface in the dutchman transition forging it was decided to establish whether hot cracking was the operative mechanism for the condition detected. A ferrite survey was therefore made at 6" increments of the six wire cladding deposited on the dutchman transition forging and immediate adjacent beads on the lower head dome. Ten beads in all were inspected, the results of the survey being shown in Attachment C. Included in the sketches are the areas which showed the worst

penetrant indications. It is apparent from these records that the defect condition was equally prevalent in areas containing 10% ferrite as in other areas with lower measured values.

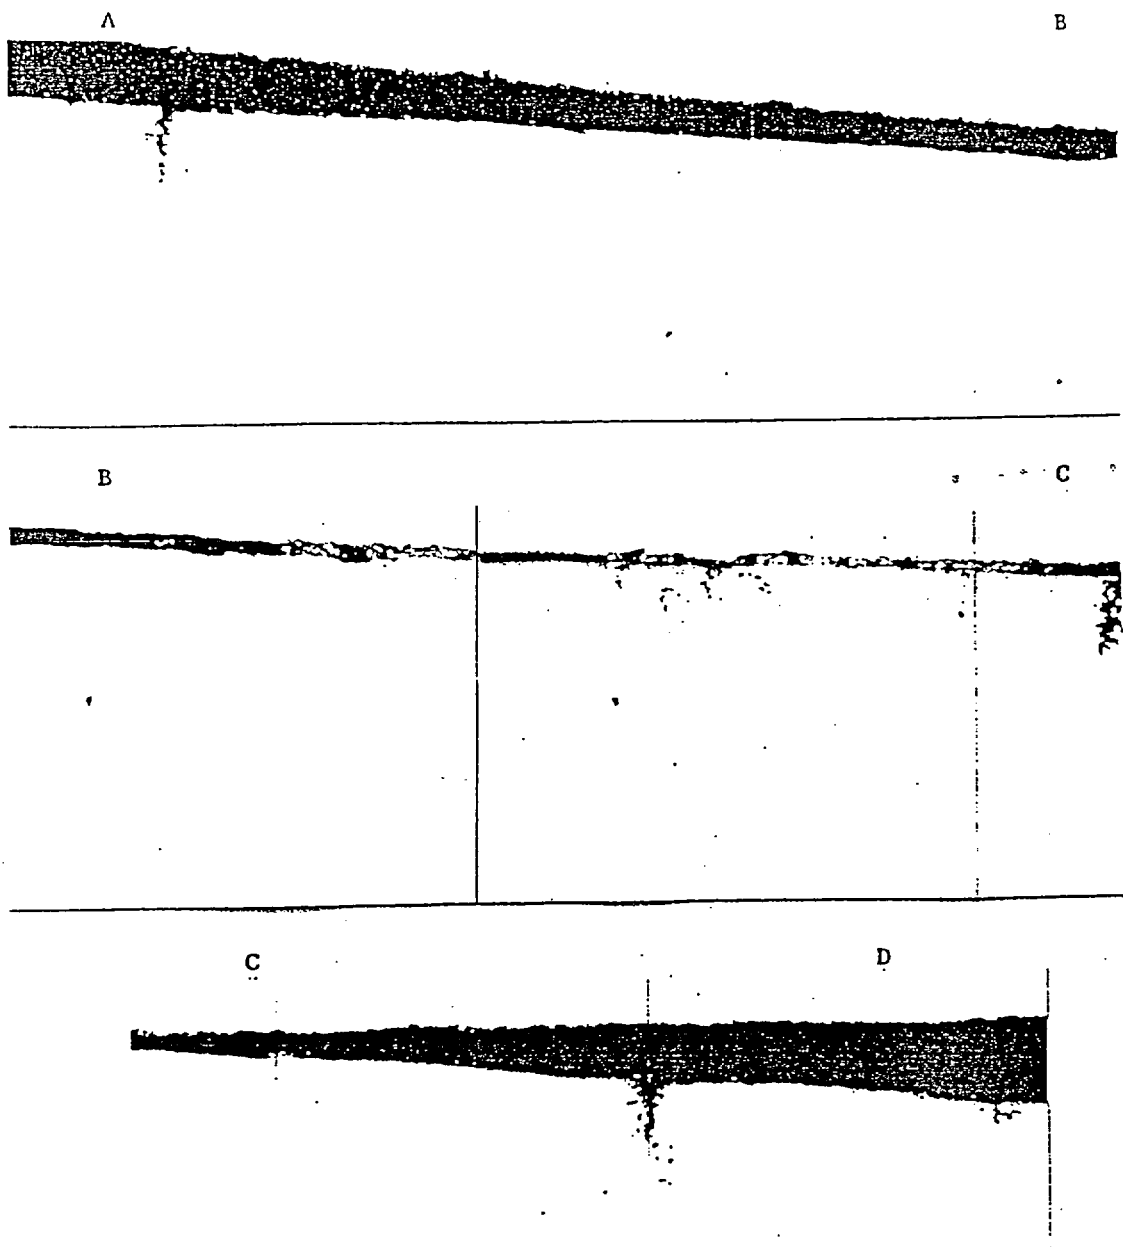
Figure 1 shows a view of a cross-section of NSS14 cladding containing surface defects. Figures 2 and 3 show higher magnification

views of the defects and indicate that the defects are interdendritic with entrapped slag also present. The defects are not associated with regions locally denuded in ferrite phase. Work done at the Alliance Research Center(1) on samples from the same cutouts also confirms the presence of slag in the defects and a completely normal distribution of ferrite phase in the vicinity of the defects.

Fig 1 (x50) Unetched. Showing solidification defects present at surface of NSS 14 6-wire cladding.

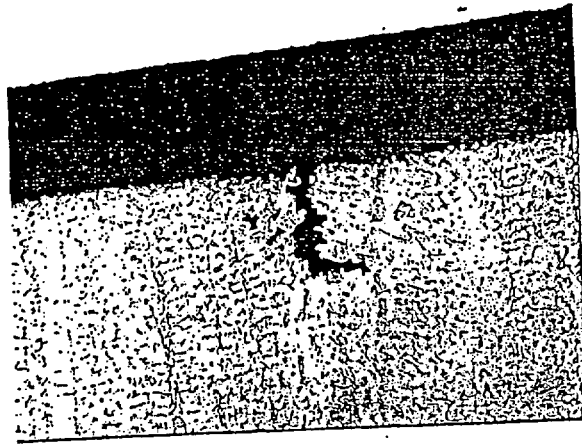
a (x100) Etchant - Kallings Reagent

Fig 2 Showing interdendritic solidification defects at surface of NSS 14 6-wire cladding.

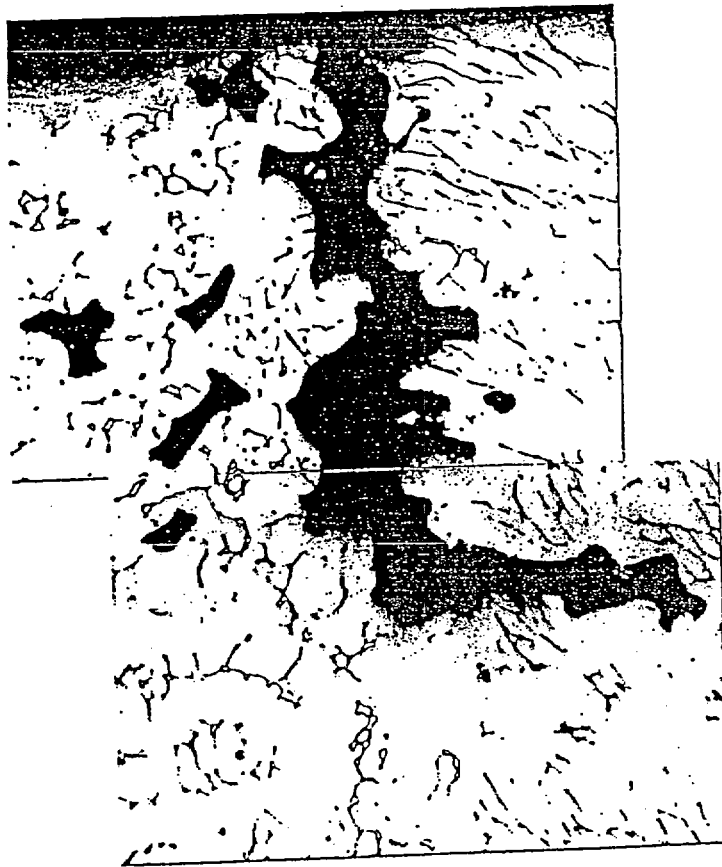
Fig 3 (x500) Higher magnification view of solidification defect shown in Fig 2a.

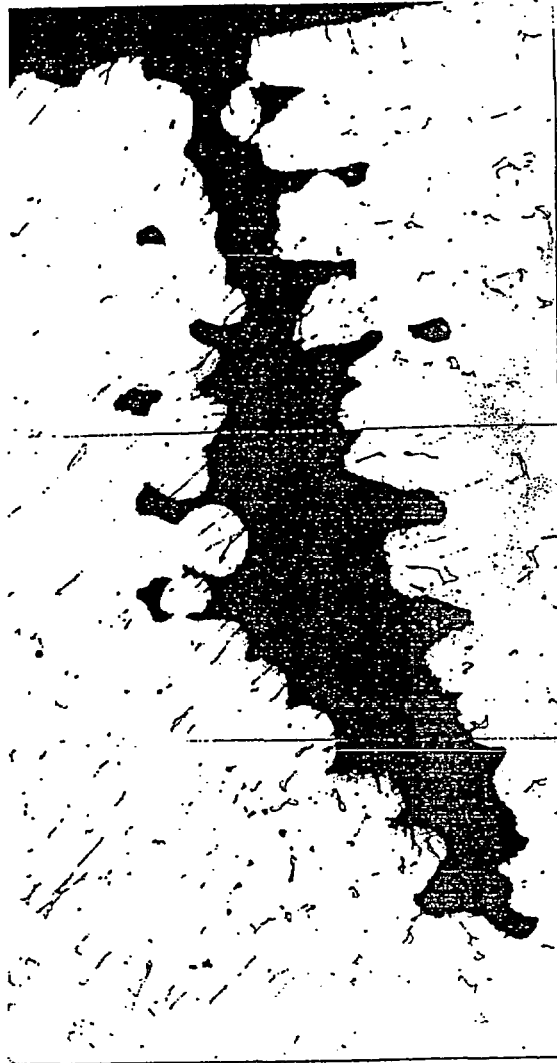
Fig 4 (x500) Higher magnification view of solidification defect shown in Fig 2b.

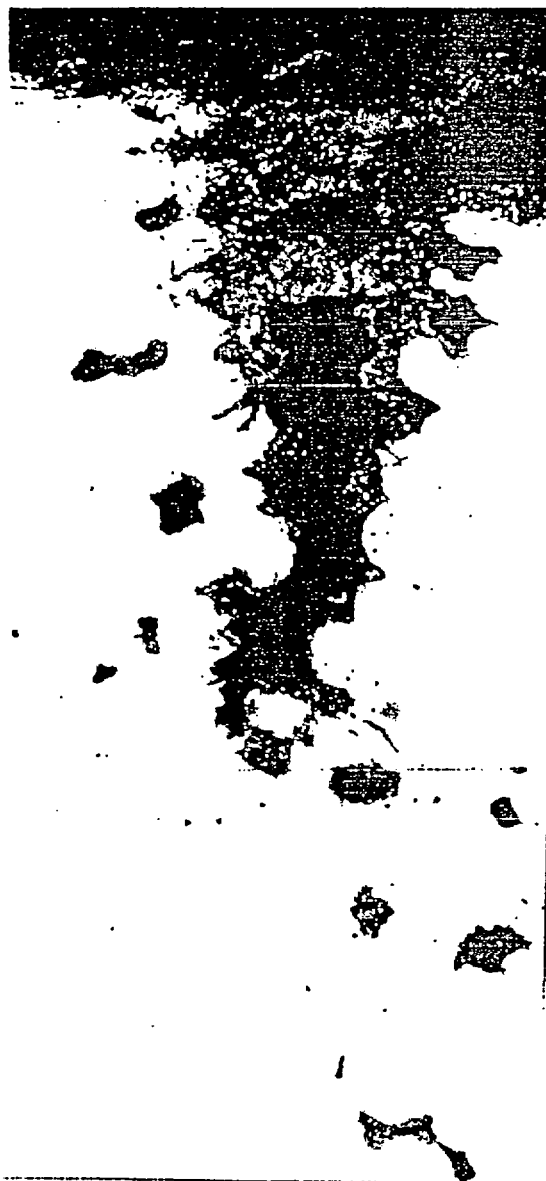
Fig 5 (x500) Showing structure of solidification defect in NSS 14 cladding after exposure to simulated production heat treatment cycles.

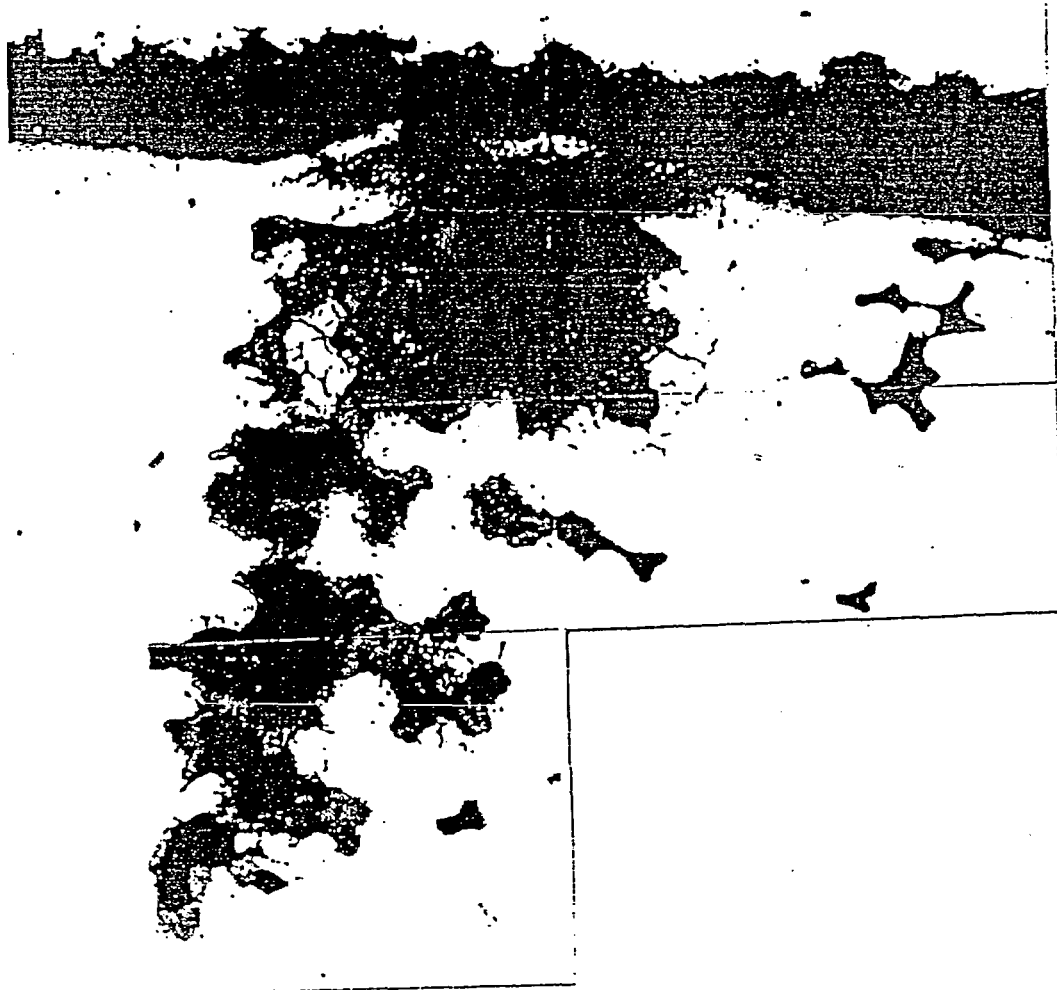
Fig 6 (x500) Showing structure of solidification defect in NSS 14 cladding after exposure to simulated production heat treatment cycles.

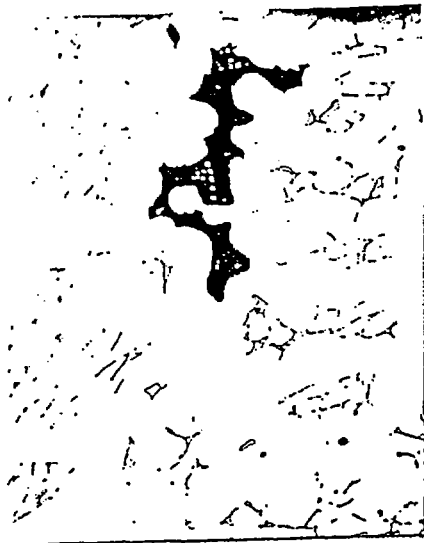
Fig. 7 (x500) Defect observed in experimental six wire cladding deposited using correct parameters. Etchant - Kallings Reagent

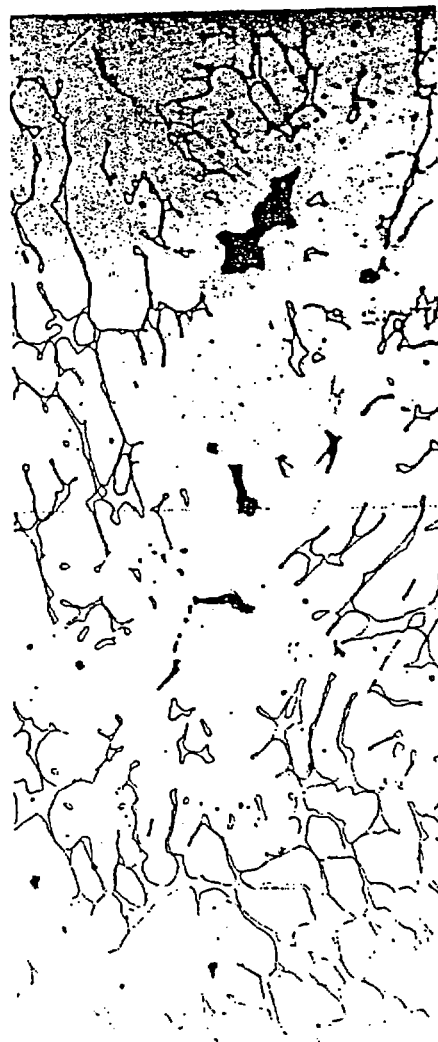
Fig. 8 (x500) Defect observed in experimental six wire cladding deposited using $3\frac{1}{2}$ "/minute Travel Speed and 35 Volts. Electrolytic Etch - 10%oxalic.

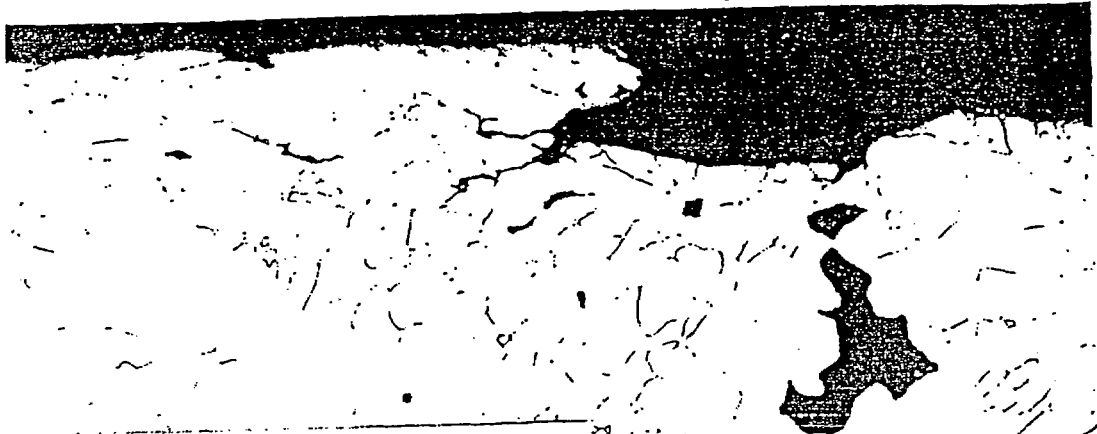
a (x500) Etchant - Kallings Reagent

Fig. 9 Defects observed in experimental six wire cladding deposited using $3\frac{1}{2}$ "/minute Travel Speed and 33 Volts.

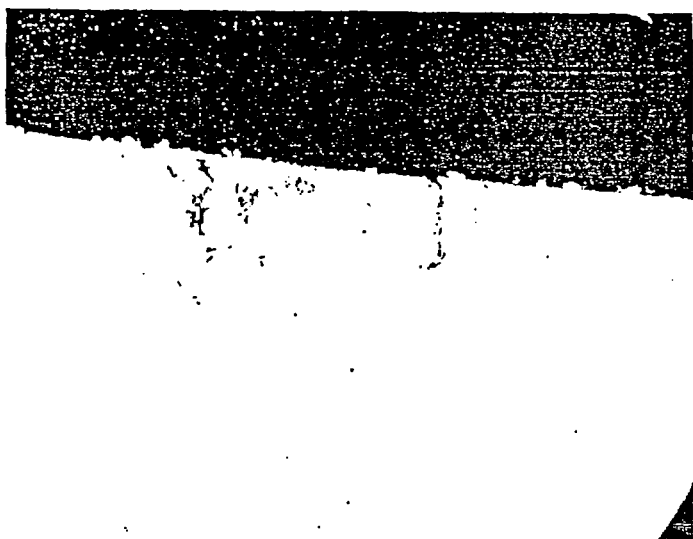
Fig. 10 (x100) Unetched. Defects observed at surface of NSS 9 production cladding.
