Research Reactor Center

Subject: Docket No. 50-186  
The Curators of the University of Missouri  
License No. R-103

**Licensee Event Report No. 03-01 – May 18, 2003**  
**University of Missouri Research Reactor**

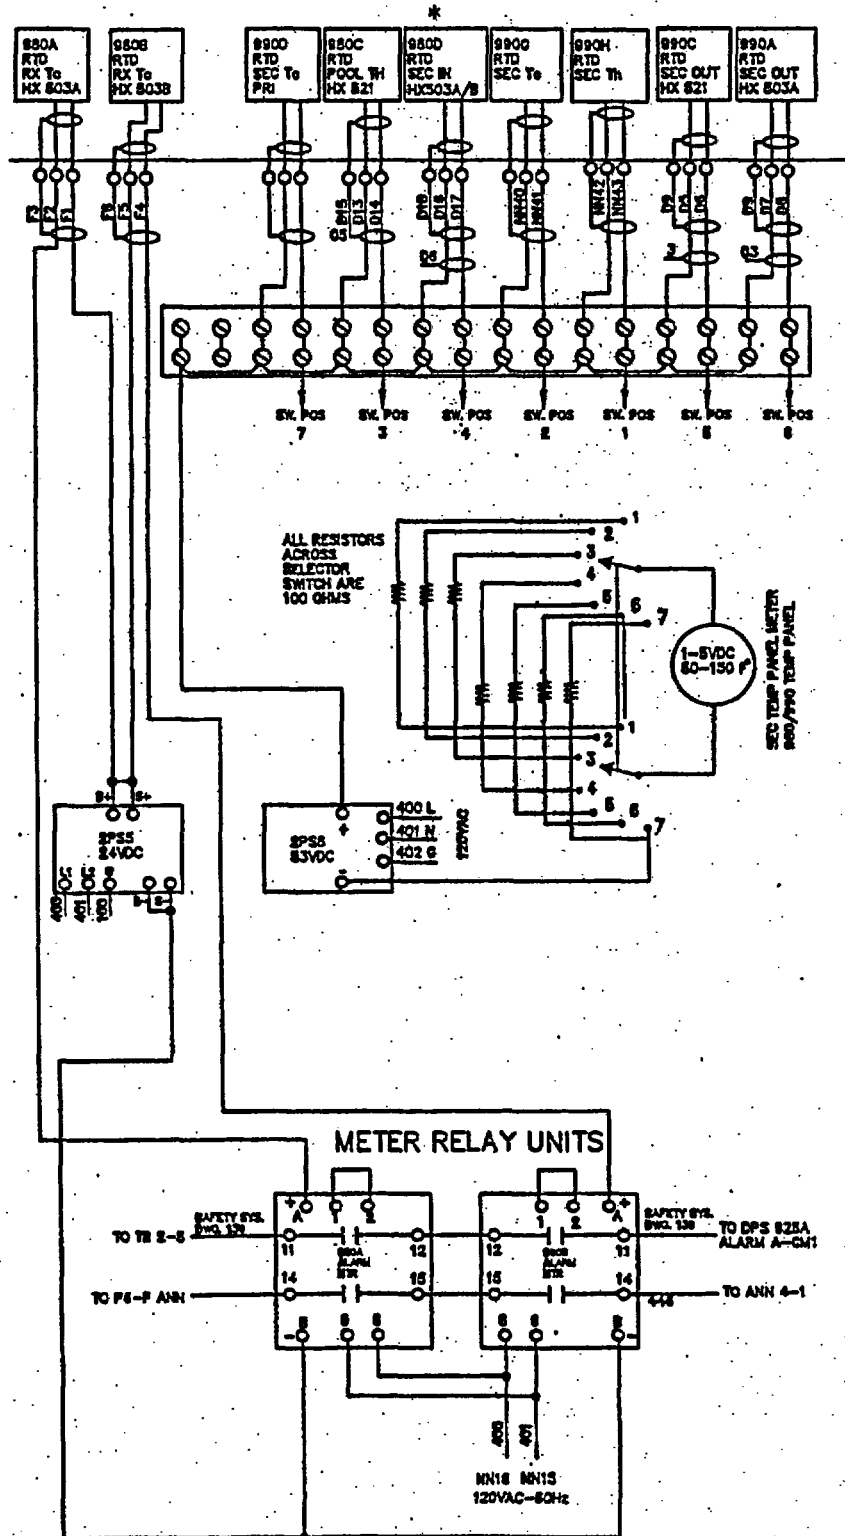
HEAT EXCHANGER OUTLET TEMPERATURE

On May 18, 2003, the duty operator initiated a manual reactor scram when primary coolant heat exchanger 503A outlet temperature instrument, TE-980A, meter indication failed downscale. The reactor was operating at 10 MW steady state at the time of the occurrence.

Temperature instrument channels TE-980A and TE-980B are shown as "Heat Exchanger Outlet Temperature" on the attached drawing. The sensor, an RTD, and Transmitter are Rosemount Model 444 Alphasine<sup>®</sup> units. Twenty-four volt power supply 2PS5 provides the operating voltage to both TE-980A and TE-980B. The output of the Transmitters is sent to corresponding Alarm Meter Relay Units mounted on the Instrument Panel in the Control Room.

The root cause of this instrument malfunction has not yet been fully determined. The downscale failure of the system could not be duplicated, nor were there any discrepancies noted during the bench tests. The RTD/Transmitter unit for TE-980B, which appeared to have failed in January 2002, was returned to Rosemount in February 2002 for failure analysis. Failure Analysis Report No. 3672, prepared by Rosemount Inc. Failure Analysis Lab, identified a failed operational amplifier on the Transmitter's Analog Output Board, which caused transmitter output drift and improper burnout mode. This report was included as an attachment to MURR LER No. 02-01. Rosemount Inc. stated that the component might have failed due to a transient voltage or a manufacturing defect in the component. Rosemount provided MURR with replacement Model 444 Alphaline<sup>®</sup> RTD/Transmitter units for the units installed in the reactor and for the ones used as spares.

The RTD/Transmitter unit for TE-980A was replaced and tested. All tests demonstrated that the instrument was operable. Compliance Procedure CP-8B was performed during May 19 maintenance day activities, once again demonstrating that the instrument was operable.
