Point Beach Nuclear Plant

Regulatory Conference Concerning Auxiliary
Feedwater Orifice Issue

June 6, 2003

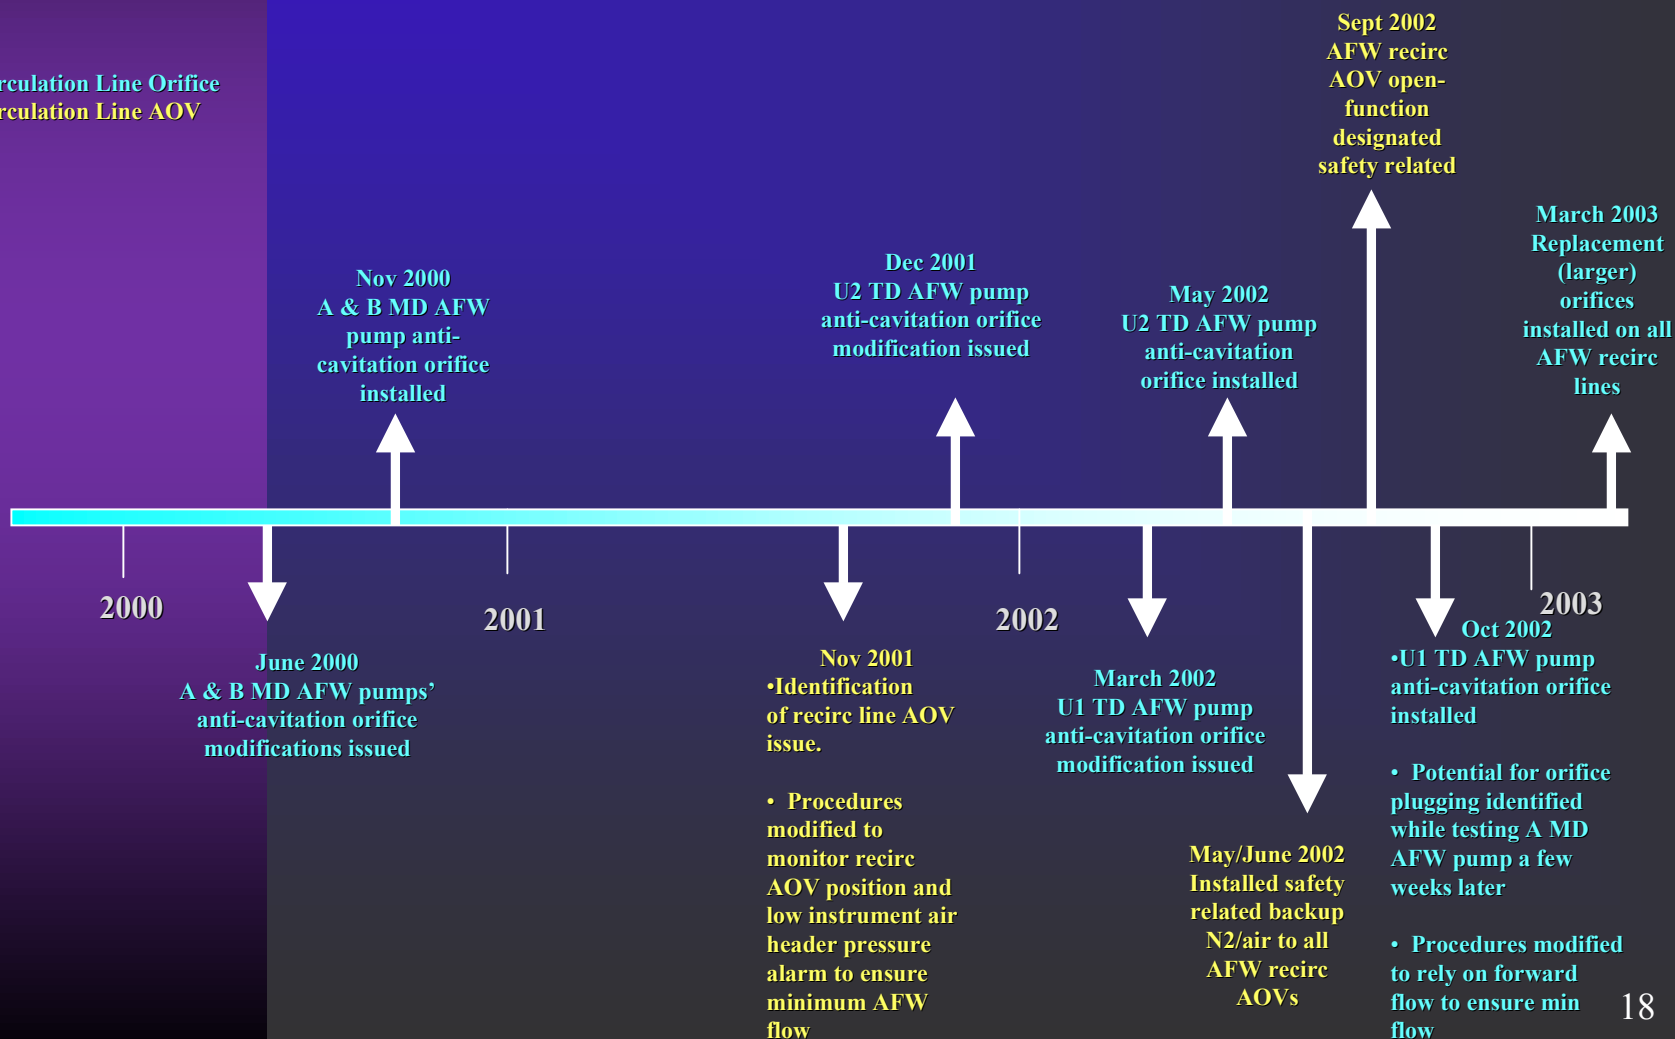
Significance Determination Historical Timeline

Recirculation Line Orifice

Recirculation Line AOV
