DOCKET 50-301; LICENSE NO. DPR-27
POINT BEACH NUCLEAR PLANT, UNIT 2
SUBMITTAL OF THE AUXILIARY FEEDWATER ORIFICE ISSUE REGULATORY
CONFERENCE SLIDE PRESENTATION

Point Beach Nuclear Plant

Regulatory Conference Concerning Auxiliary
Feedwater Orifice Issue

June 6, 2003

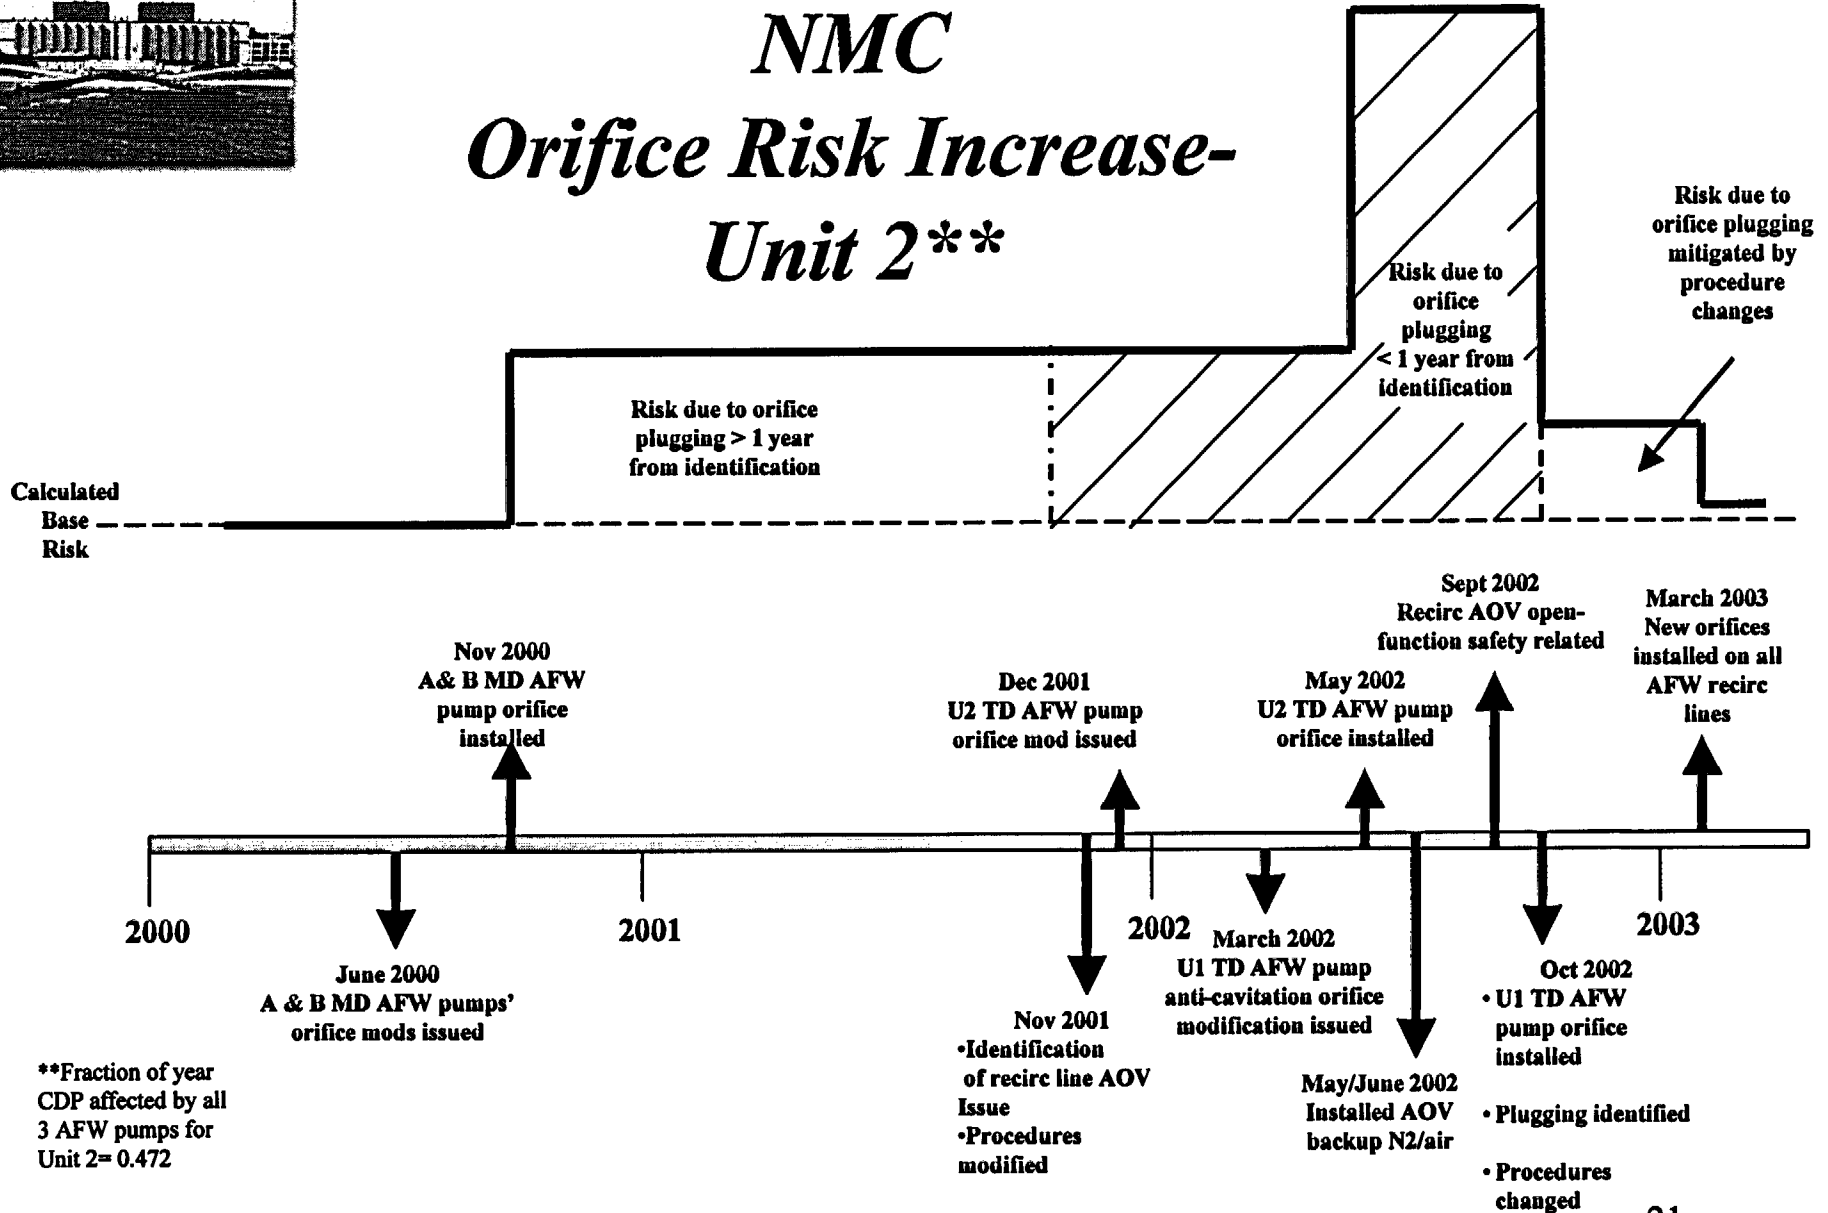
Significance Determination

**Fraction of year CDP affected by all 3 AFW pumps for Unit 2= 0.472
