Subject: 10CFR21 Reporting of Defects and Non-Compliance -
Engine Systems, Inc. Report No. 10CFR21-0087, Rev. 0

EMD Electric Start Motors at Oyster Creek

Report No. 10CFR21-0087
Rev. 0: 06/11/03

10CFR21 REPORTING OF DEFECTS AND NON-COMPLIANCE

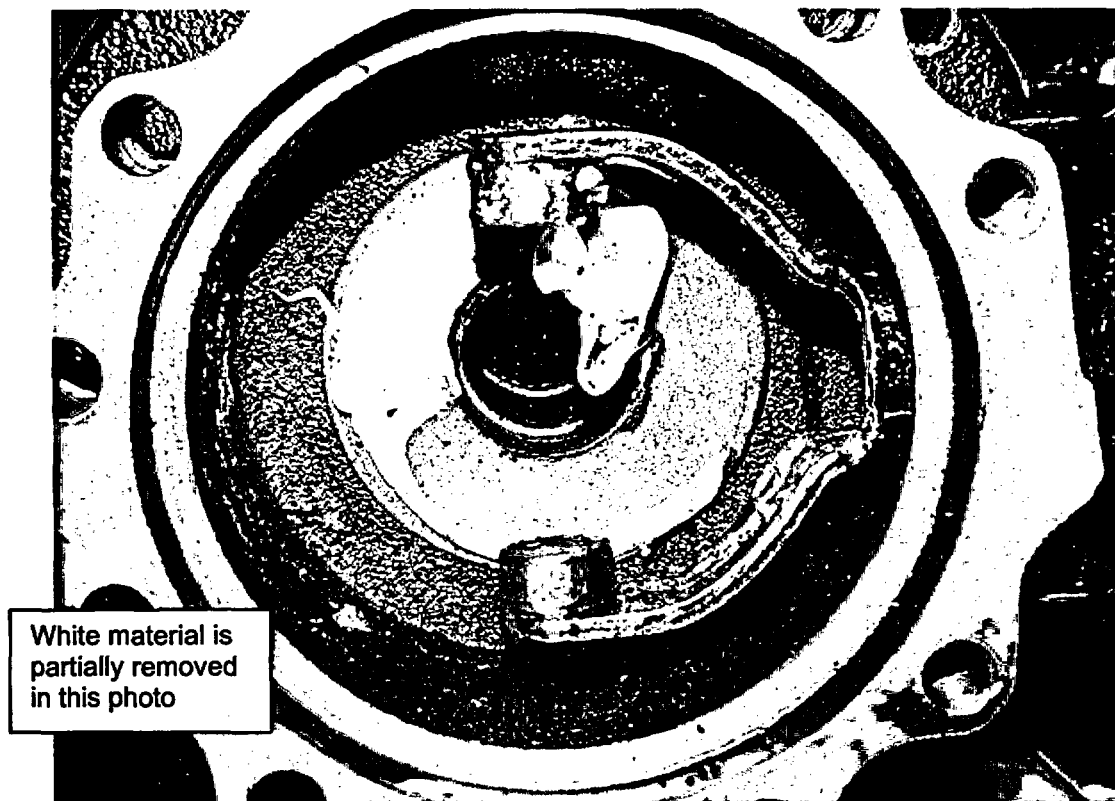
Upon removal of the Bendix assembly from the starter, a white opaque ring of material was found adhered to the lever housing. This material was in a position such that the Bendix assembly would rest against it in the de-energized state.

White material is
partially removed
in this photo

Internal view of lever housing, Bendix removed

Improper operation of the starter's drive assembly was caused by the presence of silicone RTV adhesive on the face of the lever housing. In this starter assembly, the brake washer was apparently adhered to the Bendix assembly using the pre-applied adhesive while RTV was applied to the lever housing and/or to the opposite face of the brake washer. The RTV surface maintained a sticky finish relative to the face of the brake washer, and this led to higher than normal required forces to separate the two. Therefore, with normal test voltage applied to the starter's solenoid, the Bendix would not engage.

After removal of the improperly applied RTV, the Bendix assembly operated properly.

1. Inspect starters with serial numbers containing "99" for a "sticking" starter drive. Two (2) starting motors are required for the engine. The solenoids of each motor are connected in series; therefore, the starter drive must engage at ½ of the minimum system voltage.
2. Starters with sticking drives should be disassembled and the RTV removed; or, returned to ESI for evaluation and repair.

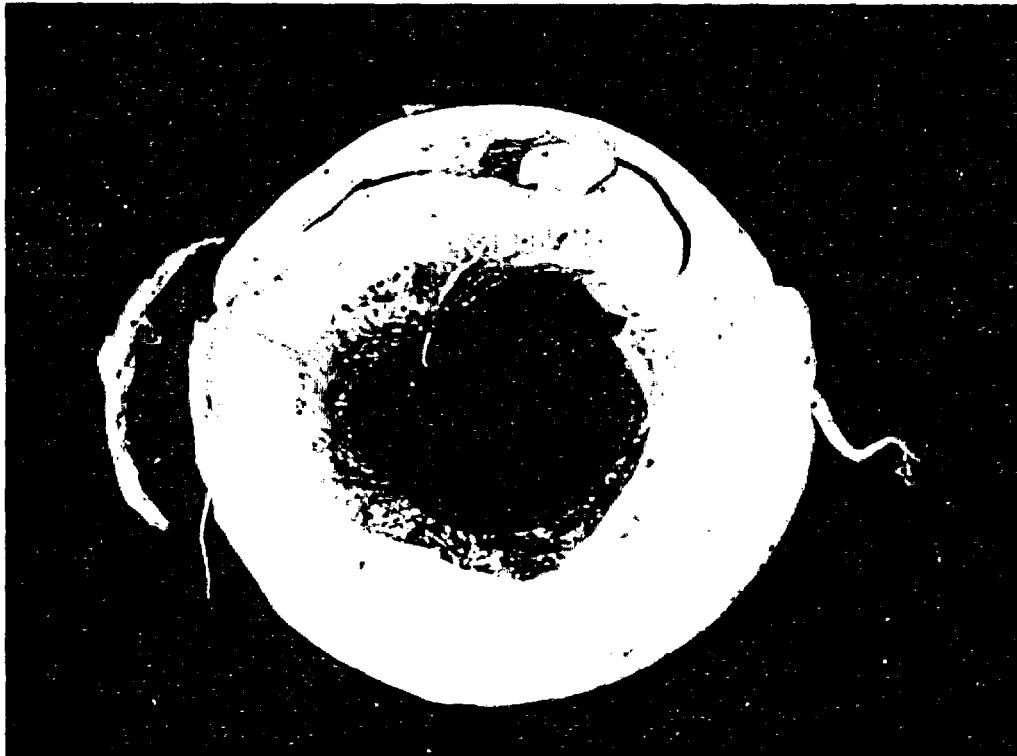
White material removed from lever housing

ESI contacted the manufacturer, Delco Remy, to discuss the findings. The representative reviewed photos of the material found and determined it was an RTV adhesive formerly used to adhere the brake washer. Delco Remy's practice is to either adhere the brake washer to the lever housing or to the Bendix assembly. In the early 1980's, RTV was used exclusively to adhere the brake washer. In 1986, their sub-supplier applied a mastic type adhesive on the brake washer. Sometimes the pre-applied adhesive did not provide sufficient bond strength, so RTV was used occasionally as a supplemental adhesive. At some point in 1999, the manufacturer stated that they had a process problem in which the brake washer was installed in the standard manner, but RTV was applied to the opposite side also. Delco Remy could not confirm the exact dates of this problem, but they estimate that it occurred only over a 2 week period. In April, 2001 a stronger adhesive was applied by the brake washer sub-supplier and the use of RTV was eliminated.

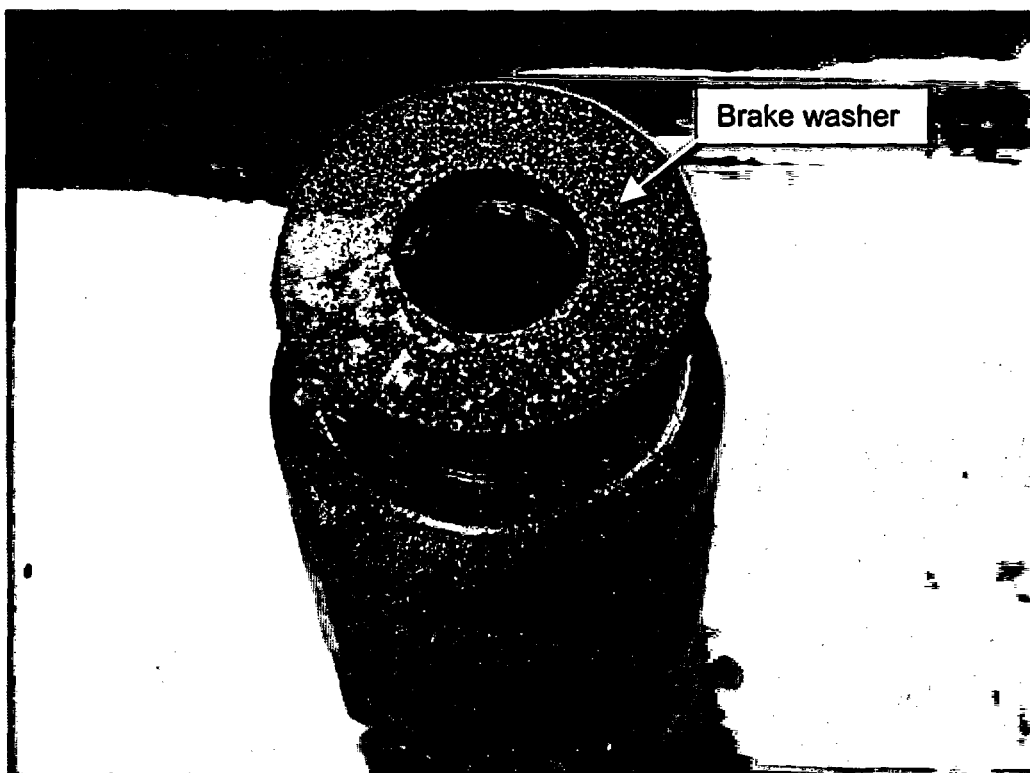
Non-drive end of Bendix assembly, brake washer surface

The function of the brake washer is to slow down the starter's armature after the engine starts and the pinion disengages. This reduces the starter's coast down time and conserves brush life.
