MEMORANDUM FOR: Ronald L. Ballard, Chief
Geology and Engineering Branch, HLWM

FROM: Keith I. McConnell, Section Leader
Geology/Geophysics Section
Geology and Engineering Branch, HLWM

SUBJECT: TRIP REPORT FOR MIDWAY VALLEY SITE VISIT - SEPTEMBER
17 & 18, 1992

RECENTLY ACQUIRED STRUCTURAL
INFORMATION ALONG THE GHOST
DANCE FAULT

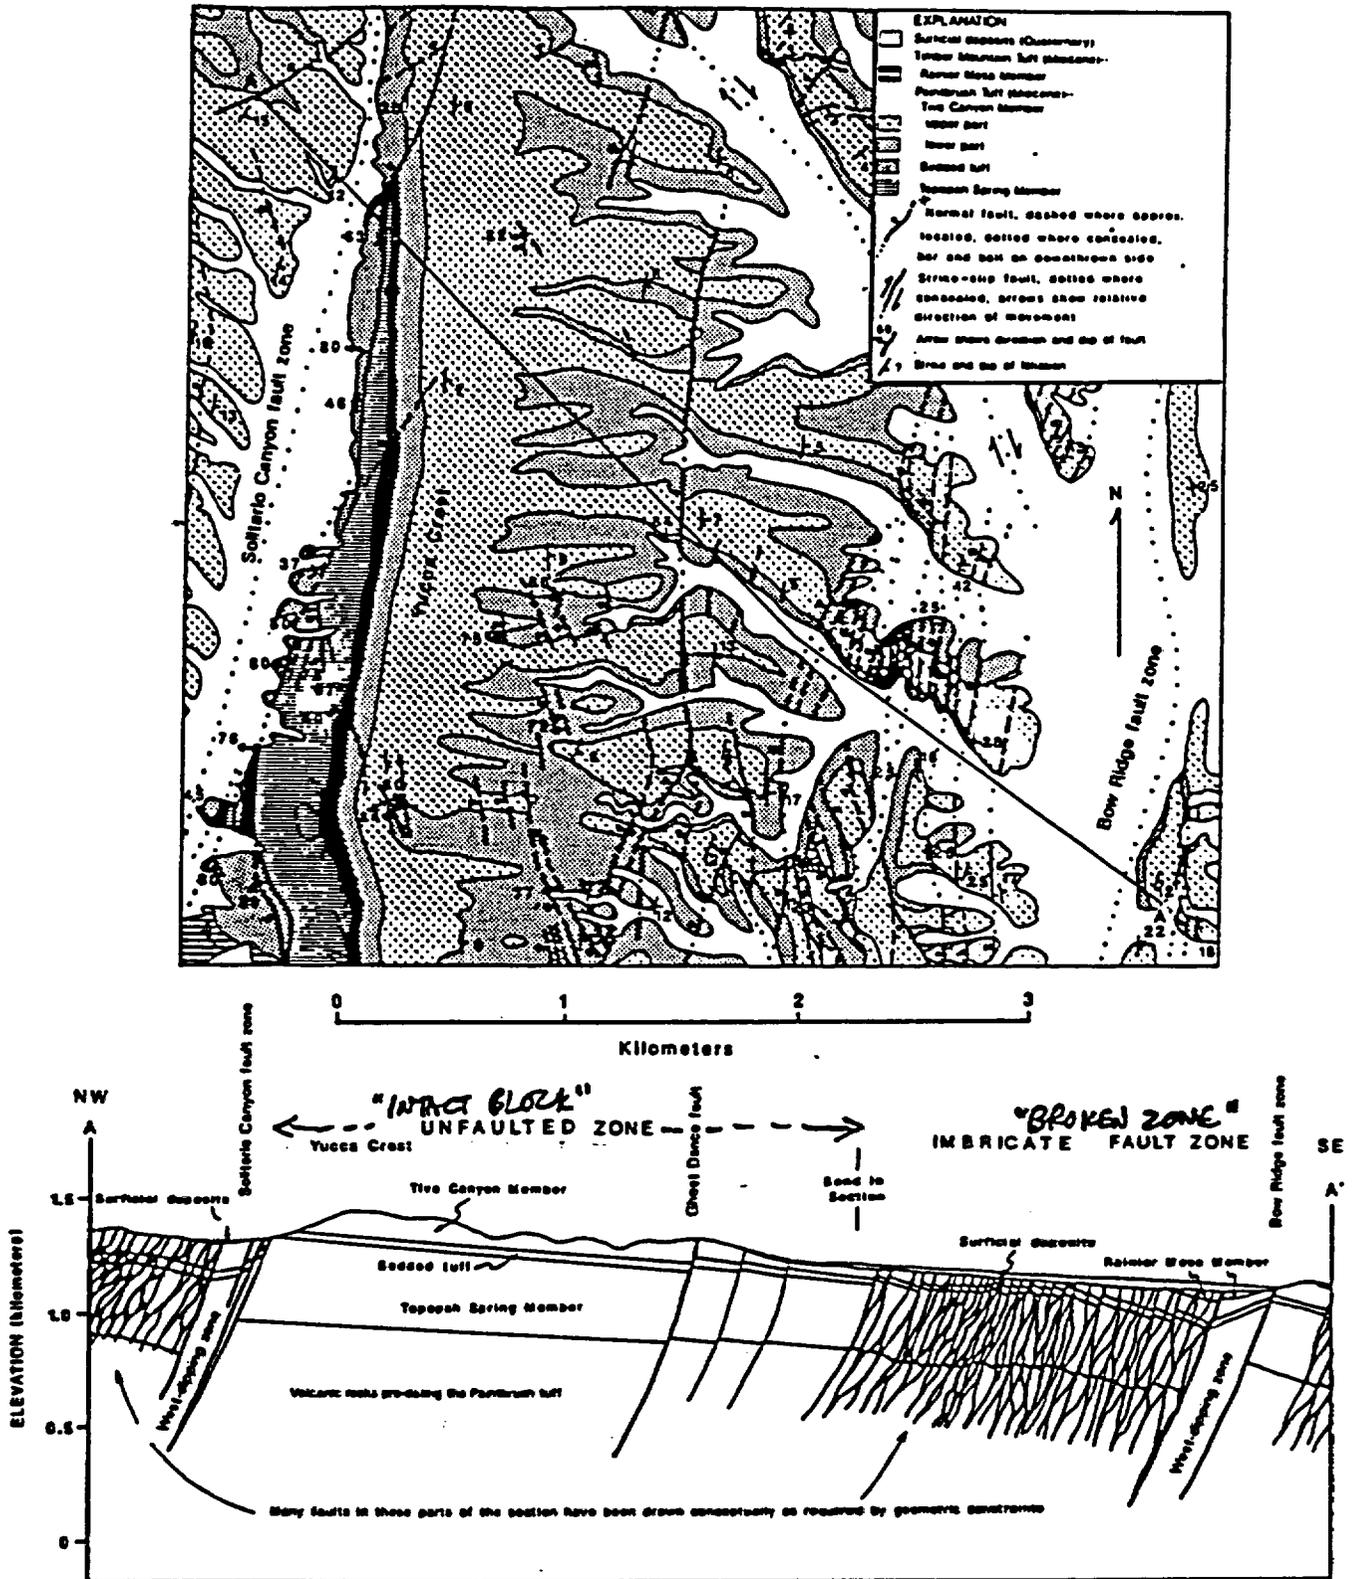
Figure 5. Geologic map and cross section of an area typical of the northern part of Yucca Mountain (Fig. 3). Geology from Scott and Bonk (1984). Line A-A' locates cross section. Note that only a few of the faults in the imbricate fault zone shown in the cross section can be correlated with mapped faults. The faults shown are a conceptualized projection from fragmental evidence seen in small exposures.

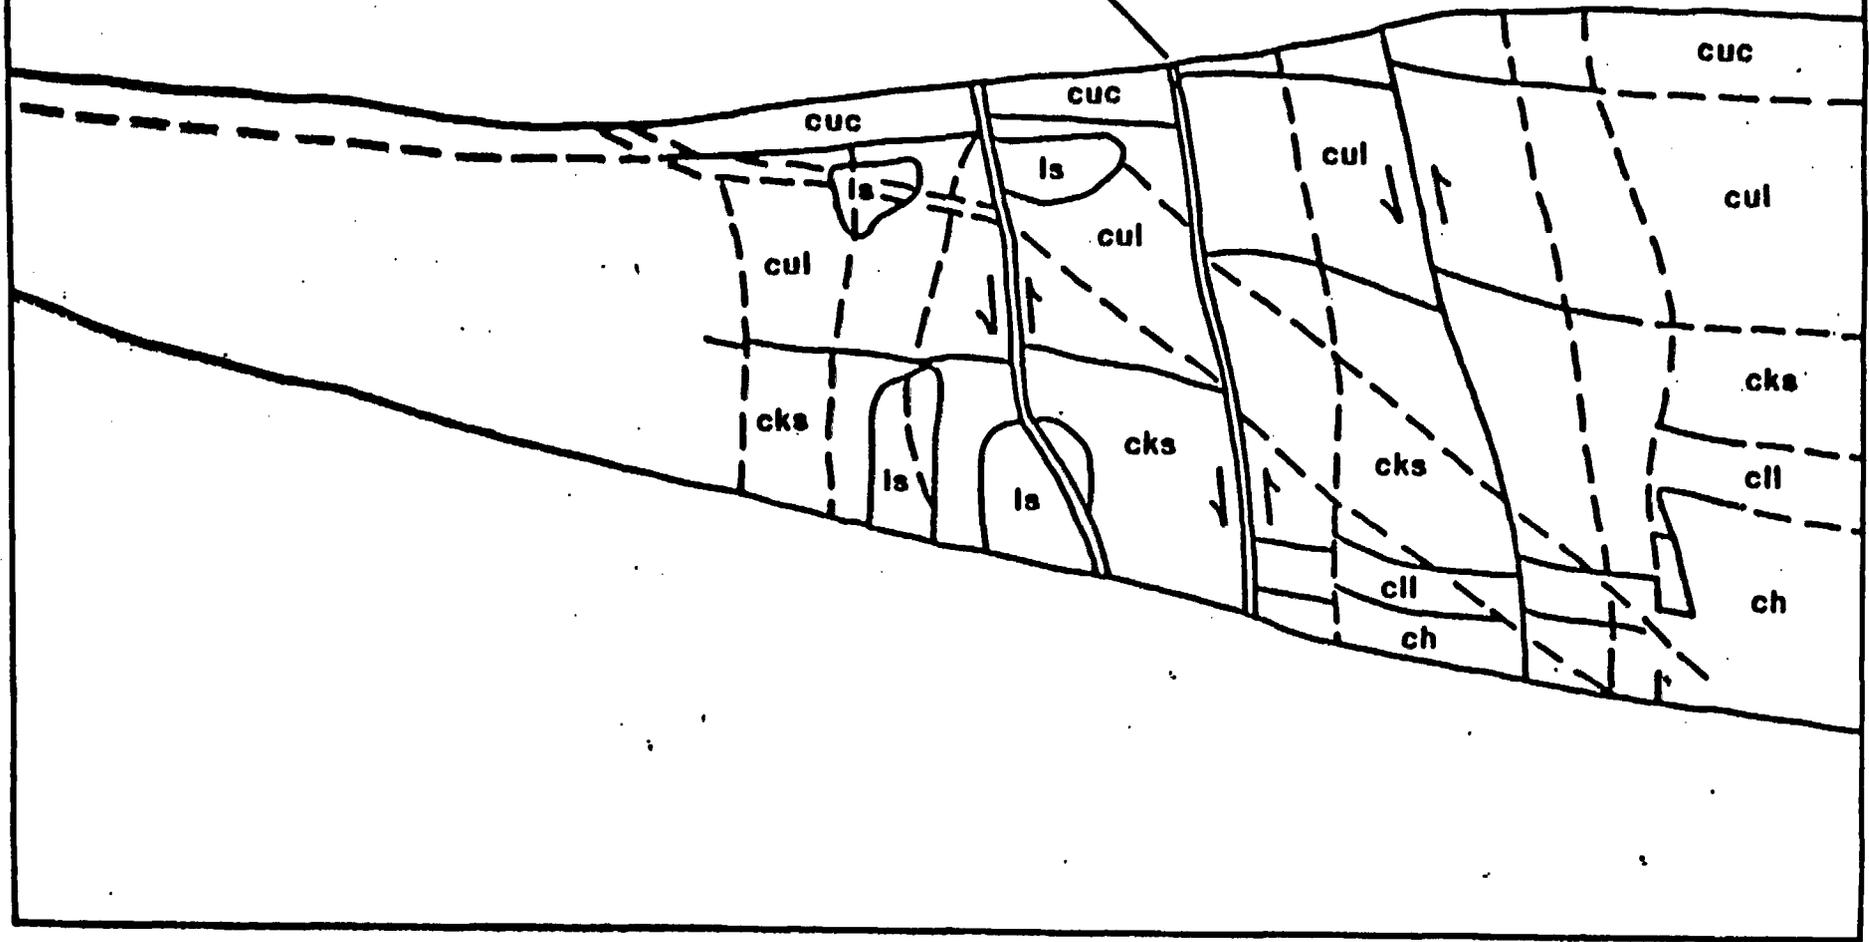
VIEW NORTH OF ANTLER RIDGE
SHOWING GHOST DANCE FAULT ZONE
(OVERLAY)

Southern exposure Antler Ridge
view is North thru Christ Dome (GD)
250' of section

ORIGINAL GHOST
DANCE FAULT

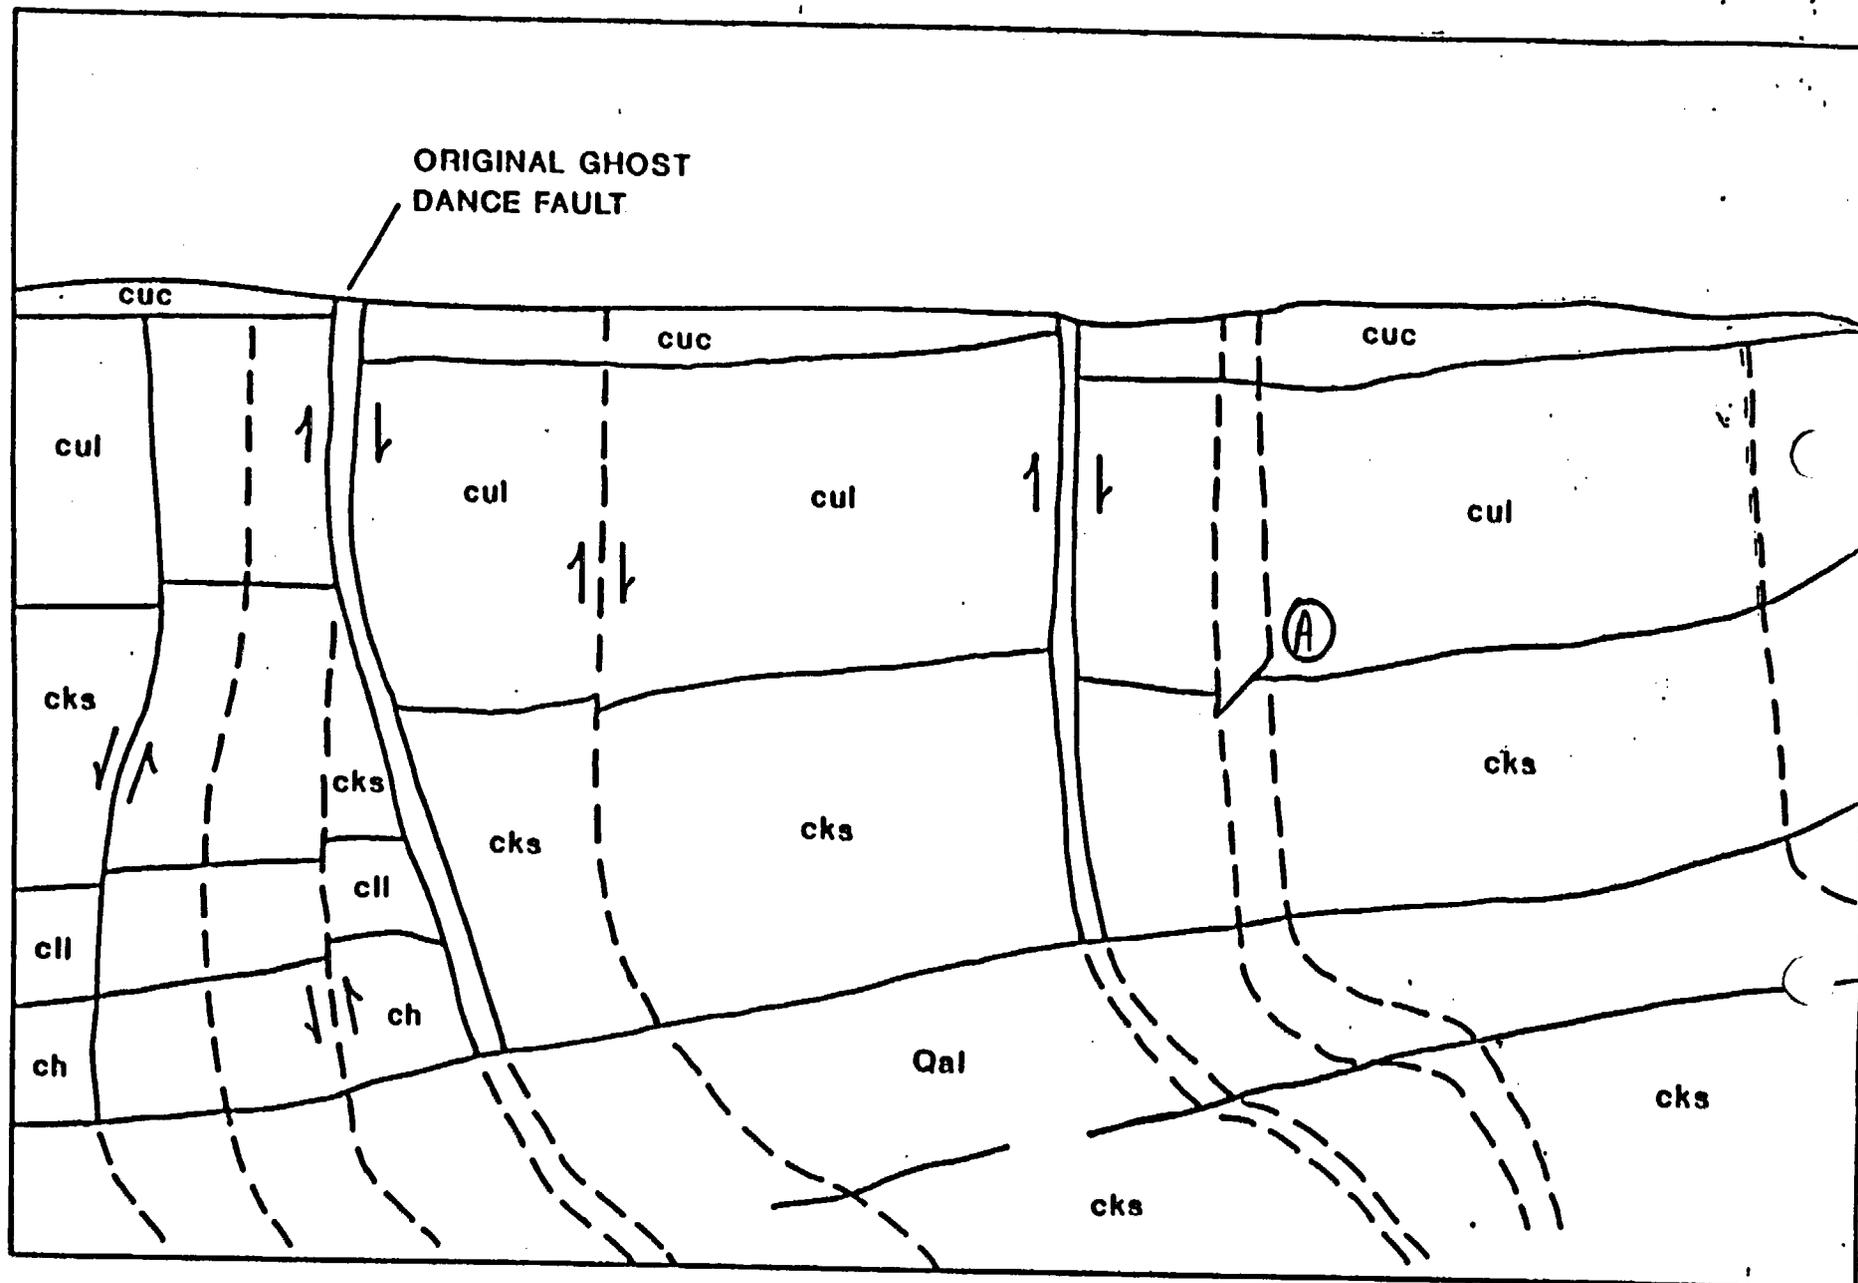
SOUTHERN VIEW OF BROKEN LIMB RIDGE

View to South
WTZ pad area
200' of Section

Breached Zones

Ⓐ ≡ abrupt change in dip
