# Nozzle Insulation Collars

# Inspection Plans

# Last Outage - 2R15

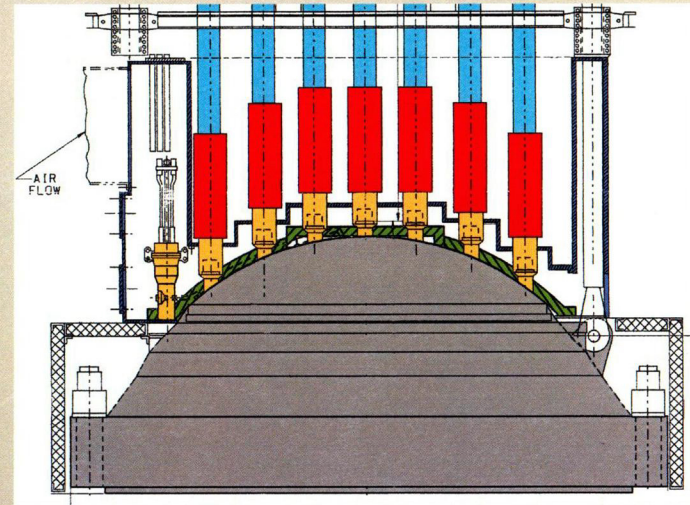
# 2R15 - Supplemental Visual Inspection Above Insulation

- ▶ Performed visual exam above shroud, around all ICI nozzles, and some outboard CEDM nozzles
- ▶ No boron found
