RESPONSE TO NRC QUESTIONS ON STEAM GENERATOR TUBE INSPECTION

PREPARED BY FLORIDA POWER AND LIGHT COMPANY

ST. LUCIE UNIT 2 - DOCKET NO. 50-389

Reference: NRC letter dated April 8, 2003, Saint Lucie Nuclear Plant, Unit 2:
Upcoming Steam Generator Tube Inservice Inspection (TAC No. MB81 34)

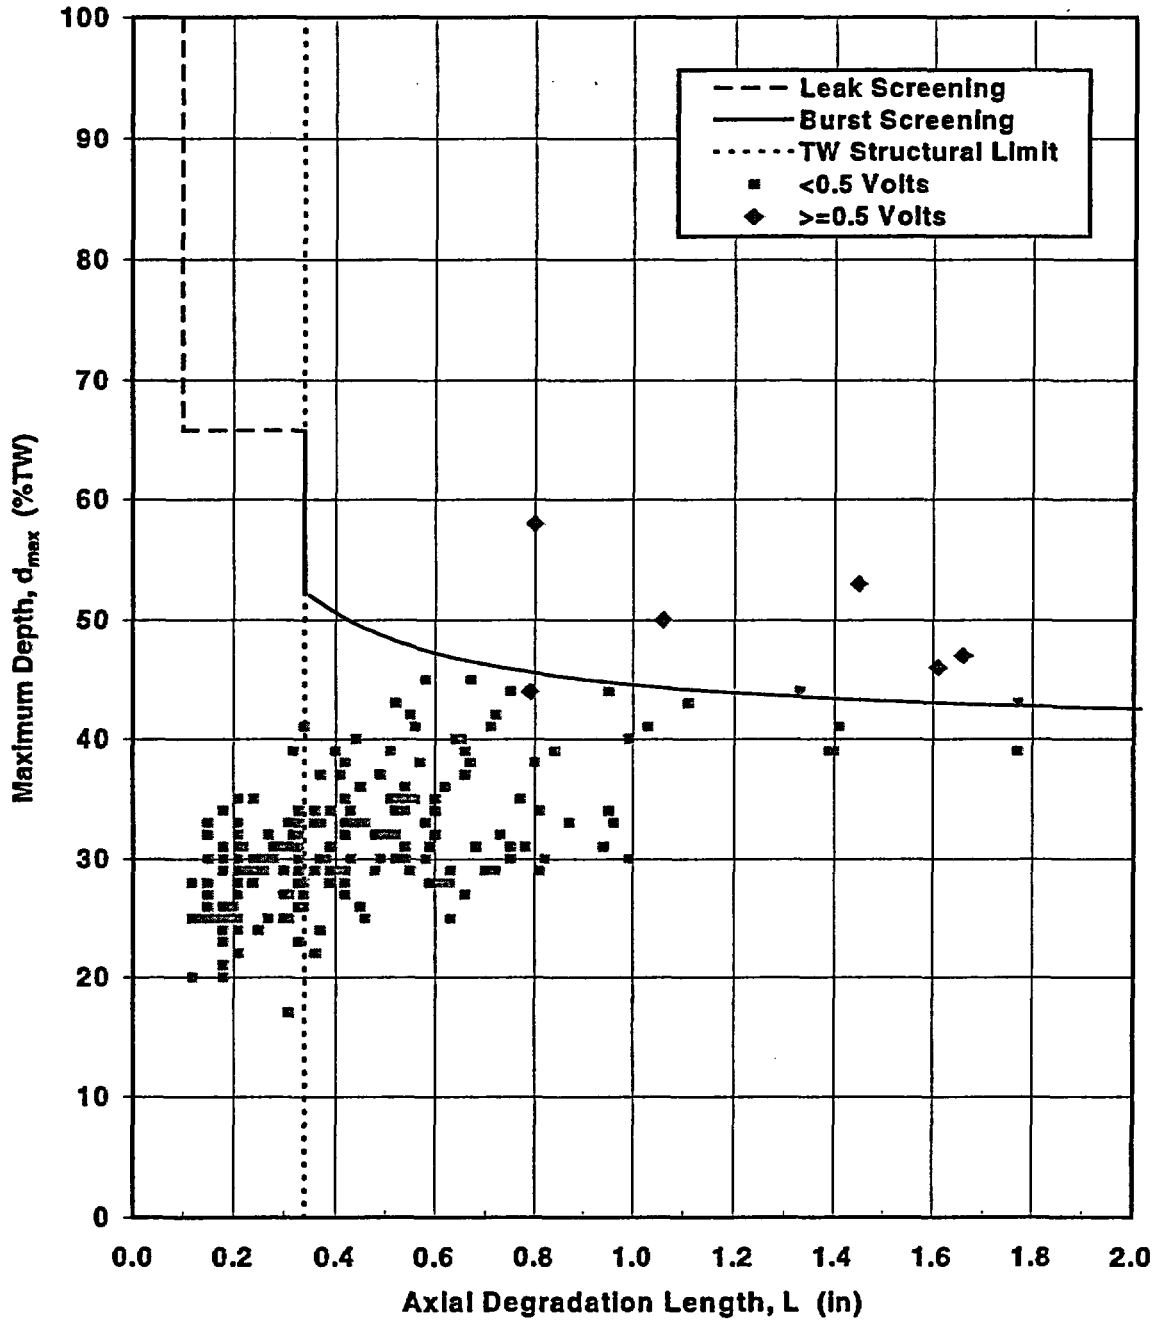
Axial ODSCC at Eggcrates Screening Limits - PSL-2 SG A

Initial in situ screening plots are provided for indications reported in the April 2003 inspection to provide a perspective on estimated length, depth and voltage. This initial screening is conservative in that the flaw is modeled by a bounding geometric shape. For example, a circumferential indication is treated as a rectangular-shaped crack where the maximum depth is assumed over the entire flaw length. Flaws exceeding the screening criteria are further evaluated with detailed plus point profiles and structural evaluations are then completed to determine if these flaws require in situ testing. For the flaws evaluated to date, none require in situ testing based on these evaluations.

Reply – No new degradation modes were detected in this inspection. Axial ODSCC continues to be the dominant mechanism. The number of axial indications at eggcrate tube supports is greater than expected. However, the severity of these indications does not appear to present a challenge to tube integrity.

Reply – Wear indications will be plugged based on the Technical Specification plugging limit of 40% through-wall depth. Corrosion indications will be plugged on detection.
