**RESPONSE TO NRC QUESTIONS ON STEAM GENERATOR TUBE INSPECTION**

**PREPARED BY FLORIDA POWER AND LIGHT COMPANY**

**ST. LUCIE UNIT 2 - DOCKET NO. 50-389**

Reference: NRC letter dated April 8, 2003, Saint Lucie Nuclear Plant, Unit 2:  
Upcoming Steam Generator Tube Inservice Inspection (TAC No. MB81 34)

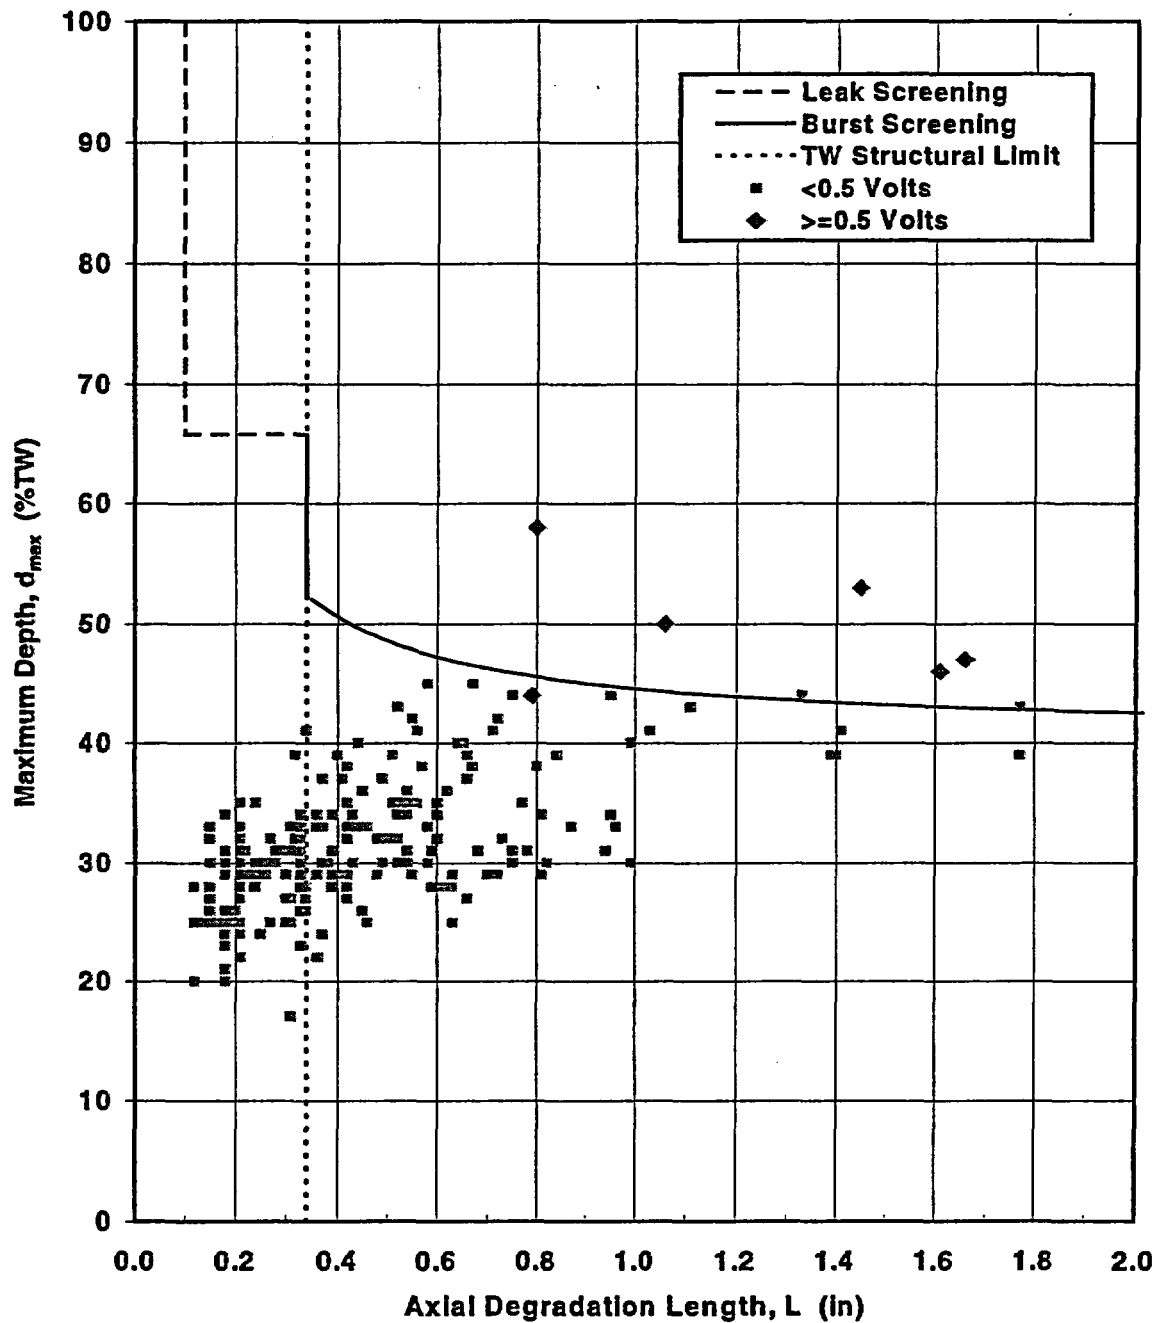
**Axial ODSCC at Eggcrates Screening Limits - PSL-2 SG A**

Initial in situ screening plots are provided for indications reported in the April 2003 inspection to provide a perspective on estimated length, depth and voltage. This initial screening is conservative in that the flaw is modeled by a bounding geometric shape. For example, a circumferential indication is treated as a rectangular-shaped crack where the maximum depth is assumed over the entire flaw length. Flaws exceeding the screening criteria are further evaluated with detailed plus point profiles and structural evaluations are then completed to determine if these flaws require in situ testing. For the flaws evaluated to date, none require in situ testing based on these evaluations.

Reply – No new degradation modes were detected in this inspection. Axial ODSCC continues to be the dominant mechanism. The number of axial indications at eggcrate tube supports is greater than expected. However, the severity of these indications does not appear to present a challenge to tube integrity.

Reply – Wear indications will be plugged based on the Technical Specification plugging limit of 40% through-wall depth. Corrosion indications will be plugged on detection.
