**SUBJECT: NRC HISTORICAL REVIEW TEAM REPORT - RADIOLOGICAL CONTROL AND  
AREA CONTAMINATION ISSUES AT HADDAM NECK**

## HISTORICAL REVIEW TEAM REPORT

March 1998

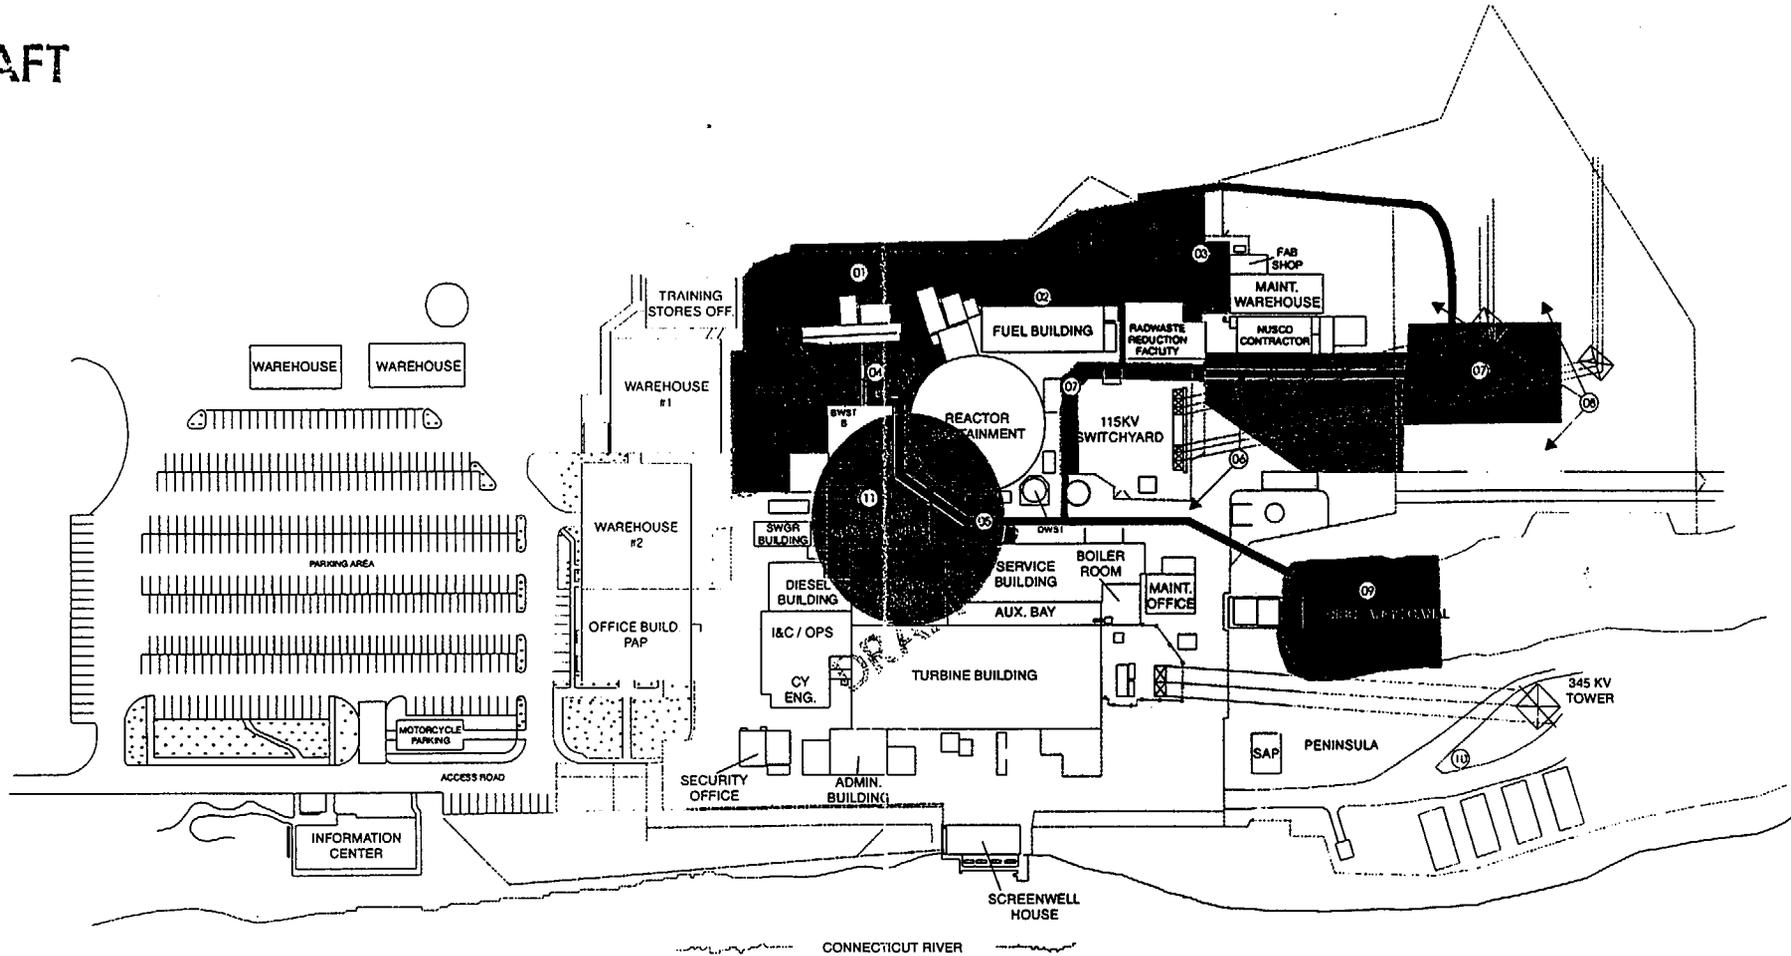
SUPPLEMENT A-2

The licensee's documentation indicated that areas of potential residual contamination were principally located around (and potentially under) various radiological controlled process buildings. A site map depicting suspected areas of residual contamination is included as Supplement A-2. These buildings are centrally located on the site and within the protected area. The licensee performed core bores at three locations around this area and noted that, based on these limited preliminary samples, no significant subsurface (e.g., greater than 6 inches) residual activity was present. Additional samples are planned.

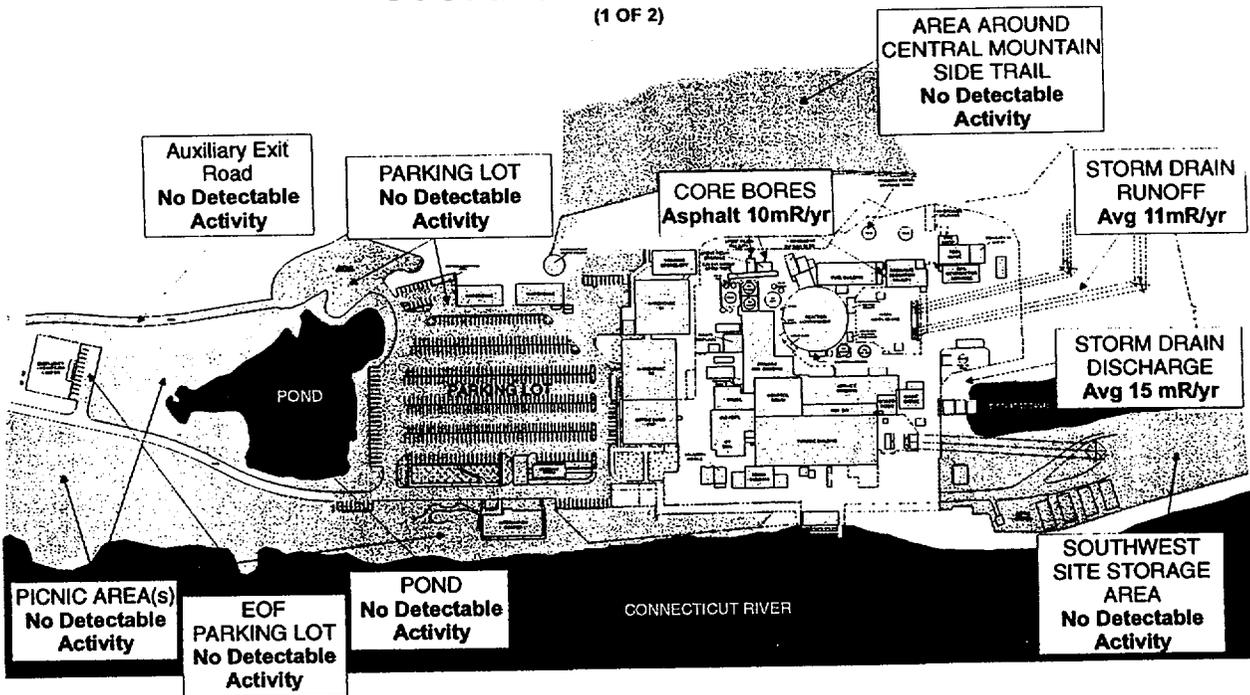
**SCOPING SURVEY STATUS**

COMMENTS: Areas Evaluated by Scanning, Soil Sampling and Exposure Rate Readings
