**SOUTH TEXAS PROJECT UNIT 1  
BOTTOM MOUNTED INSTRUMENTATION NOZZLE  
LEAKAGE ISSUE**

**Matthew A. Mitchell, Senior Materials Engineer  
Materials and Chemical Engineering Branch  
Office of Nuclear Reactor Regulation**

**Advisory Committee on Reactor Safeguards Full Committee Meeting  
July 11, 2003**

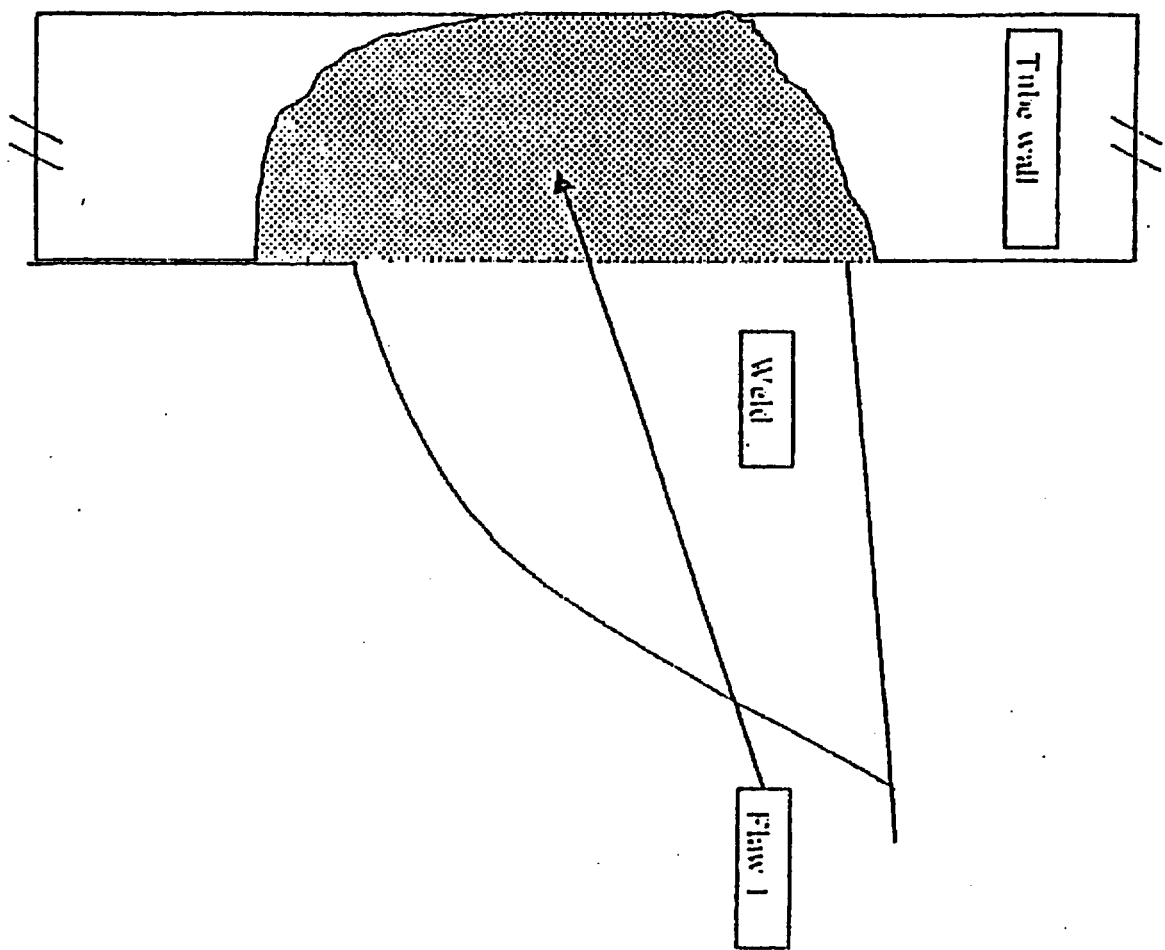
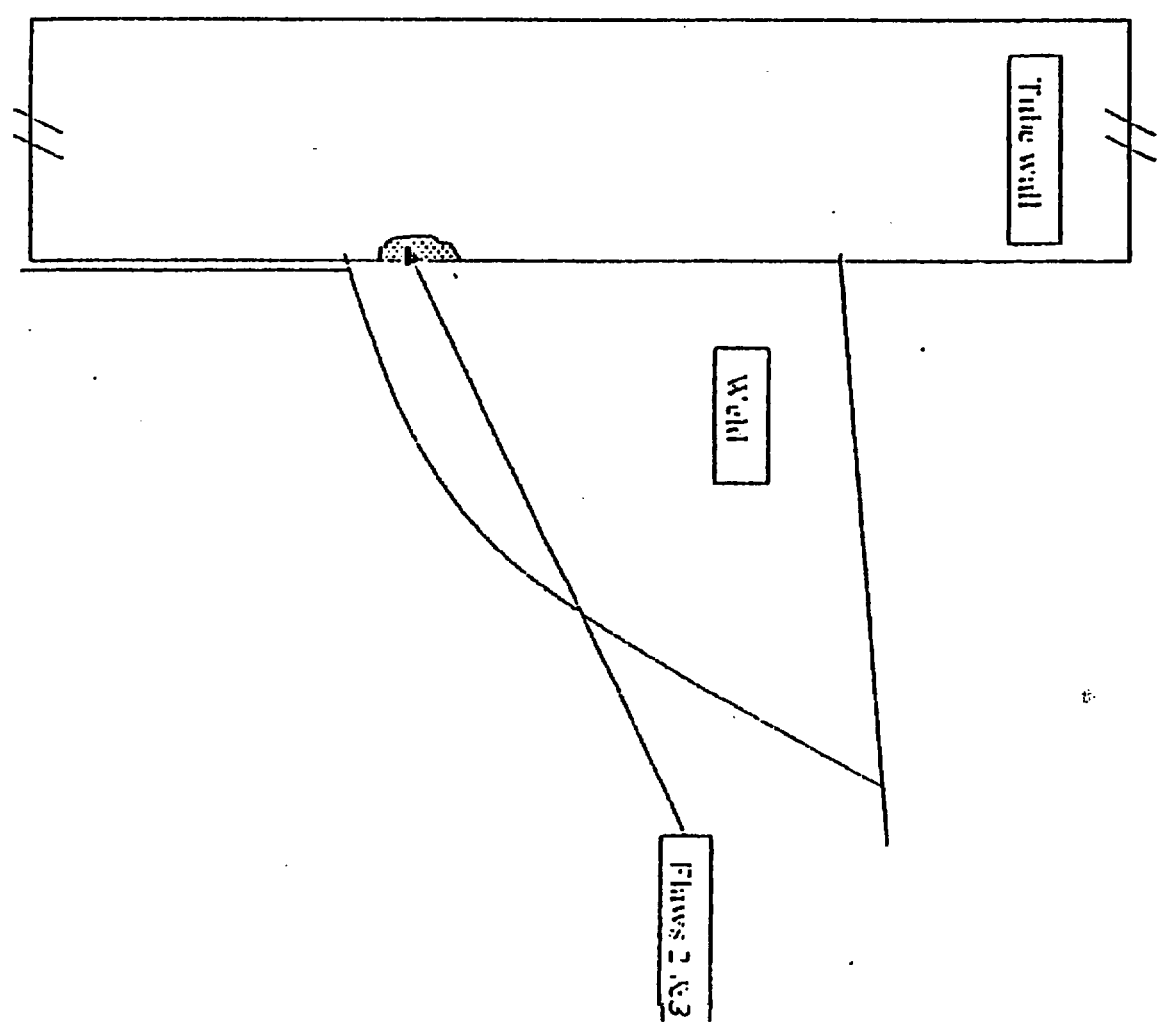
# Penetration #1

- In April 2003, the licensee discovered deposits characterized as, in total, “about the size of one half of an aspirin tablet” around bottom mounted instrumentation (BMI) penetrations #1 and #46.
- Chemical analysis showed evidence of boron and lithium, indicating the reactor coolant system (RCS) to be the most likely source of the deposits.
- Radiochemical analysis based on cesium isotope dating indicated that the deposits were approximately four years old.

- The licensee's NDE results showed:
  - Three axially-oriented indications in nozzle #1. One indication characterized as having a length of ~1.38 inches, extending from above to below the J-groove weld and penetrating the ID of the tube. The other two indications were much smaller and near the root of the weld.
  - Two axially-oriented indications in nozzle #46. One indication characterized as having a length of ~0.98 inches and extending from above to below the J-groove weld. The other indication characterized as having a length of ~0.95 inches and not surface connected.
  - EVT-1 examinations showed signs of extensive grinding on the nozzle and J-groove weld surfaces of many penetrations.

- The licensee has repaired STP Unit 1 nozzles #1 and #46 using a “half nozzle repair” similar in design to those used to repair other Alloy 600 penetrations.
- The repair was made using Alloy 690 nozzle material and Alloy 52/152 weld material, including the installation of a temper bead weld pad on the outside of the RPV lower head. The RCS pressure boundary weld was moved to the outside surface of the RPV.
- Questions regarding future inspections of the repair, along with inspections of the ferritic base material which will be left exposed to the reactor coolant, are being addressed by the licensee in support of NRC staff review and approval of the repair.
