South Texas Project Electric Generating Station P.O. Box 289 Wadsworth, Texas 77483

July 11, 2003
NOC-AE-03001557
10CFR50

South Texas Project
Units 1 & 2
Docket Nos. STN 50-498, STN 50-499
Additional Information Regarding STP's Commitment to Investigate and Repair
Bottom Mounted Instrumentation Penetration Indications

South Texas Project Status Report on Resolving the Unit 1 BMI Issue

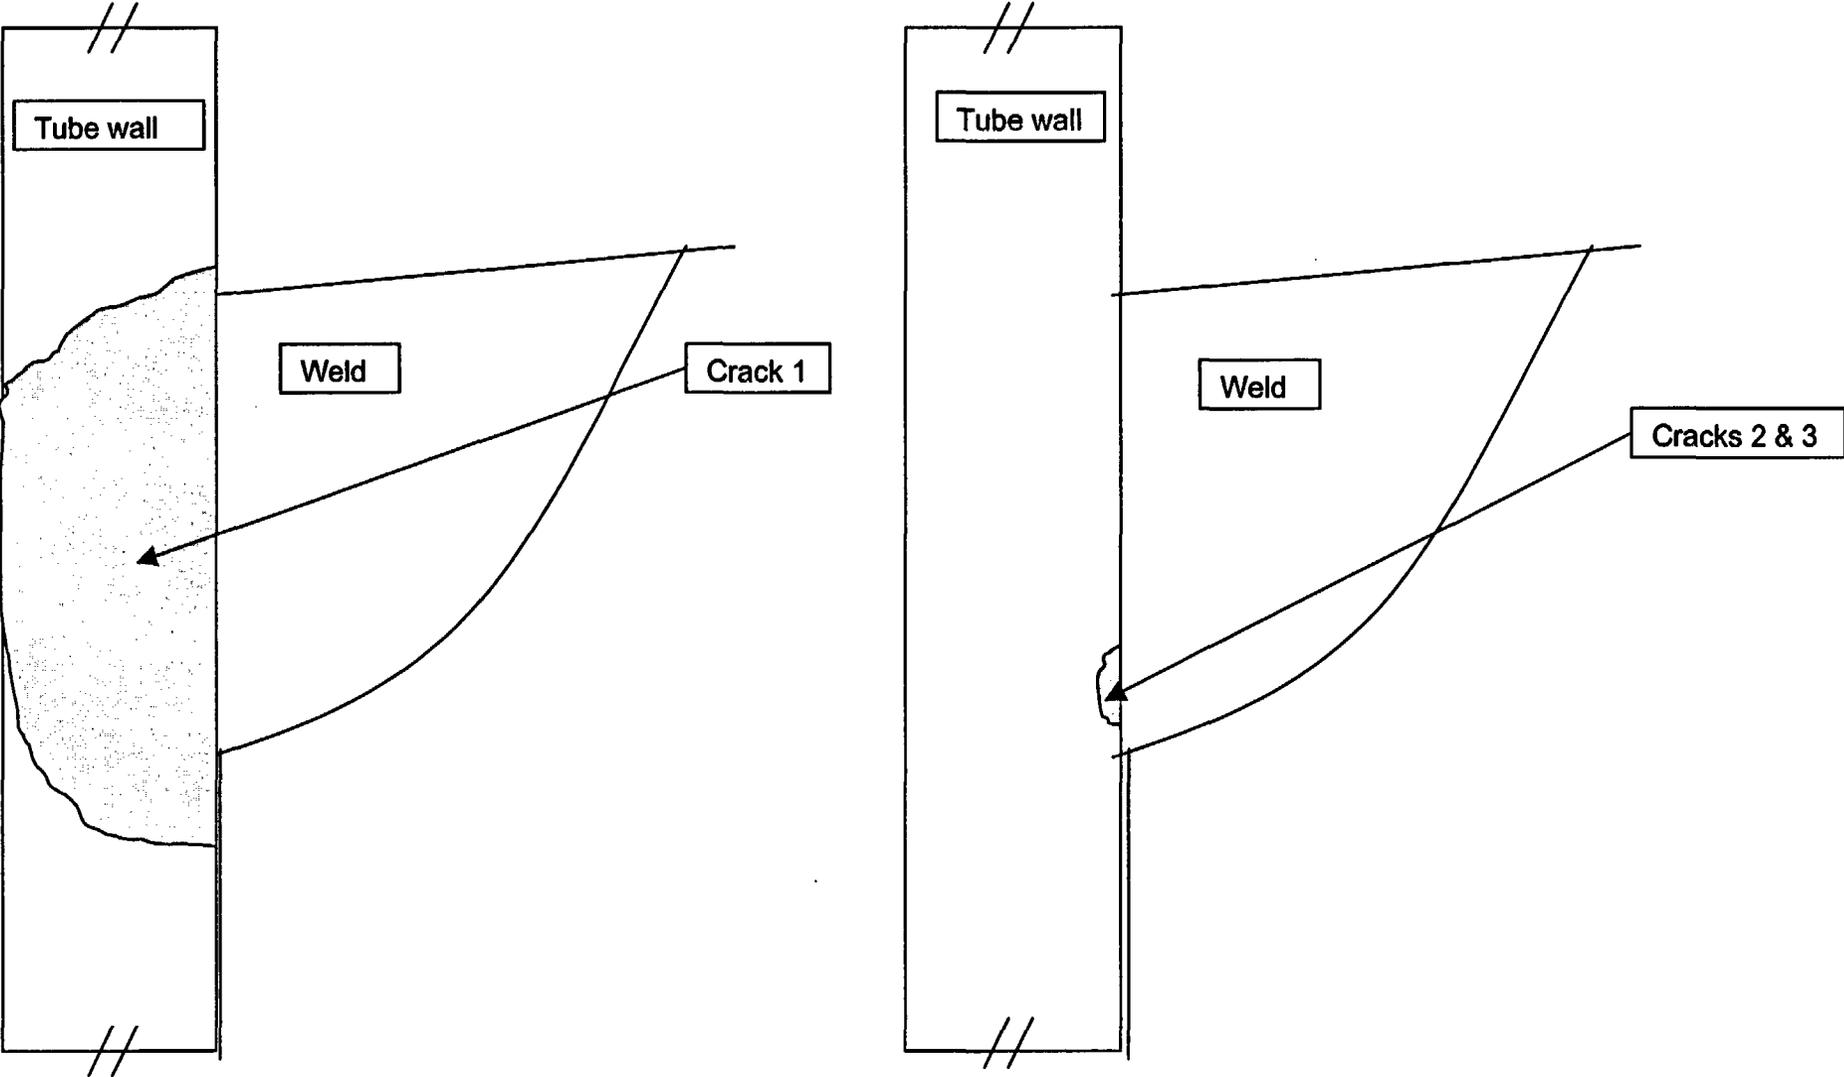
South Texas Project Status Report on Resolving the Unit 1 BMI Issue – Attachment 5 Two Dimensional Representation of Cracks in Nozzle 1

Nozzle 1 had three cracks. Each crack was axially oriented to the J-groove weld. One crack extended above and below the J-groove weld and penetrated the inside diameter of the nozzle. The second and third cracks were much smaller and on the outside diameter of the nozzle close to the initial weld passes. The second and third cracks did not extend above or below the J-groove weld and did not penetrate the inside diameter of the weld.

All three probes confirmed the presence of five cracks, three in nozzle 1 and two in nozzle 46. Attachments 5 and 6 are two-dimensional representations of the cracks. There were no cracks indicated in any of the remaining nozzles, and no circumferential cracks were found. In addition, the UT probes indicated anomalous conditions at the nozzle weld interface in all of the nozzles, possibly indicating lack of weld fusion or some other anomalous weld condition. The possible significance of lack of fusion in the BMI nozzle welds is discussed later in Section V. E. 4. The extensive data derived from the primary UT inspection are electronically recorded for detailed analysis and preserved as a baseline for future UT inspections.
