Millstone Power Station, Unit No. 3
Relief Request From ASME Code Section XI Repair and Replacement Requirements
For a Flaw in a Service Water System Brazed Joint

**Millstone Power Station, Unit No. 3
Summary of Flaw Evaluation and Relief Request From ASME Code Section XI
Repair and Replacement Requirements for a Flaw in a Service Water System Brazed Joint**

Technical Evaluation M3-EV-03-0014
Structural Evaluation of Line 3-SWP-003-67-3 with Leak on Brazed Joint FW-74-1

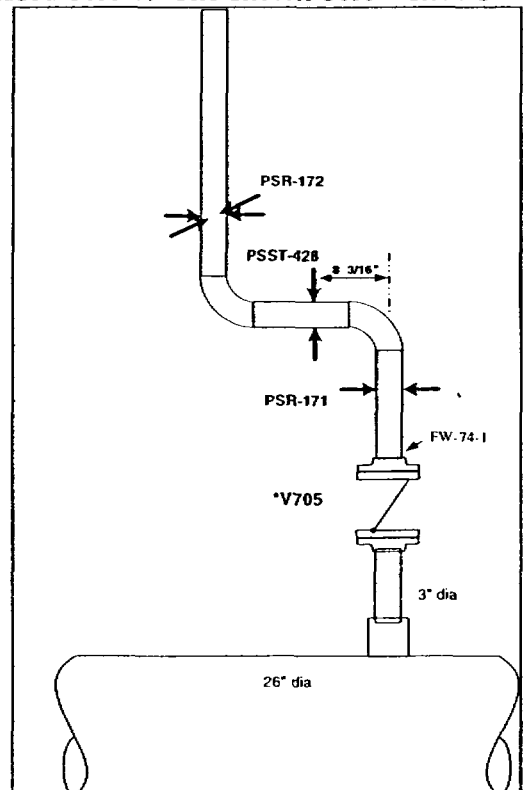
For the purpose of analyzing structural capacity of the associated components, this evaluation assumes the total loss of the leaking brazed joint. In this case, the configuration of piping and supports is such that the piping is constrained to stay within the fitting socket, and the leakage flow is limited by the small annular area between the pipe and fitting socket. At full design pressure of 100 psig the pressure thrust attempting to separate the joint would be approximately 740 lbs. Seismic and other design loads are also considered as discussed below. The sketch below shows the basic configuration under consideration.

The piping is restrained in the vertical direction by hanger strut PSST428 that is offset only 8.2 inches from the brazed joint. The strut has essentially a zero gap. Therefore, vertical deflection of the pipe out of the braze socket is minimal compared to the approximately ½” engagement. Per Reference 14, vertical load capacity of PSST 428 is well in excess of the 2338 lb. original design value and provides sufficient margin for the maximum calculated load of 2011 lb per Reference 14. This design load includes seismic, thermal and deadloads. With the brazed joint disrupted, the thermal expansion load is minimal. Therefore the additional thrust load is within the capability of the support. Similarly, N-S pipe support PSR171, located 14 inches above FW-74-1, has a design capacity of 1988 lb. and a maximum calculated load of 430 lb per Reference 12. Downstream a two way lateral support, located approximately 4 feet away from FW-74-1, has significant design capacity in the pipe strap

(Reference 13) and tube steel frame (Reference 15) to accommodate increased load postulated from the failure of FW-74-1. Valve 3SWP*V705 is anchored by the 26" header pipe line 3-SWP-026-66-3 that is also well restrained. The remaining stub of pipe to the header pipe is short so no excessive bending moments will be generated even in a seismic event. Thus, because the line and valve are rigidly supported, the pipe can not disengage from the flange socket, even with full pressure and seismic loads applied under accident conditions. The monel pipe retains its integrity with no degradation (Reference 16), and the flange socket hub retains integrity and can be credited for side loading at the piping interface. There is only a thin annular area (associated with initial fit-up clearances) between the pipe and flange socket so leakage flow would be minimal. The predicted leakage flow has been determined to be acceptable with regard to system performance, Reference 5. Therefore it is concluded the piping will maintain its structural contiguity and flow capability even though the brazed joint is assumed totally failed and leakage will occur.
